SI B11 18 18  
Engine

## SERVICE ACTION: ALPINA B7 WITH N63R ENGINE – CHECK AND REPLACE OIL FEED LINES AND THE MAP THERMOSTAT ELECTRICAL CONNECTOR

G12 (ALPINA B7 Sedan)

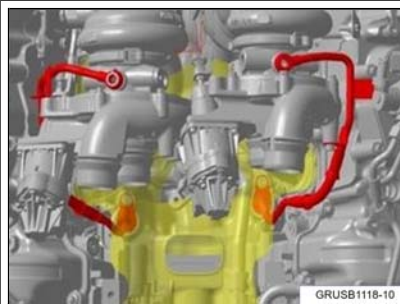
Turbocharger oil feed line overview:

The oil feed line locations are shown with red highlight

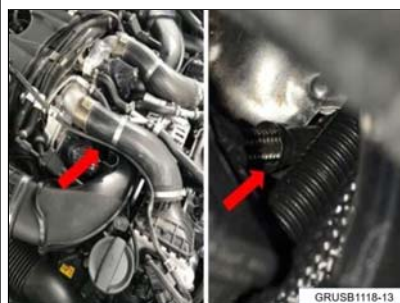
2. Check the exhaust turbocharger oil feed line on bank 1.

If the flexible section of the feed line is made of braided stainless steel (see arrows) then take no further action. **Do not replace the line.**

If the flexible section is black rubber then the oil feed line will need to be replaced.

**Refer to Repair Instruction 11 42 200 "Remove and install / renew the oil feed line for the exhaust turbocharger N63O2"**  
**Do not remove the turbochargers!**

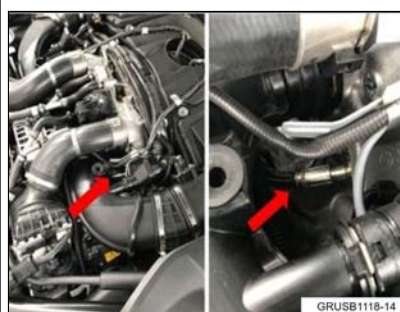
3. Check the exhaust turbocharger oil feed line on bank 2.

If the flexible section of the feed line is made of braided stainless steel (see arrows) then take no further action. **Do not replace the line.**

If the flexible section is black rubber then the oil feed line will need to be replaced

**Refer to Repair Instruction 11 42 200 "Remove and install / renew the oil feed line for the exhaust turbocharger N63O2"**  
**Do not remove the turbochargers!**

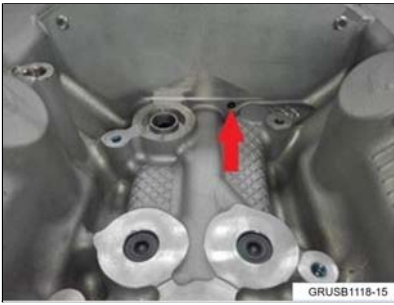
Check the engine block (V-space) for engine oil residue and clean as needed.

If there is leakage, the exhaust system, both exhaust turbochargers, the lower heat shield, the complete exhaust manifold and the oil-to-coolant heat exchanger needs to be removed to clean this area.

| | <p>11 62 065 "Removing and installing/replacing the right exhaust manifold (bank 1-4)"<br/> 11 44 000 "Removing and installing/replacing the oil-to-coolant heat exchanger"<br/> Wipe dry with a shop towel and rinse the residual oil with cleaner via the drain hole and flush it out (see arrow).</p> |

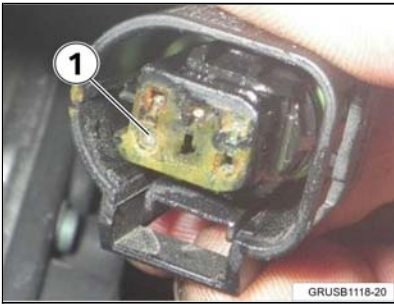
| | <p>2. Remove the connector and check the pins in the connector for traces of water or corrosion.</p> <p>Example: This connector is already corroded.<br/> If the pins in the connector are corroded, the engine wiring harness and the characteristic map thermostat need to be replaced.<br/> Refer to the following Repair Instructions:<br/> 12 51 300 "Removing and installing/replacing the wiring harness section of engine ignition control for cylinders 1-4".<br/> 11 53 000 "Removing and installing/replacing the coolant thermostat".</p> |

**If no corrosion is found then do not replace any parts.**
