TECHNICAL SERVICE BULLETIN

Intermittent Grinding Noise From Integrated Wheel Ends (IWEs) While Driving In Two Wheel Drive (2WD)

18-2273
17 September
2018

Ford 2013-2018 Expedition
2013-2018 F-150
Lincoln 2013-2018 Navigator

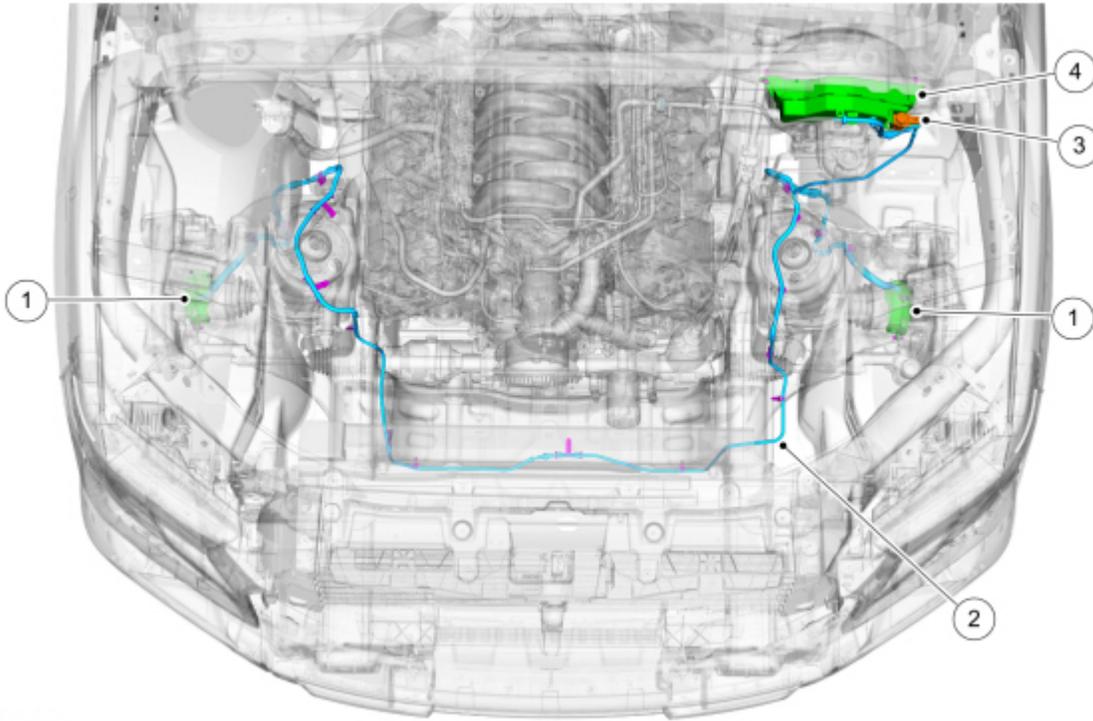
Figure 1

1. Inspect the IWE vacuum hoses. Refer to Workshop Manual (WSM), Section 308-07A. Are there any disconnected or damaged vacuum hoses? (Figure 1)

(1). Yes - this article does not apply. Refer to WSM, Section 308-07A for normal diagnostics.

(2). No – proceed to Step 2.
