## BR 190 - Worn seat cover in area of side bolster (code 555)

| Topic number | LI91.18-P-067198 |
| Validity | MODEL 190.3## (code 555) up to production date 12/2016 |

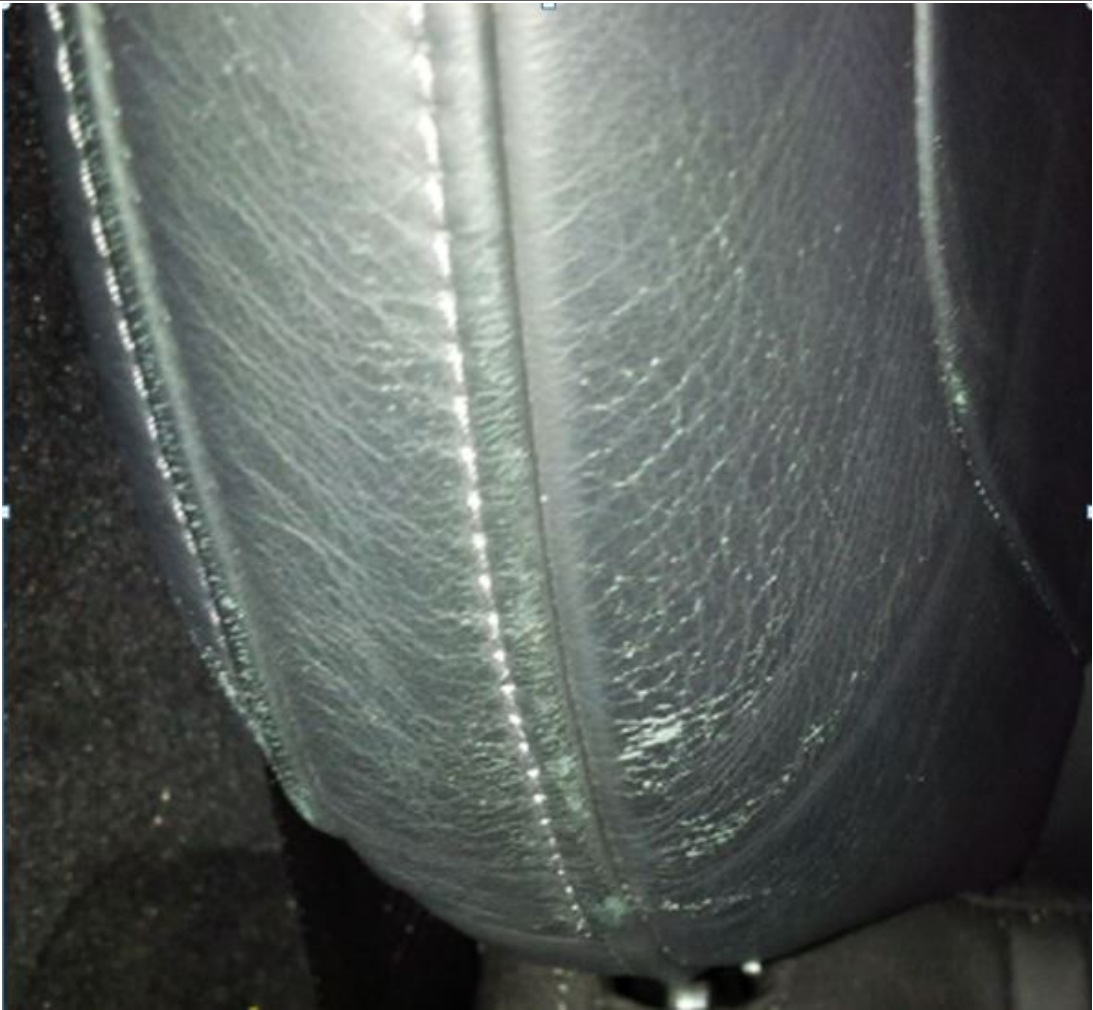
Beschädigung\_Abnutzung Sitzbezug.JPG:

Worn seat cover in area of side bolster.

| Attachments | |
|---|---|
| Beschädigung_Abnutzung Sitzbezug.JPG | Damage/wear on seat side bolster/seam |

Material wear in area of seat cushion and/or backrest.

Replace left and/or right front seat backrest cover.

Important: The trim in the seat backrest must not be removed. The cover can be unhooked (see instructions for unhooking cover from trim).
