# Service Action

## Code: 66J8

| Subject | Under Hood Cowl Seam |
| Affected Vehicles | <b>U.S.A. &amp; CANADA: Certain 2018 MY Volkswagen Tiguan</b><br><i>Check Campaigns/Actions screen in Elsa on the day of repair to verify that a VIN qualifies for repair under this action. Elsa is the <u>only</u> valid campaign inquiry &amp; verification source.</i> <ul style="list-style-type: none"><li>✓ Campaign status must show "open."</li><li>✓ If Elsa shows other open action(s), inform your customer so that the work can also be completed at the same time the vehicle is in the workshop for this campaign.</li></ul> |

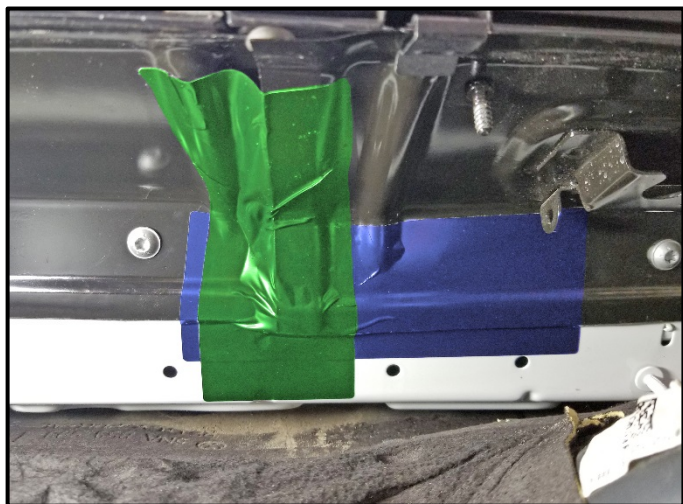
| Problem Description | In certain situations, water may leak through the seam in the under hood cowl and into the vehicle interior. |

- Install water tape over cowl seam to divert water drainage.
