UPDATE Technical Bulletin

August 02, 2018

UPDATE – 69V7 Atlas Quality Package (NVLW)

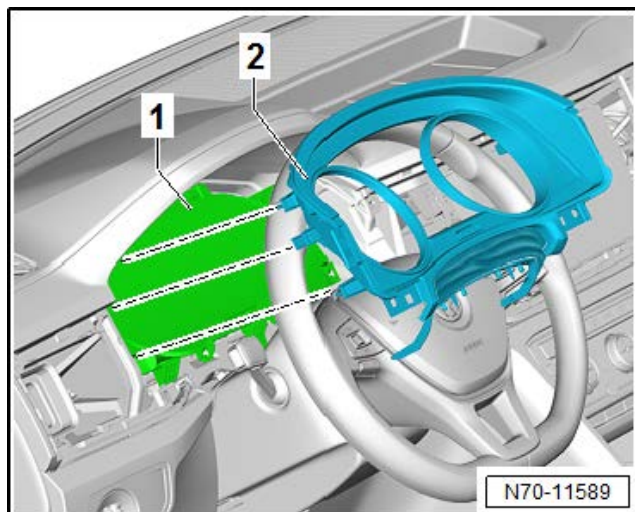
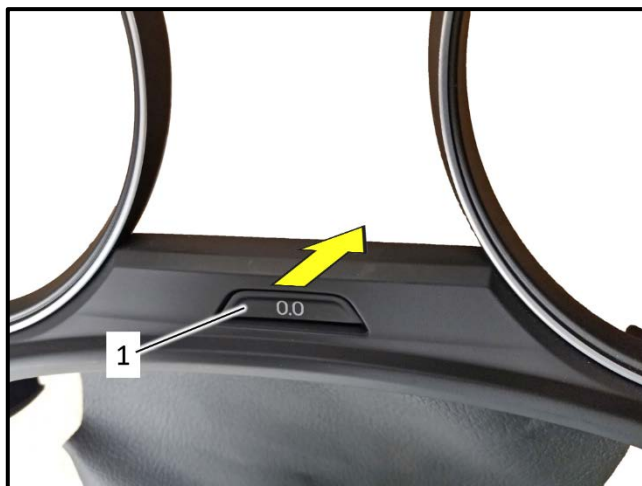
Criteria 04: Reset button sticks in the instrument panel. This can also cause the clock to reset on its own and/or DTC B123807: Instrument panel insert buttons mechanical malfunction.

Criteria 04: Due to excess material on the reset button, the reset button sticks.

- Remove instrument cluster trim <2>:
- Refer to ELSA Repair Manual: *Repair Manual > Body > Body Interior > 70 Interior Trim > Instrument Panel > Instrument Cluster Trim, Removing and Installing*
- Remove components in the following order:
 1. Outer instrument panel vent (left side vent)
 2. Center vents
 3. Infotainment display
 4. Passenger side decorative trim
 5. Center instrument panel decorative trim
 6. Upper steering column trim

- The upper steering column trim does not need to be removed from the instrument cluster trim.
 - The upper steering column trim only has to be separated from the lower steering column trim.
-
- Press out the reset button <1> in direction of <arrow>.
 - Install new reset button.
 - Reinstall instrument cluster trim.
 - Reassemble components in the reverse order of removal.
