# UPDATE Technical Bulletin

August 09, 2018

## UPDATE – 69V7 Atlas Quality Package (NVLW)

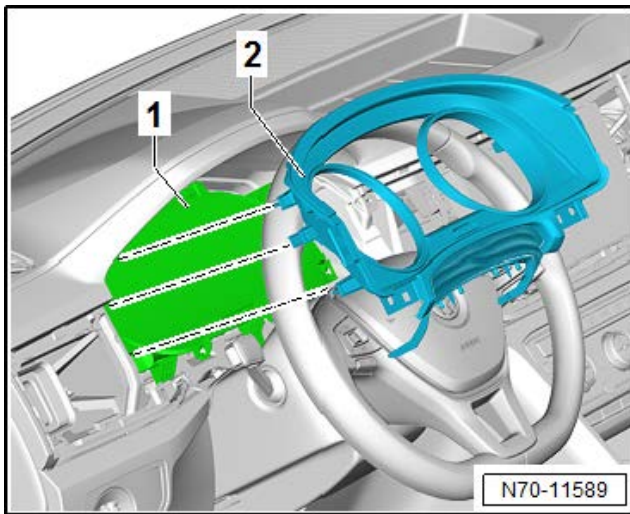
**Criteria 04:** Reset button sticks in the instrument panel. This can also cause the clock to reset on its own and/or DTC B123807: Instrument panel insert buttons mechanical malfunction.

**Criteria 04:** Due to excess material on the reset button, the reset button sticks.

- Remove instrument cluster trim <2>:
- Refer to ELSA Repair Manual: *Repair Manual > Body > Body Interior > 70 Interior Trim > Instrument Panel > Instrument Cluster Trim, Removing and Installing*
- Remove components in the following order:
  1. Outer instrument panel vent (left side vent)
  2. Center vents
  3. Infotainment display
  4. Passenger side decorative trim
  5. Center instrument panel decorative trim
  6. Upper steering column trim
