# Service Action

## Code: 40M3

<b>Subject</b>	<b>Coupling Rod Nuts and Air Conditioning Evaporator Drain Tube</b>
<b>Release Date</b>	August 15, 2018
<b>Revision Summary</b>	<b>Removed Criteria 02 (HVAC Drain Tube) repair and claiming.</b>
<b>Affected Vehicles</b>	<b>U.S.A. &amp; CANADA: Certain 2018 MY Volkswagen Atlas</b> <i>Check Campaigns/Actions screen in Elsa on the day of repair to verify that a VIN qualifies for repair under this action. Elsa is the <u>only</u> valid campaign inquiry &amp; verification source.</i> <ul style="list-style-type: none"><li>✓ Campaign status must show "open."</li><li>✓ If Elsa shows other open action(s), inform your customer so that the work can also be completed at the same time the vehicle is in the workshop for this campaign.</li></ul>
<b>Problem Description</b>	Volkswagen has received reports of vehicle front end noise from customers. After detailed analysis, Volkswagen has determined that this noise originates from a loose fastener(s) at the front coupling rods.  Also, a small number of vehicles built within a certain production period may have an air conditioning evaporator drain tube that became twisted during vehicle assembly. This can

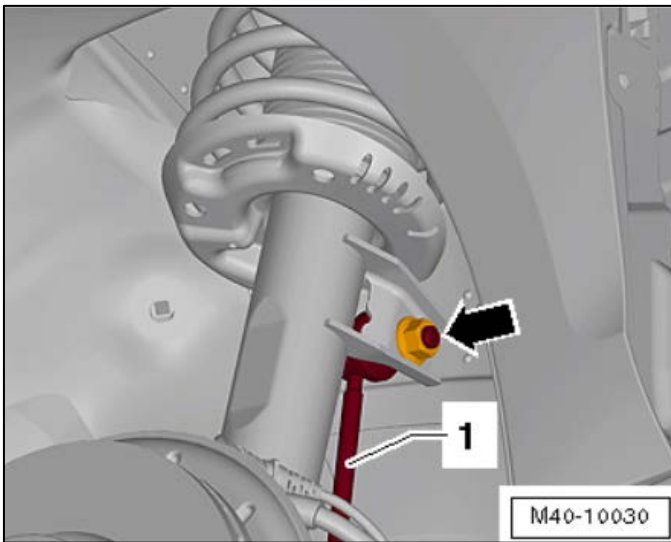
**Section B – Replace Coupling Rod Nuts**

- The front upper coupling rod nuts are being replaced on both sides of the vehicle.
- If the upper coupling rod nut was loose at the time of the repair and there is damage to the coupling rod, it must be replaced.
- The front wheels do not require removal to perform this repair.

Over-torquing the coupling rod nut can result in coupling rod bolt failure. Do not over-torque nut <arrow>.

- Raise vehicle on hoist.
- Remove upper coupling rod nuts <arrow>.
- Install new nuts and torque to 40 Nm + 60°.
