Technical Bulletin

Model(s)	Year	Eng. Code	Trans. Code	VIN Range From	VIN Range To
Tiguan LWB	2018	All	All	AX_JM000001	AX_JM158351

51 18 03 August 2, 2018 **2050753** Supersedes Technical Bulletin 51-18-02 (V511802) dated April 4, 2018 to update ending VIN range.

B-Pillar Noise while Driving

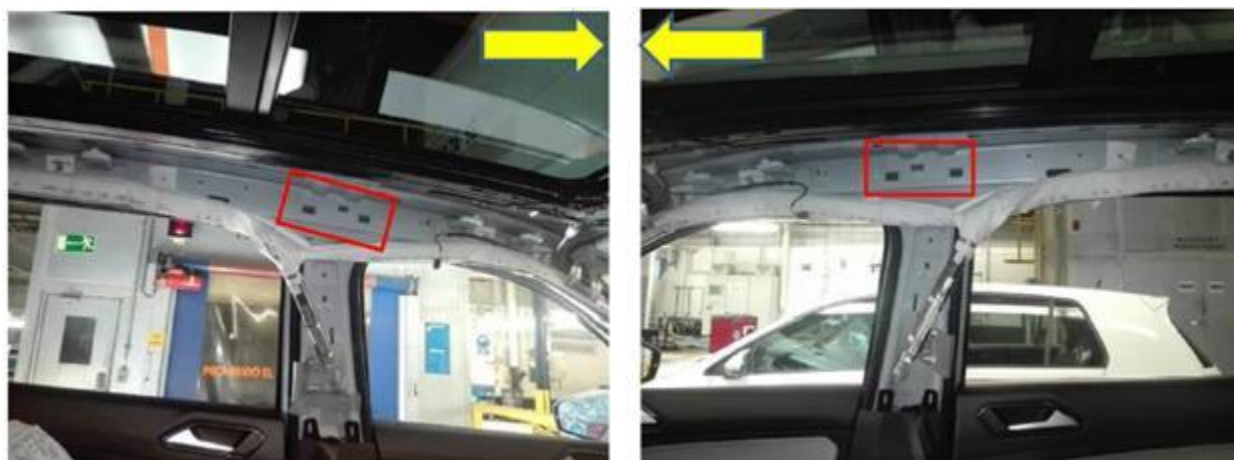
Figure 1 (NOTE: The direction of the YELLOW arrows indicates the front of the vehicle.)

- Partially remove the Head Curtain Airbag (only disconnect according to Repair Manual and remove the igniter, see Figure 1). See Repair Manual group 69 Passenger Protection in Elsa.

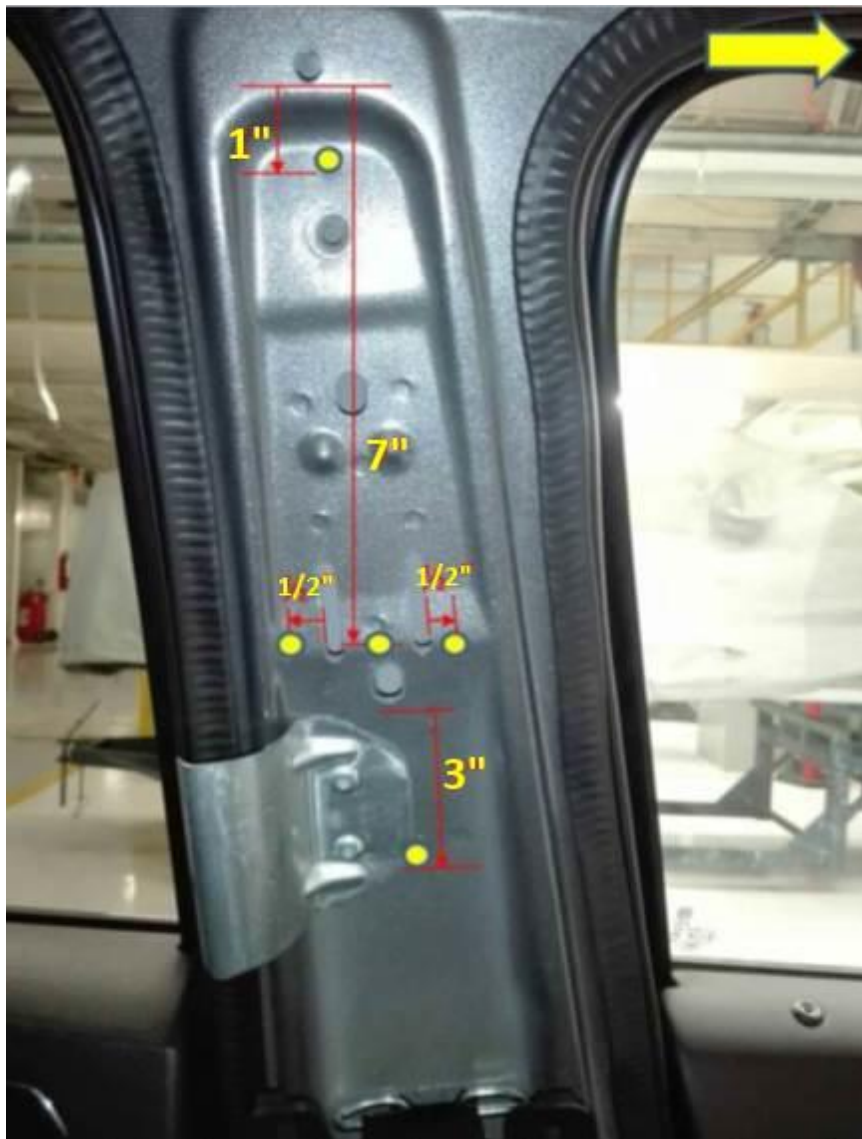
Figure 2: Striking points on the B-Pillar.

- 1.1 Using a conical punch $\frac{1}{2}$ " and metal 16 oz. hammer strike once moderately in the reference points indicated on B-Pillar below, see Figure 2.

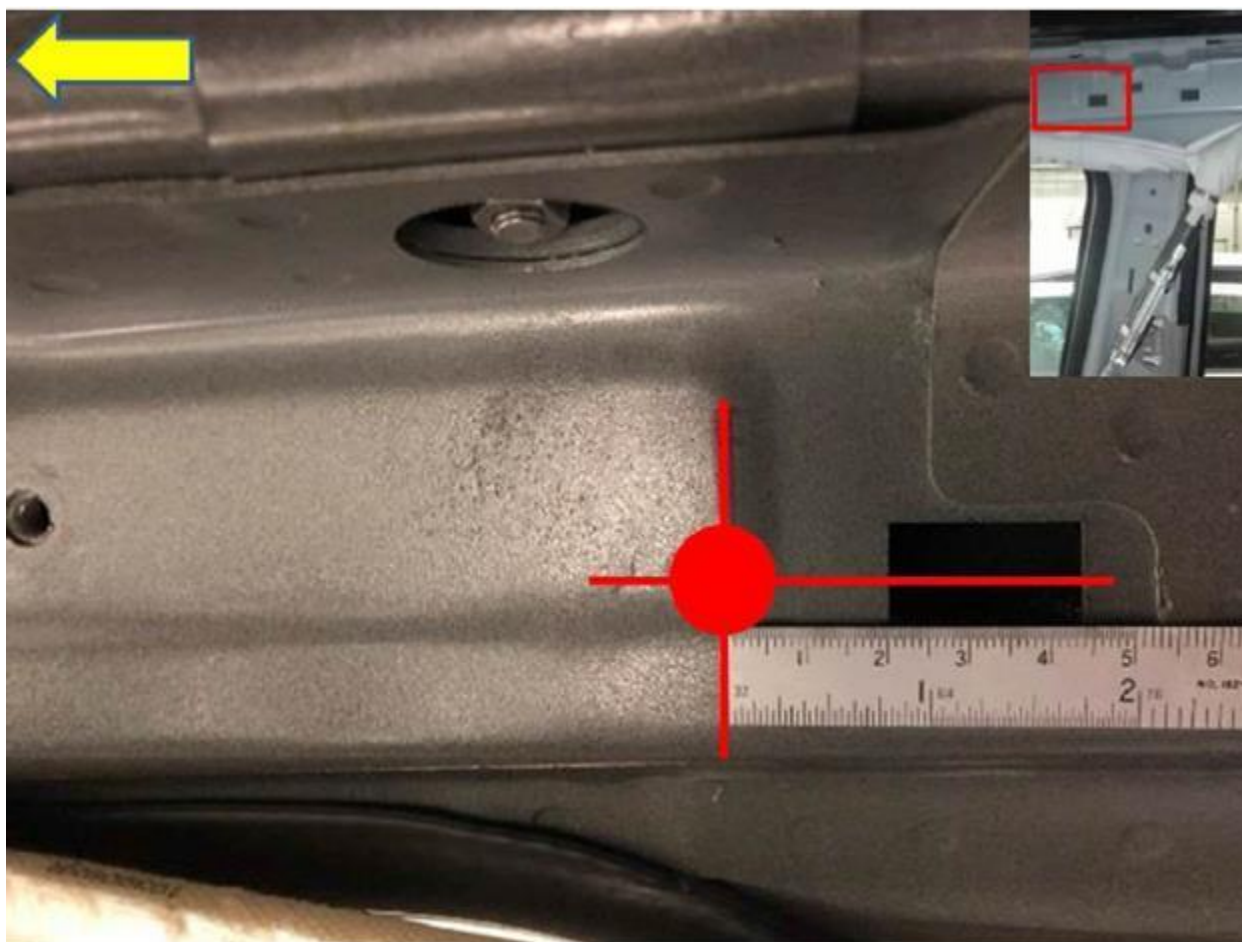
Figure 3: Reference point, front area.

- 2.1 Using a plastic 16 oz. hammer strike twice in the upper zone of the B-Pillar according to the reference points described, see Figures 3 and 4. The end result is to create a gap approximately 3 mm between the internal bracket and cover sheet metal. See Figure 5.

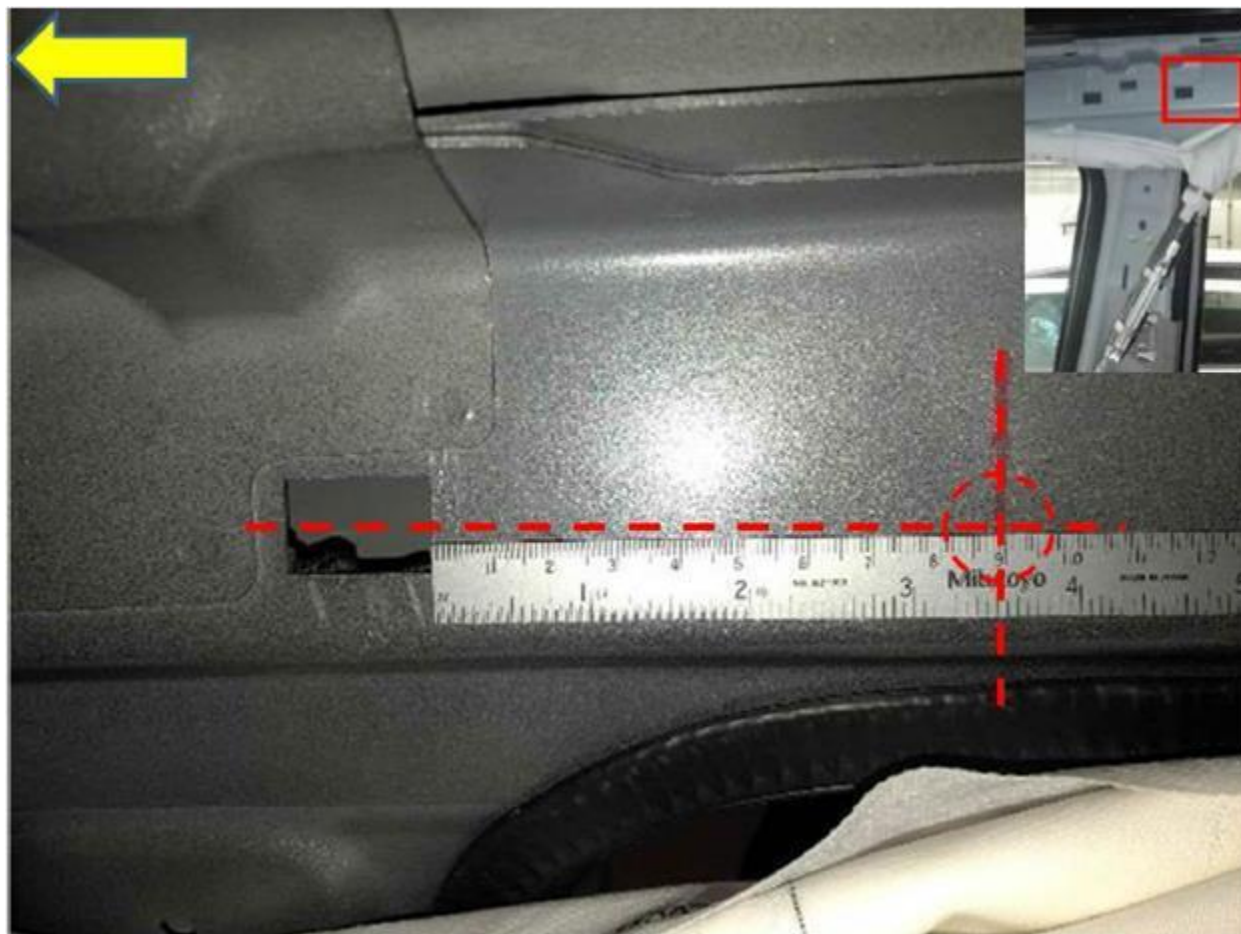
Figure 4: Reference point, rear area.

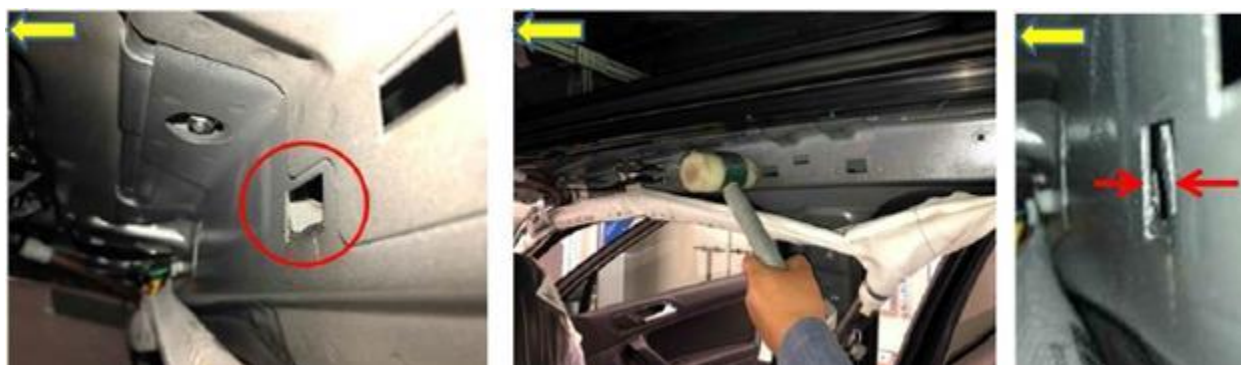
Figure 5: No gap

Striking action

Gap 3 mm

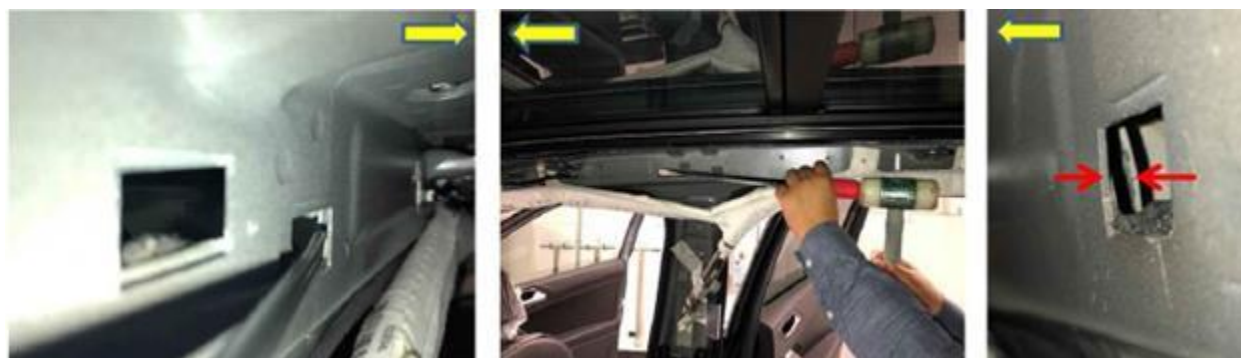
Figure 6: Insert screwdriver

Strike moderately upper/lower

Gap 3 mm

- 2.2 To ensure a uniform gap of 3 mm, insert a flat screwdriver (recommended 3/8"x16") through the indicated window and strike moderately using a plastic 16 oz. until reaching a gap of 3 mm. See Figure 6.

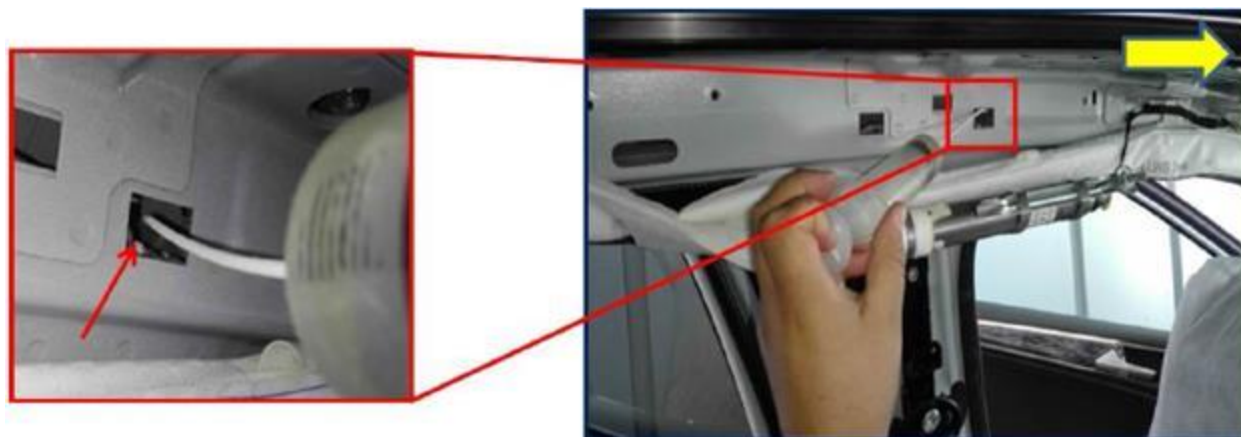
Figure 7: Front bracket

- 3.1 Apply approximately 5 ml of Teflon (Krytox™) between the lower part of the bracket and cover sheet metal, apply in a uniform application on the entire contact zone of the bracket. See Figures 7 and 8.

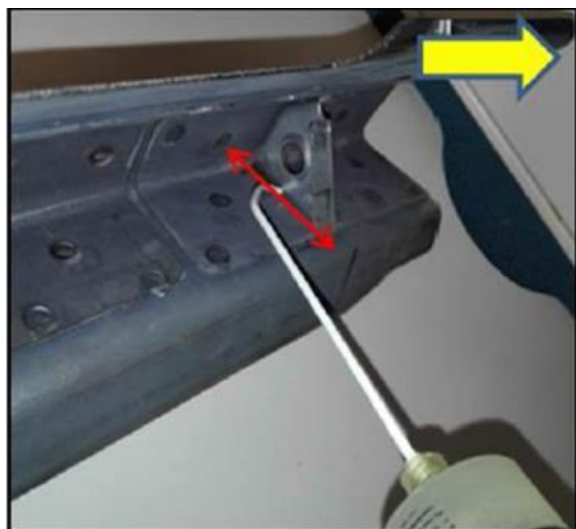
Figure 7a: Cut-away illustration of the internal area for the Krytox™ application on front bracket.

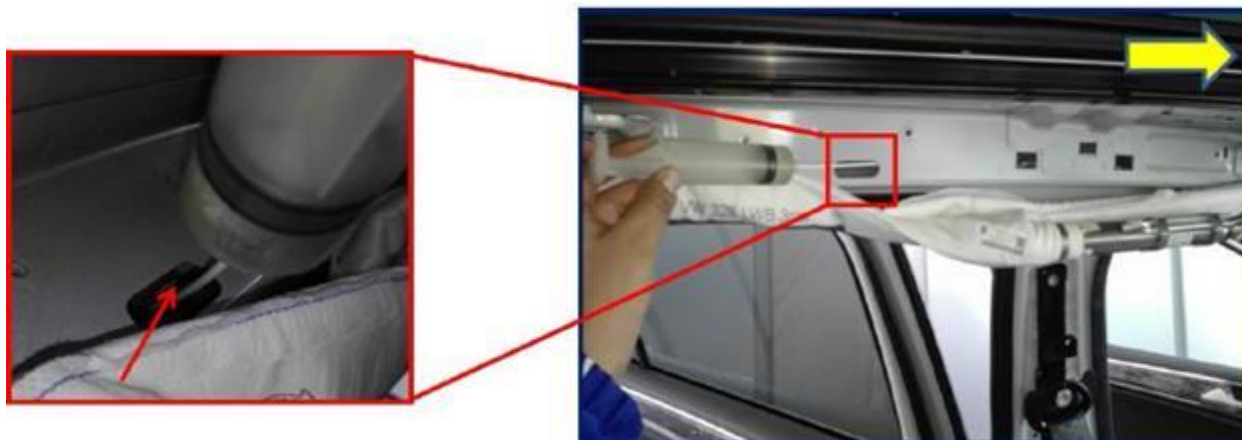
Figure 8: Rear bracket

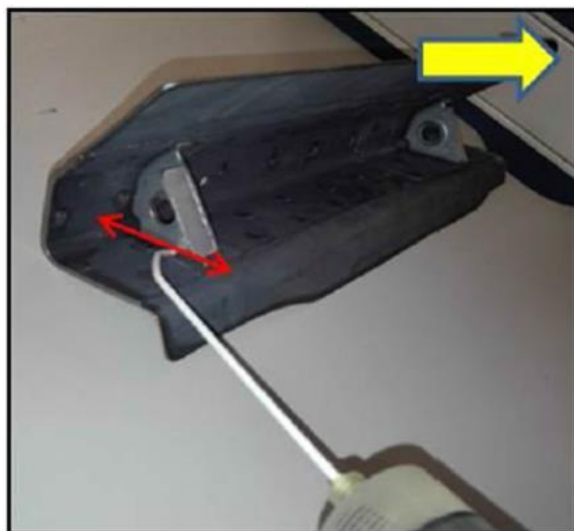
Figure 8a: Cut-away illustration of the internal area of the Krytox™ application on rear bracket.

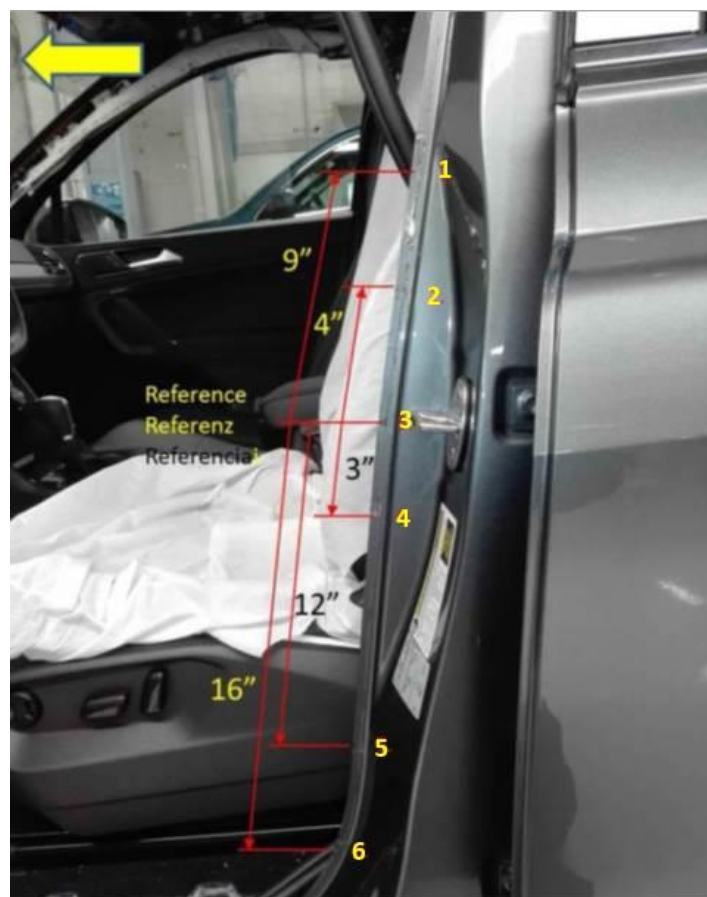
Figure 9: Sequence, bend back and forth on the metal panel of the front door frame, use the striker as the reference point.

- Remove the B-pillar trim panel and partially remove the door seal according to the Repair Manual.
- 4.1 Using vice grips or equivalent, clamp in the (6) areas indicated, bend back and forth the metal panel of the front door frame. Following the sequence described, see Figure 9.
