Technical Tip

Topic	00-18-05TT - FAZ911S Error When Adapting Module
Market area	United States 444 Volkswagen of America, Inc. (6444)
Brand	Volkswagen
Date	October 12, 2018

FAZ911S Error When Adapting Module

Model(s)	Year	Eng. Code	Trans. Code	VIN Range From	VIN Range To
Atlas	2018	All	All	All	All

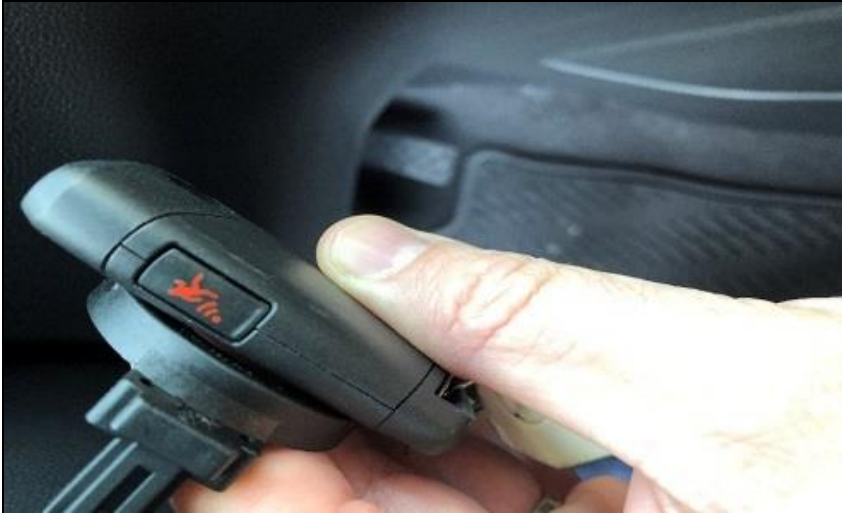
Figure 1

While trying to adapt the Engine/Motor Control Module **-J623-**, Instrument Cluster **-KX2-**, Keys or any other Module, error message FAZ9113S will stop the Test plan.

- Remove the reader coil and rotate the key until it reads in the value block (Figure 1).
