Technical Tip

Topic	55-18-01TT - Rear Lid Does Not Operate or Does Not Operate Correctly
Market area	United States 444 Volkswagen of America, Inc. (6444)
Brand	Volkswagen
Date	October 19, 2018

Rear Lid Does Not Operate or Does Not Operate Correctly

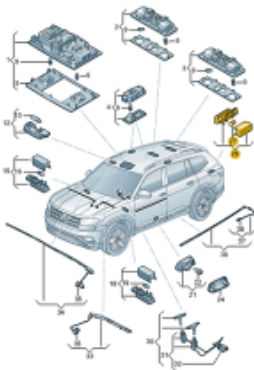
Atlas Luggage Compartment Light

- Check the luggage compartment lamp part number by VIN in ETKA

- If the incorrect parts installed, replace with the correct parts for the vehicle.
