# Technical Bulletin

**00 18 07** October 19, 2018 **2036935** Supersedes 00-18-06 (V001807) dated October 18, 2017 to update metadata selection in authoring system.

By-Pack at Delivery (U.S. Only)

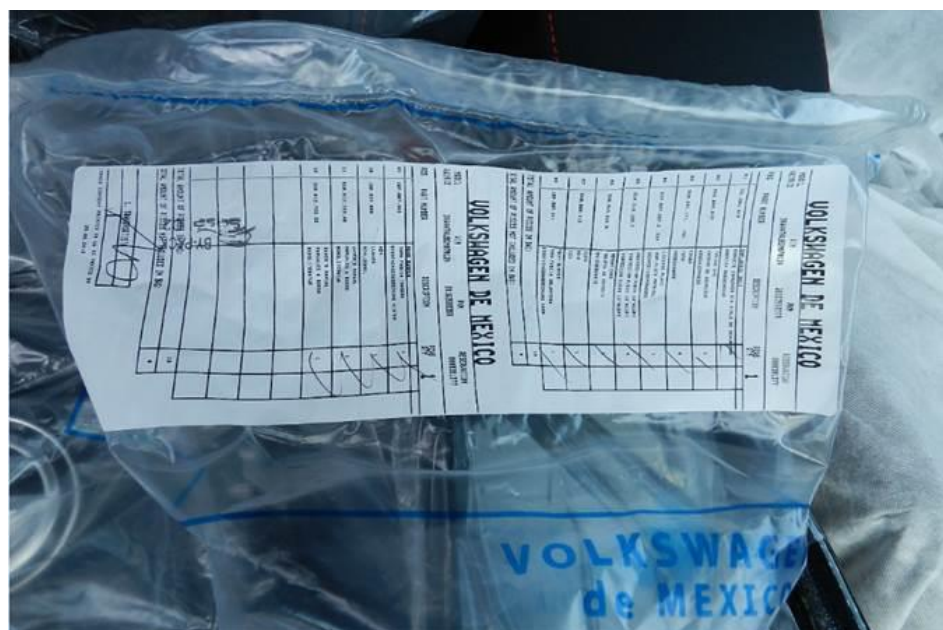
By-Pack is the term used to describe the bag that is delivered with the vehicle that contains the parts to be installed at PDI, i.e. Wheel Center Caps, Lug Caps, Wiper Blades, Etc. Figure 1.

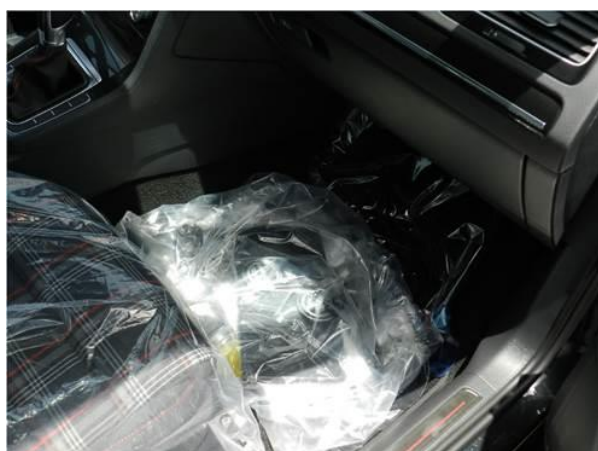
- For models produced in Mexico (Tiguan LWB, Jetta, Golf, GTI, Golf Sportwagen, Beetle & Beetle Convertible) the By-pack is located in the front passenger's side floor, Figure 5. The By-pack has separations (pouches) for the Key(s) and Tow Hook Covers and other components depending on trim level (Figure 6). All vehicles produced in Mexico has one key in the By-pack (Figure 7) and one key tether to the wiper stalk (Figure 8).

Figure 5. By-pack Location for cars produced in Mexico

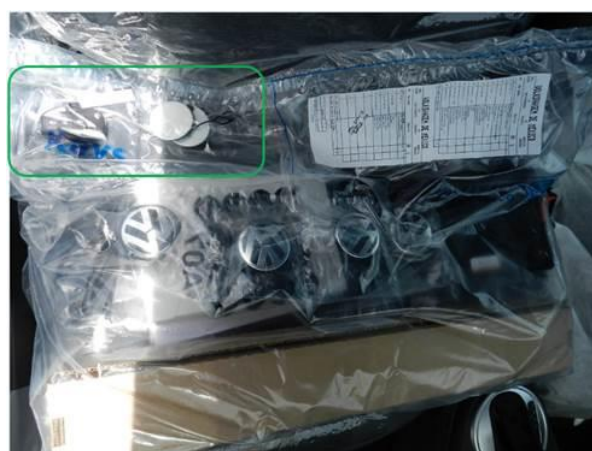
Figure 6. Separation pouches for key(s) tow hook cover, etc.

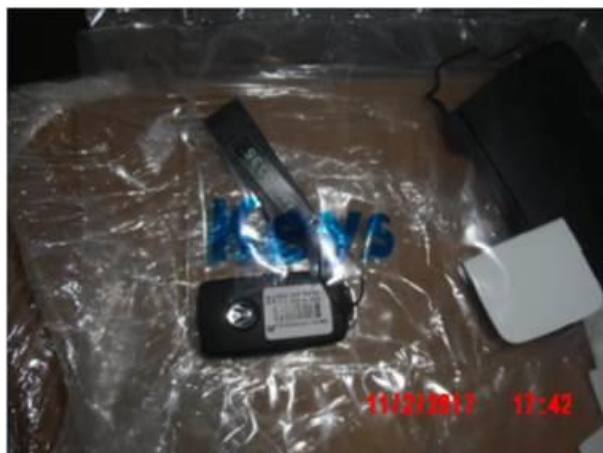
Figure 7. One key in By-pack for cars produced in Mexico.

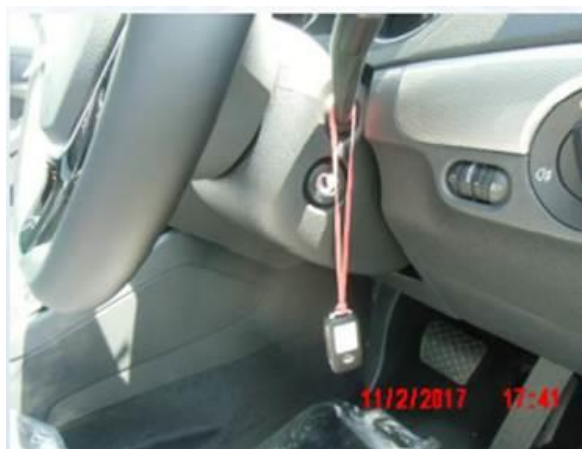
Figure 8. One key tether to the wiper stalk for cars produced in Mexico.

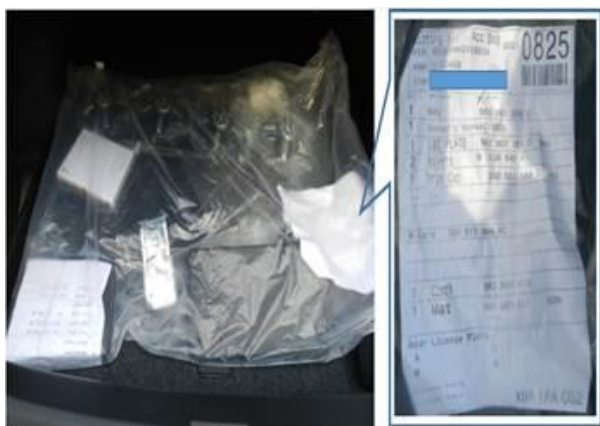
Figure 9. Passat By-pack located in the luggage compartment

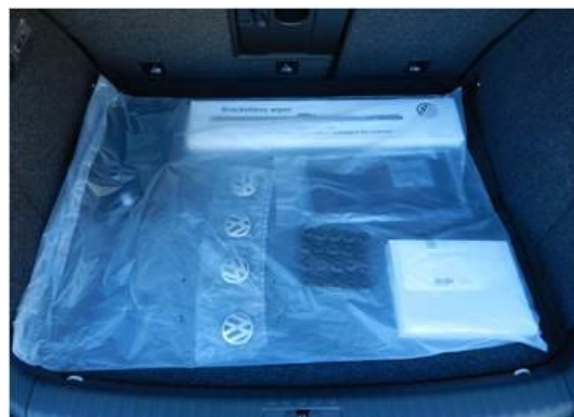
Figure 10. Tiguan Limited By-pack located in the luggage compartment
