Model(s)	Year	Eng. Code	Trans. Code	VIN Range From	VIN Range To
Jetta	2019	All	All	BU_KM023191	BU_KM118788

50 18 04 October 31, 2018 2052766

Water Leak - Driver or Passenger Floor Board

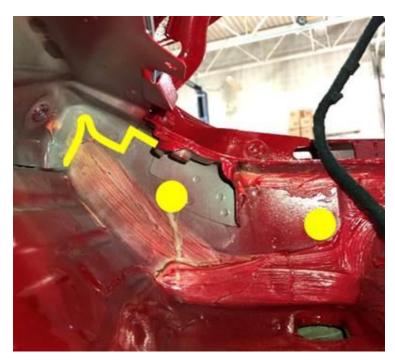
Figure 1

Water in the driver and or passenger floor board area.

Water leak due to improper application of body seam sealer.

5. Apply seam sealer in the areas marked for the driver side (Figure 1).
