Technical Bulletin

93 18 08 October 11, 2018 **2051304** Supersedes Technical Bulletin 93-18-07 (V931807) dated June 26, 2018 to change the quantity of cloth tape in the parts table.

High Voltage Battery - Charging Cable Cannot be Locked or Unlocked

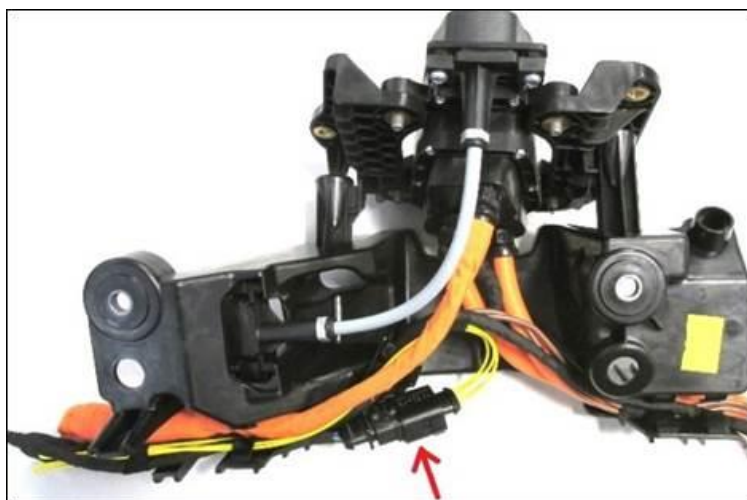
Figure 2: Finished location of new connector and correct wire routing. Repair wires (in yellow) are shown without tape for clarity only. The splices and wires must be properly wrapped in cloth tape part number N 10592002 for protection in actual repair.

- Replace the actuator **-F498-** (Figure 1) according to the repair manual and parts information table.
- Route repair wires and locate new connector as shown (Figure 2).
