Technical Journal

Trim moulding side door windows and roof rails, discoloured appearance

REF NO: TJ 30967.2.0	ISSUING DEPARTMENT: Technical Service	CAR MARKET: United States and Canada		
3 US 7	PARTNER: '510 Volvo Car USA	ISSUE DATE: 2018-04-30	STATUS DATE: 2018-05-04	
FUNC GROUP: 8414	FUNC DESC: Trim moulding at window	Page	1 of 3

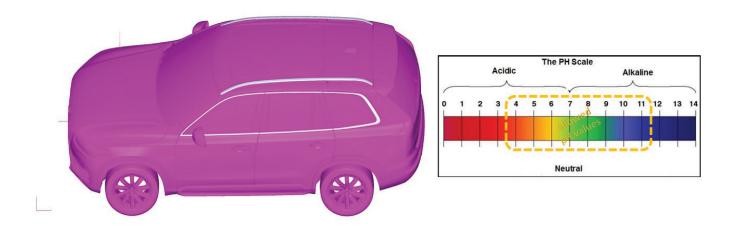
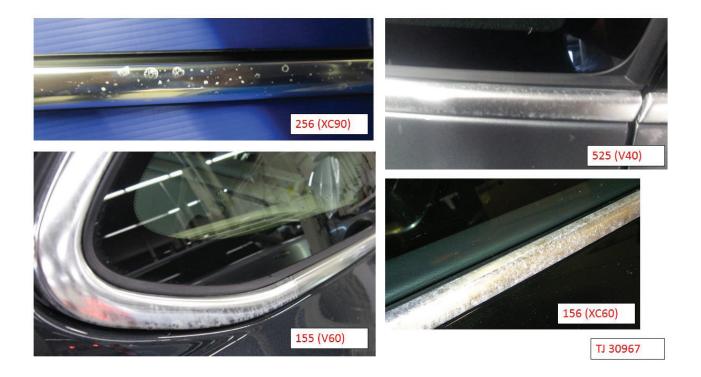
TJ 30967

Washing and cleaning products with a pH value below pH 3.5 and/or above pH 11.5 is **not recommended** as it can permanently discolour the side door, quarter glass trim moulding and roof rails, see attached pictures.

Using chrome or metal polish on anodized aluminium parts, such as side door, quarter glass trim moulding and roof rails, is **not recommended** as it can discolour the part and destroy protective layers.

Polishing with non-abrasive wax is allowed if pH value is within pH 3.5 and pH 11.5.
