Technical Journal

Trim moulding side door windows and roof rails, discoloured appearanceREF NO:
TJ 30967.2.0ISSUING DEPARTMENT:
Technical ServiceCAR MARKET:
United States and CanadaPARTNER:
3 US 7510 Volvo Car USAISSUE DATE:
2018-04-30STATUS DATE:
2018-05-04FUNC GROUP:
8414FUNC DESC:
Trim moulding at window**Page 1 of 3****“Right first time in Time”**

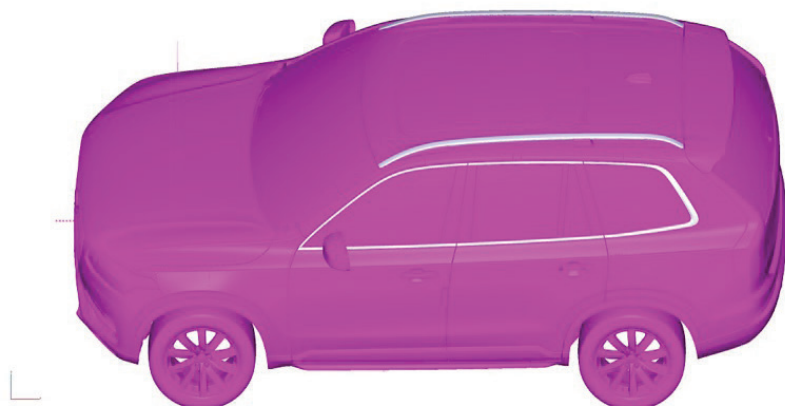
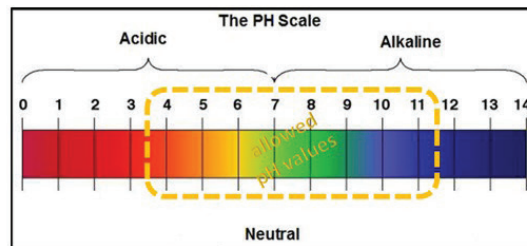
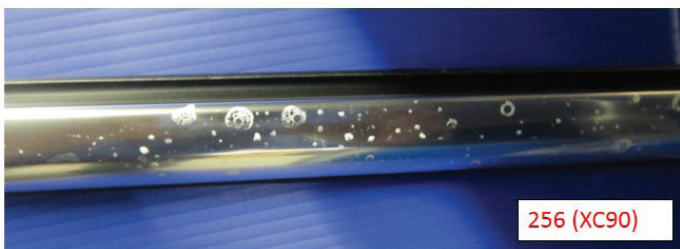
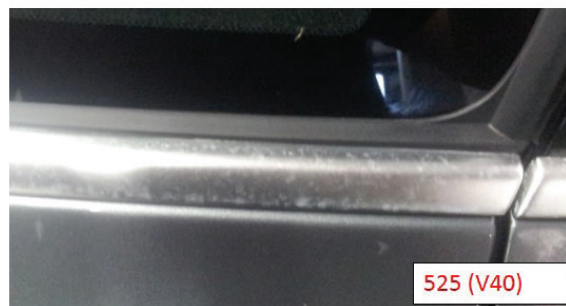
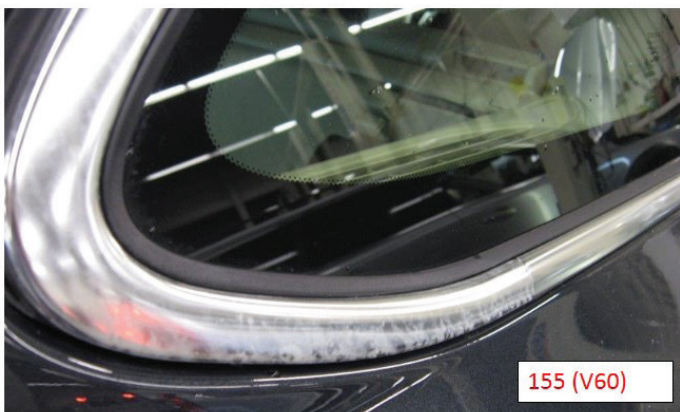
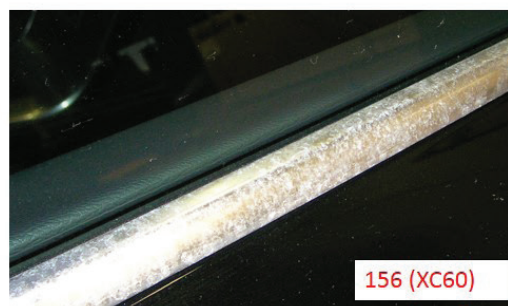
Washing and cleaning products with a pH value below pH 3.5 and/or above pH 11.5 is **not recommended** as it can permanently discolour the side door, quarter glass trim moulding and roof rails, see attached pictures.

Using chrome or metal polish on anodized aluminium parts, such as side door, quarter glass trim moulding and roof rails, is **not recommended** as it can discolour the part and destroy protective layers.

Polishing with non-abrasive wax is allowed if pH value is within pH 3.5 and pH 11.5.
