Technical Journal

TITLE: Steering wheel off center

REF NO:	ISSUING DEPARTMENT:	CAR MARKET:		
TJ 33715.2.0	Technical Service	United States and Canada		
	PARTNER:	ISSUE DATE:	STATUS DATE:	
3 US 7	7510 Volvo Car USA	2018-05-08	2018-05-11	
FUNC GROUP:	FUNC DESC:			
6410	Steering wheel, column lock, steering co	Page 1 of 3

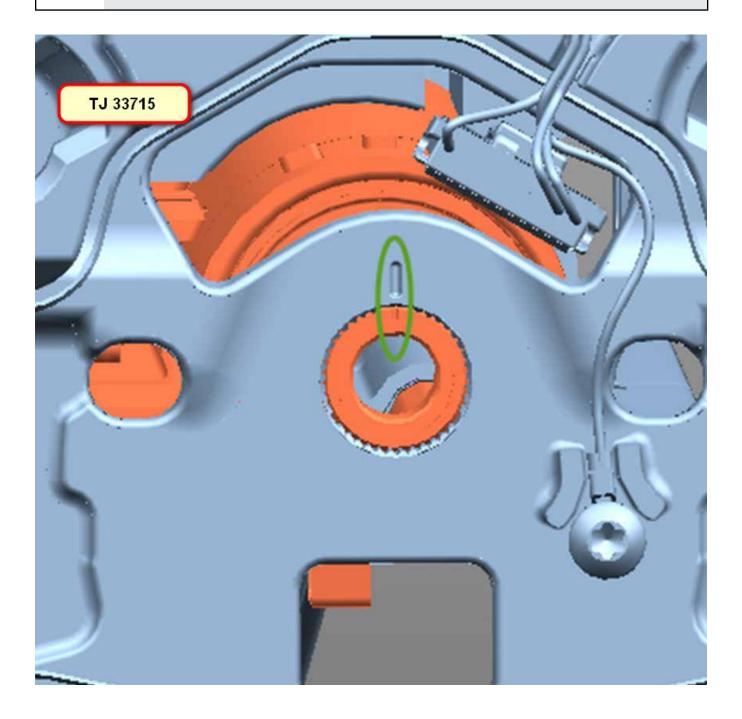
Technical Journal 33715.2.0

If steering wheel is off center while driving straight forward, then follow Service below.

The steering wheel is always positioned correctly at the assembly line, but if the steering wheel is removed for various adjustments it may not be reinstalled correctly on the steering column.

- 1. Remove driver's airbag according to VIDA (VCC-ID: VCC-502656-1)
- 2. Remove the screw for steering wheel according to VIDA (VCC-ID: VCC-502279-1)
- 3. Align the steering wheel to the steering column, follow the markings according to picture TJ 33715.jpg
- 4. Reinstall all parts according to VIDA (torque screw 60 N)
- 5. Perform a wheel alignment on front wheels according to VIDA (VCC-ID: VCC-502859-1)
- 5. Verify repair
