Technical Journal

Click noise from rear body / suspension / shock absorber

REF NO: TJ 33962.1.0	ISSUING DEPARTMENT: Technical Service	CAR MARKET: United States and Canada	
PARTNER: 3 US 7510 Volvo Car USA		ISSUE DATE: 2018-07-12	STATUS DATE: 2018-07-19
FUNC GROUP: 7612	FUNC DESC: Shock absorber, rear	Page 1 of 3

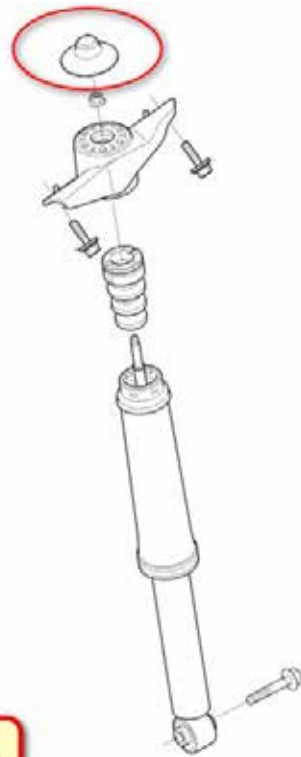
If there is a rattling / clicking / ticking noise while driving, and the noise is likely coming from the rear body or rear suspension, please follow the advice under Service.

- wheel
- outer wheelhouse trim panel
- plastic cap from the shock absorber top mount (see picture 1)

Remove:

Reinstall all parts.
