# Abnormal Cruise Control Feeling "Rocking Back and Forth" Between 55 and 75 mph

**Service Category** Engine/Hybrid System

**Section** Cruise Control

YEAR(S)	MODEL(S)	ADDITIONAL INFORMATION
2016 - 2018	RAV4

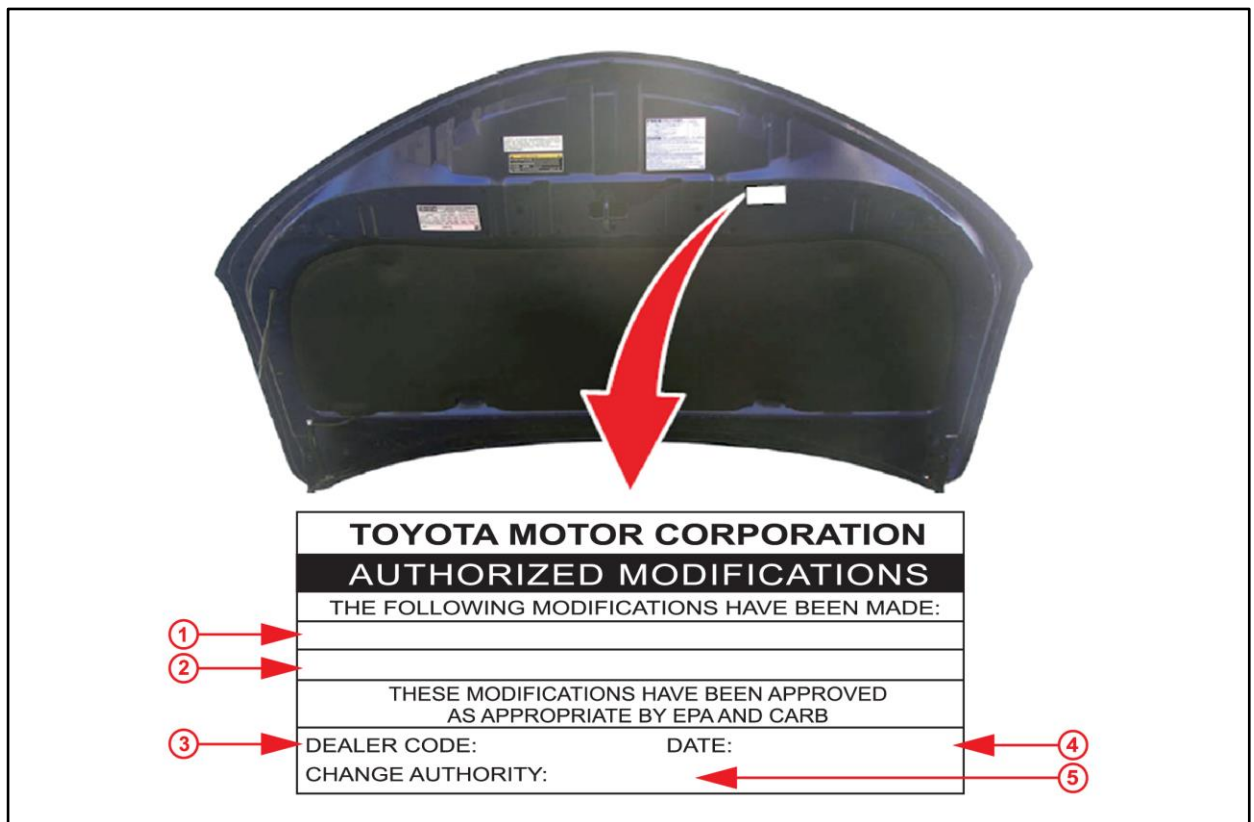
**Figure 1. Location of Authorized Modifications Label for 2016 – 2018 RAV4**

2. Check for the Authorized Modifications Label affixed to the vehicle in the location shown below. Confirm if the ECM (PCM) calibration has been updated.  
 Is the calibration ID listed the latest ECM (PCM) calibration?
  - **YES** – This bulletin does NOT apply. Continue diagnosis using the applicable Repair Manual.
  - **NO** – Continue to step 3.

4. Prepare and install the Authorized Modifications Label.
  - A. Using a permanent marker, enter the following information on the label:
    - ECM part number [*Refer to the **Parts Information** section for the **NEW PART NUMBER***]
    - Calibration ID(s) [*Refer to the **Calibration Information** section for the **NEW CALIBRATION ID***]
    - Dealer Code
    - Repair Date
    - Change Authority [**This bulletin number**]
  - B. Install the Authorized Modifications Label to the vehicle at the location shown in Figure 1. The Authorized Modifications Label is available through the MDC, P/N 00451-00001-LBL.
5. Confirm the rocking condition is no longer present.
