Techstream Cannot Command Self-EVAP Test

Service Category Engine/Hybrid System

Section Emission Control

YEAR(S)	MODEL(S)	ADDITIONAL INFORMATION
2016 - 2018	Land Cruiser

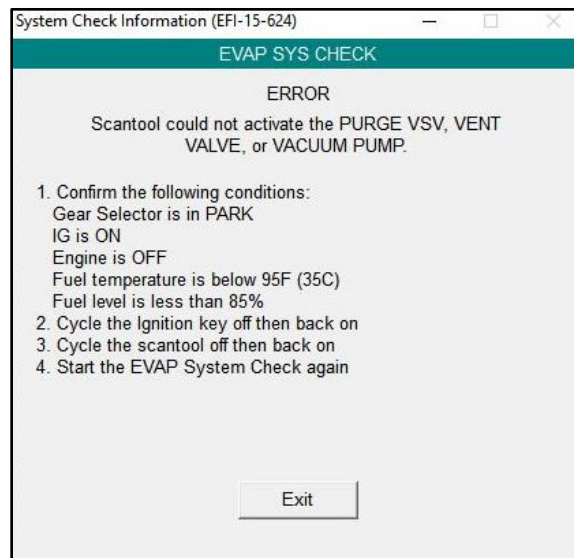
Figure 1.

Some 2016 – 2018 model year Land Cruiser vehicles may exhibit a condition where the Techstream EVAP System Check Utility will not run as shown. The Transmission Control Module (TCM) logic has been modified to address this condition. Follow the Repair Procedure in this bulletin to address this condition.

1. Connect Techstream to the vehicle and attempt to run the EVAP System Check Utility (*Engine and ECT – Utility – Evaporative System Check*).
Does the EVAP System Check run?
 - **YES** — This bulletin does NOT apply. Continue diagnosis using the applicable Repair Manual.
 - **NO** — Continue to step 2.
2. Check for the Authorized Modifications Label affixed to the vehicle in the location shown below. Confirm if the TCM calibration has been updated.
Is the calibration ID listed the latest TCM calibration?
 - **YES** — This bulletin does NOT apply. Continue diagnosis using the applicable Repair Manual.
 - **NO** — Continue to step 3.

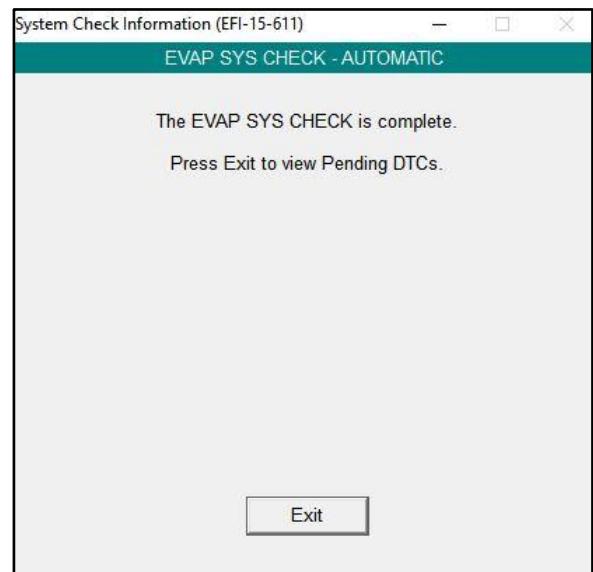
Figure 3.

5. Connect Techstream to the vehicle and run the EVAP System Check Utility (*Engine and ECT – Utility – Evaporative System Check*).
Confirm proper operation as shown.
