Customer Satisfaction Program

18305 LCV Engine Camshaft Cap Bolts Incorrect Torque

Reference Number: N182164320

Release Date: October 2018
Revision: 00

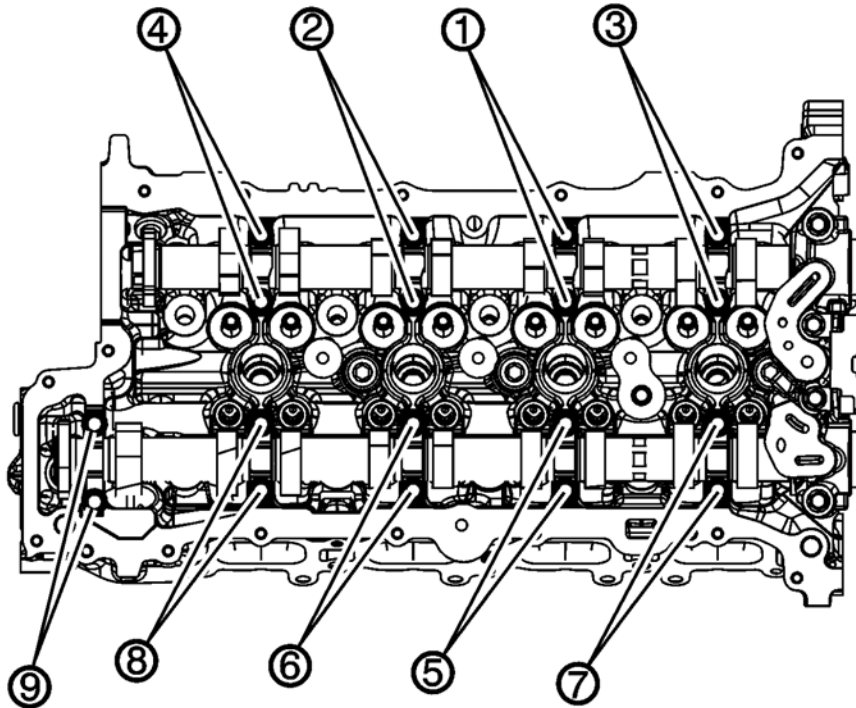
2744052

Condition	Certain 2013 model year Chevrolet Malibu and 2013-2014 model year Cadillac ATS vehicles, serviced with a replacement engine, may have a condition in which the service engine camshaft cap bolts were not tightened to specification during the manufacturing process. If the camshaft cap bolts were not tightened to specification, they may loosen, resulting in loss of propulsion, reduced engine performance, and possible engine failure. A "Service Engine Soon" message may illuminate on the vehicle's Driver Information Center.
Correction	Inspect and torque engine camshaft cap bolts.

1. Remove the camshaft cover. Refer to *Camshaft Cover Replacement (LCV)*
2. Tighten the camshaft cap bolts using the sequence shown below.

Caution: Proceed with the following steps one camshaft cap at a time as described below. Failure to do so could result in damage to the head, camshaft caps, or camshafts.

- 2.1. Starting with the number 1 camshaft cap (as shown above), loosen each bolt on the cap until they are both loose to the touch.
 - 2.2. Using a torque wrench, tighten both bolts to **8 N-m (71 lb-in)**.
 - 2.3. Loosen the camshaft cap bolts 180 degrees.
 - 2.4. Re-torque the camshaft cap bolts to **10N-m (89 lb-in), twice**.
 - 2.5. Move on to the next camshaft cap in sequence and repeat steps 2.1 through 2.4 until all 9 camshaft caps have been torqued to the correct spec. For the number 8 and 9 caps, start with the inside bolt.
 - 2.6. Tighten all four front camshaft cap bolts to **10N-M (89 lb-in), twice**.
3. Reinstall the camshaft cover. Refer to *Camshaft Cover Replacement (LCV)* in SI.
