# Service Update

## 18338 Defrost Linkage Not Fully Seated

Reference Number: N182183980

Release Date: October 2018

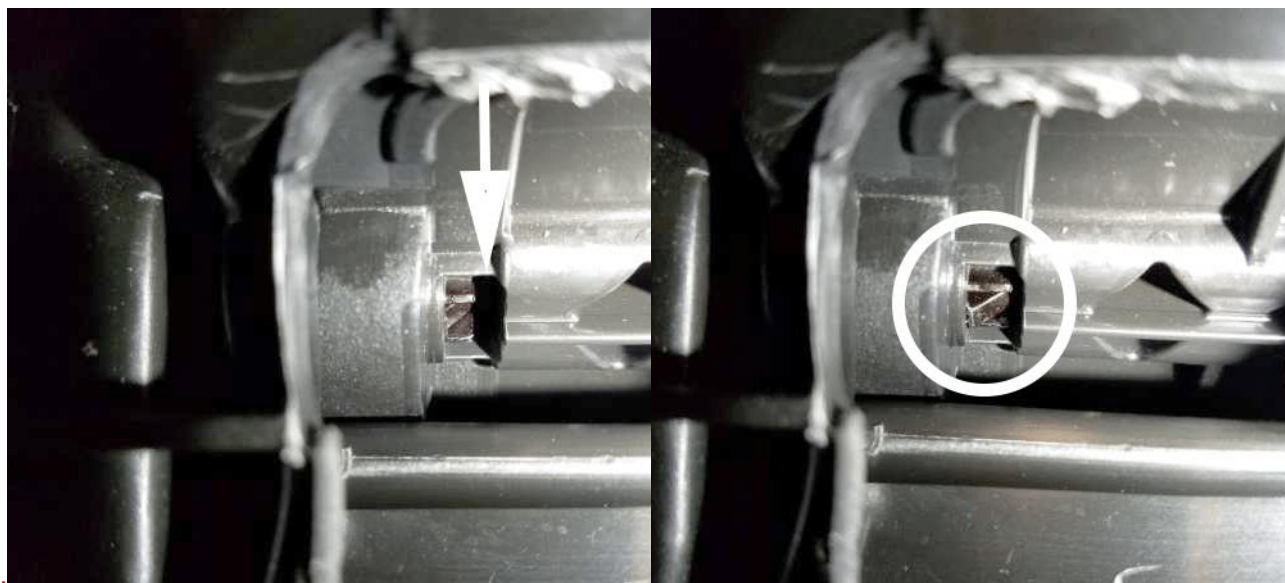
**Note:** The following pictures illustrate the difference between an incorrectly installed defrost lever and a properly installed defrost lever and are for reference only to demonstrate the issue we are fixing. The picture with an arrow points to the gap indicating a bad part, and the picture with a circle shows a correctly installed part.

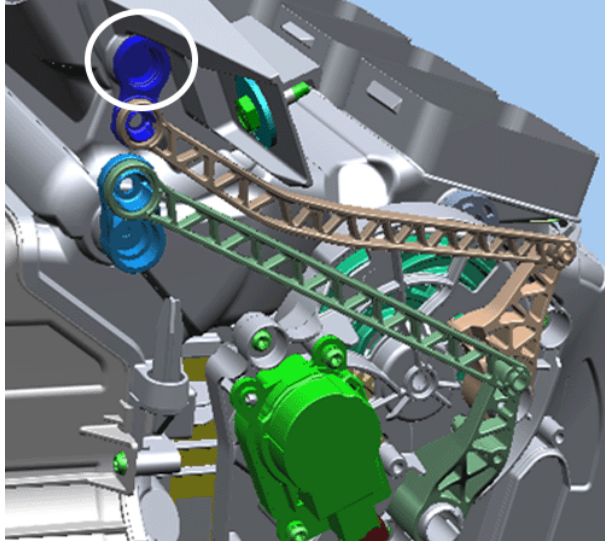
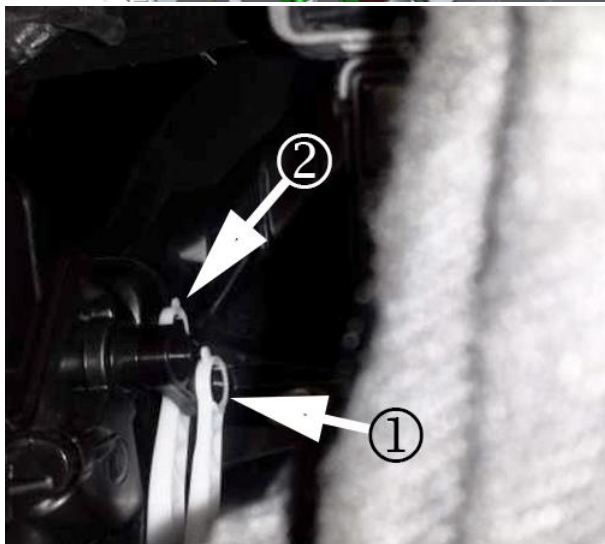
4. Using a flashlight, locate the kinematics package consisting of two white links and two black levers. The black defrost lever is not involved in this concern, but it is attached to a very similar white floor link. Use care to ensure the correct linkage is identified. Floor linkage (1), defrost linkage (2) (also circled in the computer math drawing), is the area of concern.

5. Perform a wiggle test, using your index finger to wiggle the defrost lever in and out.
  - A good part will create an audible clunk noise as it is wiggled back and forth as the defrost door bangs into the HVAC housing. Proceed to step 10.

- A bad part will be loose and can pull itself free from the defrost door during the wiggle test. Be careful not to pull the lever entirely out of the door. There may be an audible series of clicks during this, but it is different from the clunk sound caused by a good part. If the vehicle fails the wiggle test, proceed to step 6.

8. Using a helper, as one person keeps pressure on the defrost door bearing with the backing tool, a second person in the driver's foot well will press the defrost door lever into the defrost door until it locks. Repeat the wiggle test from step 5 to verify that the lever is locked.
