# Technical Service Bulletin

#### 20 Fuel cannot be added to vehicle or fueling vehicle is difficult

20 18 04 2044039/5 August 15, 2018. Supersedes Technical Service Bulletin Group 20 number 18-01 dated April 30, 2018 for reasons listed below.

Model(s)	Year	VIN Range	Vehicle-Specific Equipment
Q7	2017 - 2018	All	Not Applicable

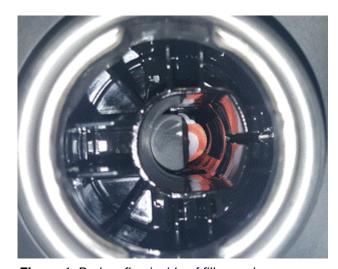
There is a broken flap inside of the filler neck (Figure 1).

Figure 1. Broken flap inside of filler neck.

Replace complete fuel tank according to the instructions in Elsa at Repair Manual, *Power Unit >> Fuel Supply >> Fuel tank >> Removing and installing fuel tank.*
