## Power reduction from 4000 rpm

| Topic number | LI49.10-P-068745 |
| Function group | 49.10 Exhaust pipes, catalytic converter, mufflers |
| Validity | Model 213.x88/x89<br>Model 222.187/188<br>Model 463.276/277 (G63 facelift)<br>Model 463.260/261 (G500 facelift) |

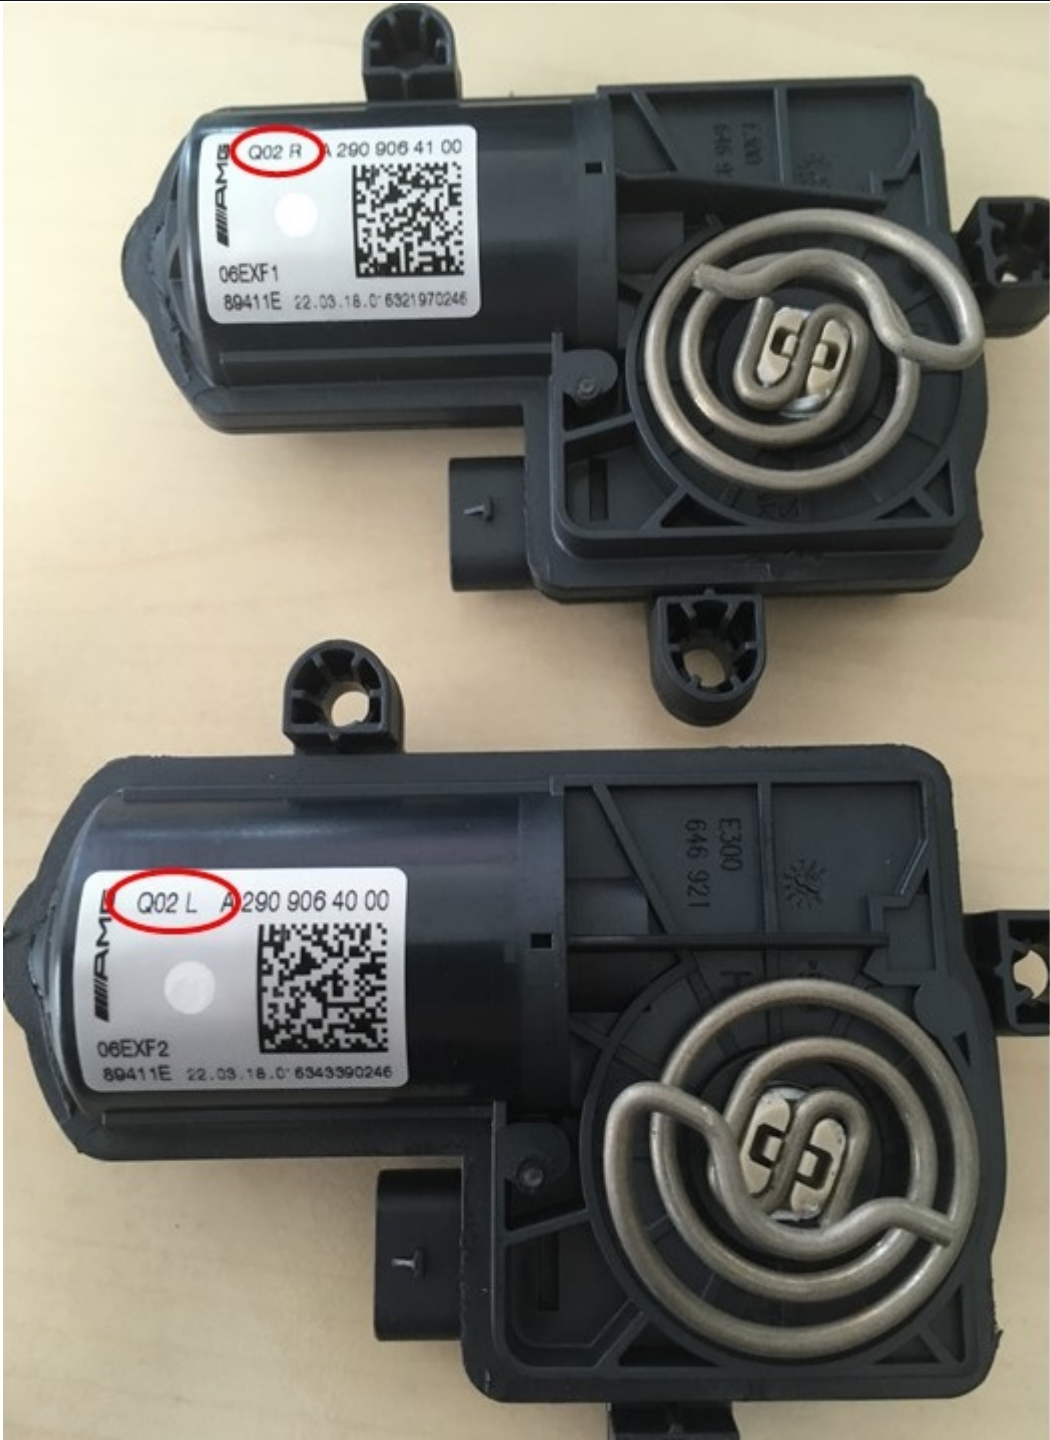
Präsentation1.jpg:

1. Check Q-status of actuators (see attachment)
2. If Q1 status actuators are installed, they must be replaced
3. If Q2 status (or higher) actuators are installed, alert the relevant MBUSA service engineer by opening a PTSS case and having it escalated directly to them

| Attachments | |
|---|---|
| Präsentation1.jpg | Q-status OK |
