# Service Campaign Bulletin

Campaign No. 2018080004, September 2018

SUBJECT: **Model GLE-Class and GLE-Couple Class (166 and 292 platform)**  
**Model Year 2018**  
**Replace threaded connections of the strut rods on the inner rear axle carrier**

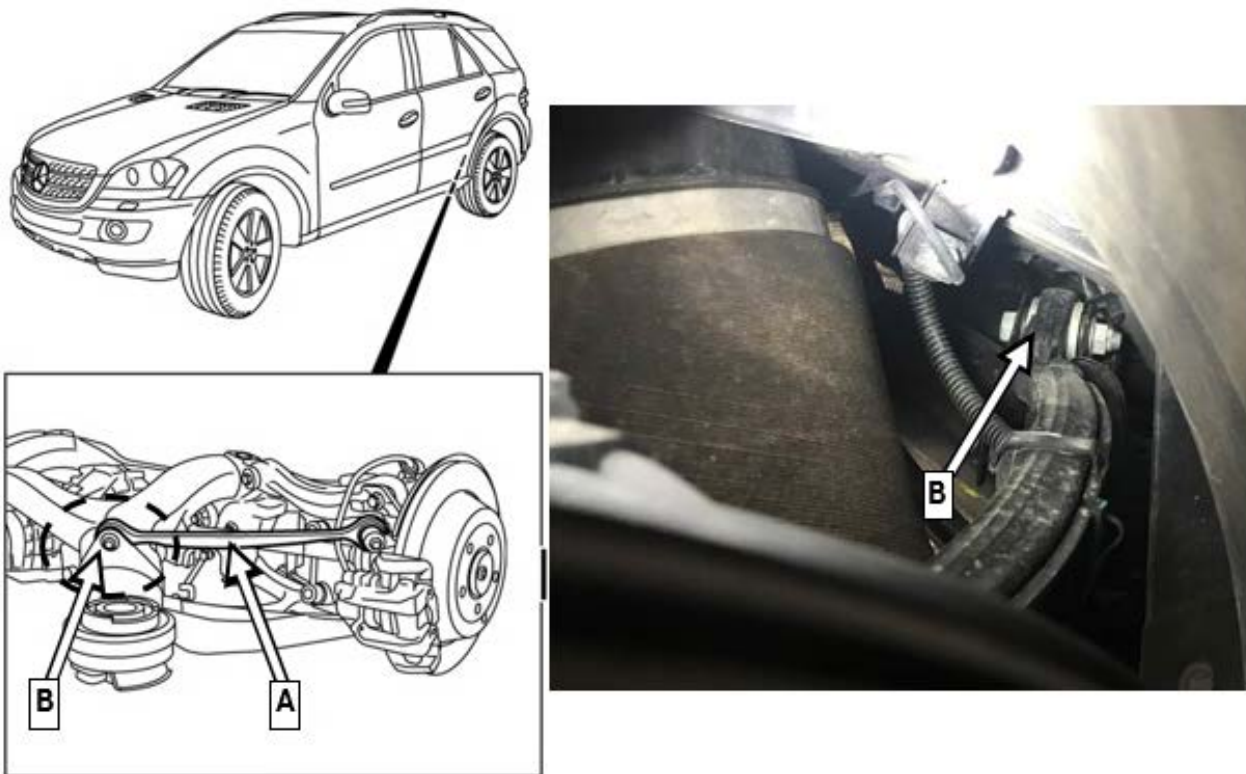
**Figure 1**

Daimler AG ("DAG"), the manufacturer of Mercedes-Benz vehicles, has determined that on certain MY18 GLE-Class and GLE-Couple Class (166, 292 platform) vehicles, the installed screws in the strut bars may not correspond to current production specifications. An authorized Mercedes-Benz dealer will replace the screws in the strut bars on the affected vehicles.

5. Replace bolt (**B, figure 1**).
  - i** For basic data, see **AR35.20-P-0111GZ**
  - i** The new bolts must be screwed in at normal level.
6. Assemble in reverse order.
