Interior transverse support ribs seperating from roof skin / structural adhesive seeping

Topic number	LI65.10-N-068734
Version	1
Function group	65.10 Roof paneling
Date	09-11-2018
Validity	906.xxx / 447.6/7
Reason for change	
Reason for block

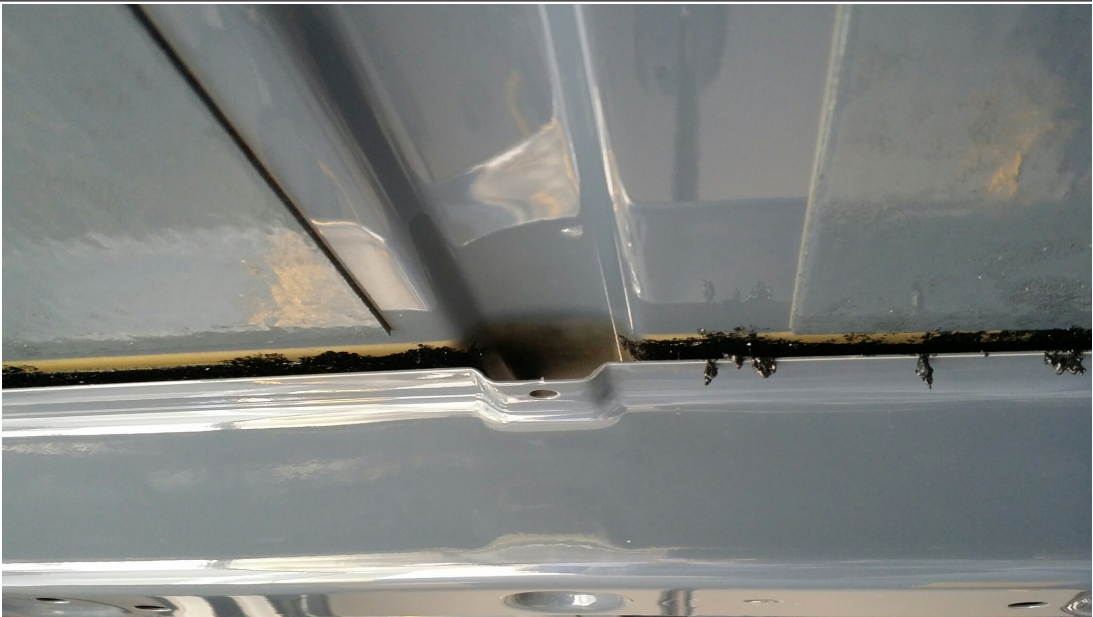
Cross Member Separation.jpeg:

Client states roof in cargo area is detaching from the transverse support ribs / structural adhesive seeping

Attachments	
File	Description
Cross Member Separation.jpeg	Cross member separation

Adhesive failure

1. Photo documentation for warranty claim – take pictures incl. tape measure to document the gap size between roof and substructure
2. If necessary, carefully lift the roof panel 2-5mm by inserting plastic wedges
3. Remove the old adhesive between outer panel and substructure using a plastic wedge
4. Prepare for new adhesive (clean with silicon remover A005 989 1971)
5. Apply activator A000 989 31 00 (alternative Teroson SB 450)
6. Apply new adhesive (blue body shop masking tape and a plastic razor blade can be used to help create a clean professional appearance, see (Final Repair Example.jpg)
7. Use the adhesive kit A005 989 61 71 (alternative Teroson MS 930)
8. Remove plastic wedges
9. Remove excessive adhesive that squeezed out
10. Park the vehicle for 10-12 hours to allow for curing

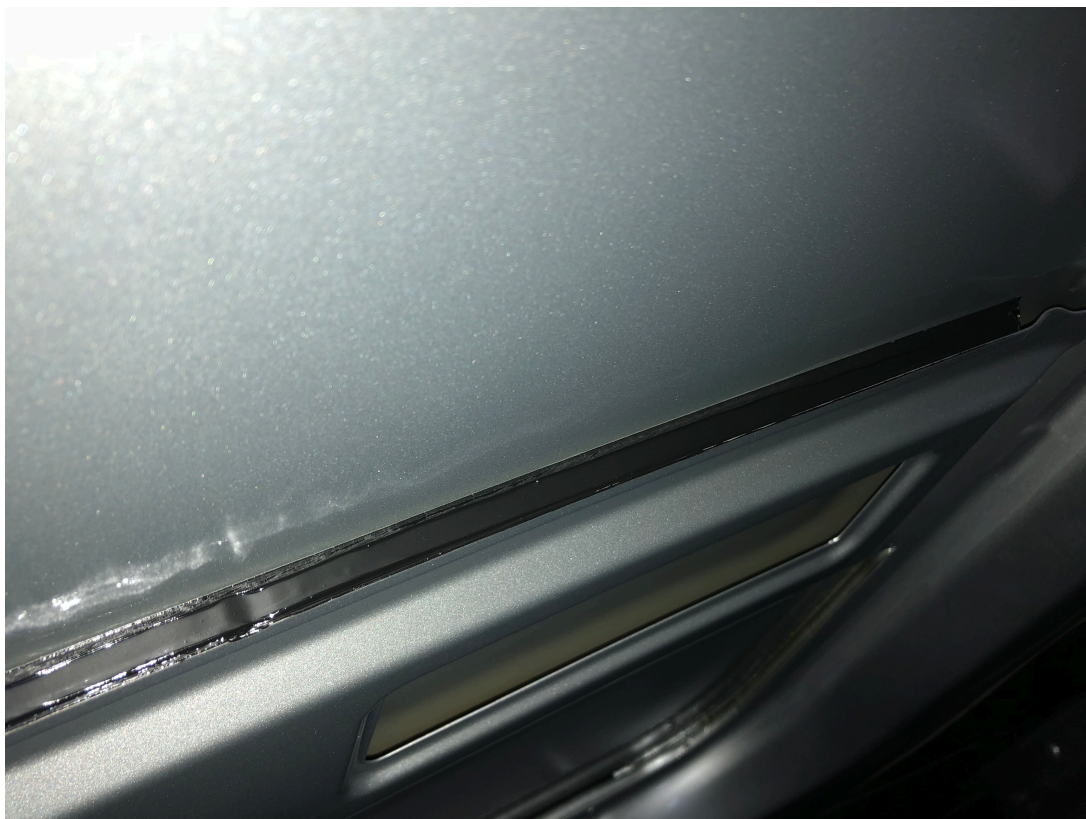
Final Repair Example.
jpg:

Attachments	
File	Description
Final Repair Example.jpg	Example of what final repair should look like
