SERVICE BULLETIN

Classification: EL18-018a	Reference: NTB18-045a	Date: September 11, 2018
------------------------------	--------------------------	-----------------------------

2011-2015 LEAF; 12 VOLT BATTERY LOSES CHARGE AND/OR TELEMATICS SERVICES DO NOT WORK

APPLIED VEHICLES: 2011-2015 LEAF (ZE0)

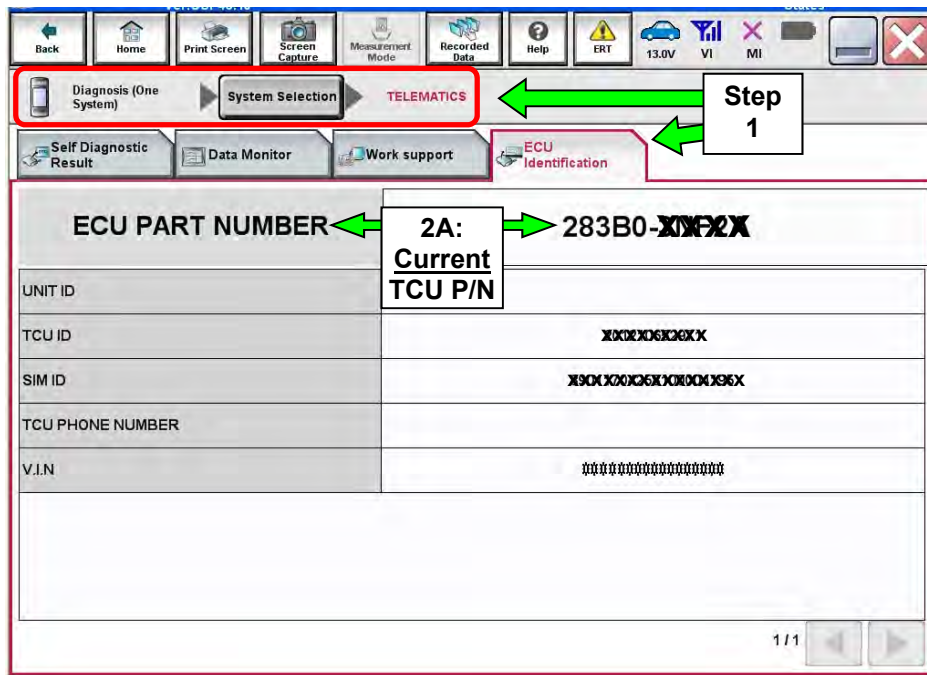
Figure 1

1. With CONSULT-III plus (C-III plus), go to **Diagnosis (One System) > System Selection > TELEMATICS > ECU identification**.
2. When you get to the screen shown in Figure 1, confirm this bulletin applies as follows.

A. Find the TCU **Part Number** and write it on the repair order.

NOTE: This is the current TCU Part Number (P/N).

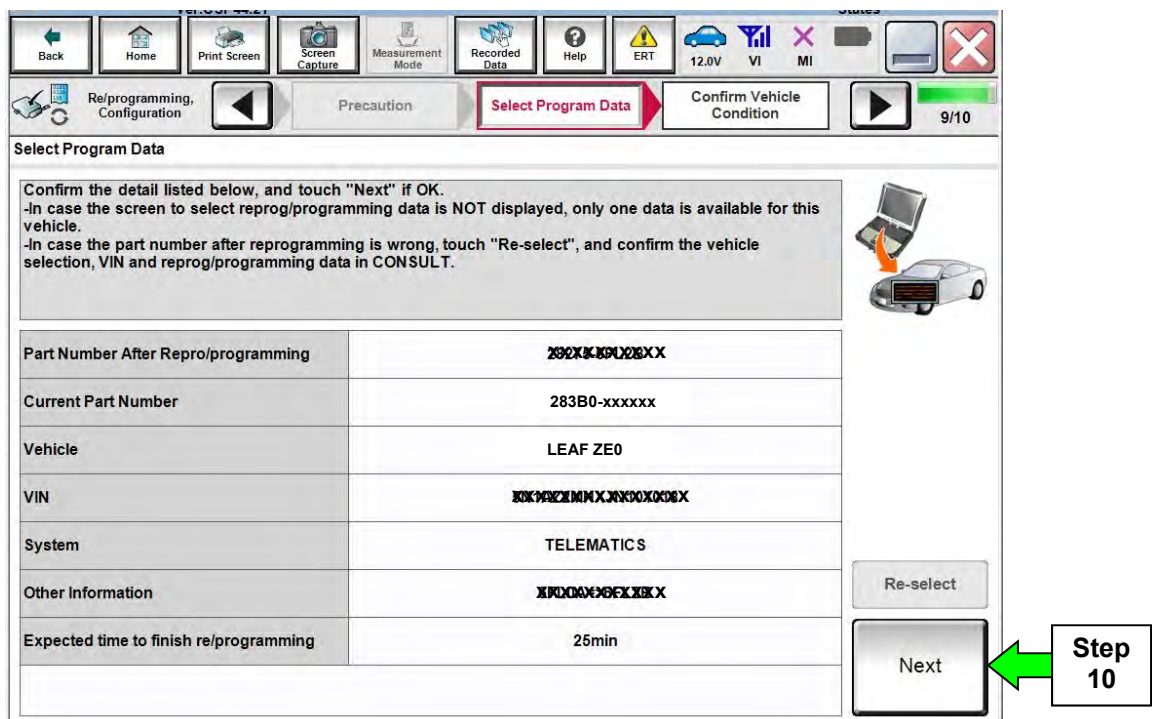
Figure 19

- Verify the **Current Part Number** and **Part Number After Reprogramming** are different, and then select **Next**.

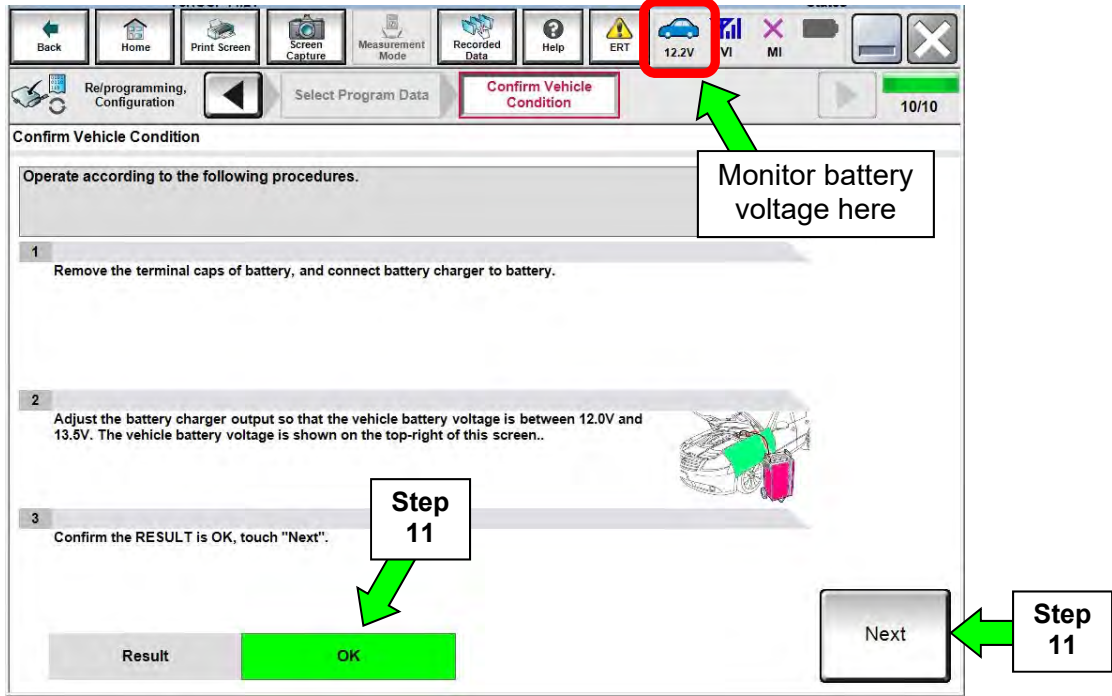
Figure 20

11. Verify **OK** is highlighted **green** (battery voltage must be between **12.0 and 15.5 volts**), and then select Next.

IMPORTANT: Battery voltage must stay between **12.0 and 15.5 volts** during reprogramming. If not, reprogramming may be interrupted and the TCU may be damaged.

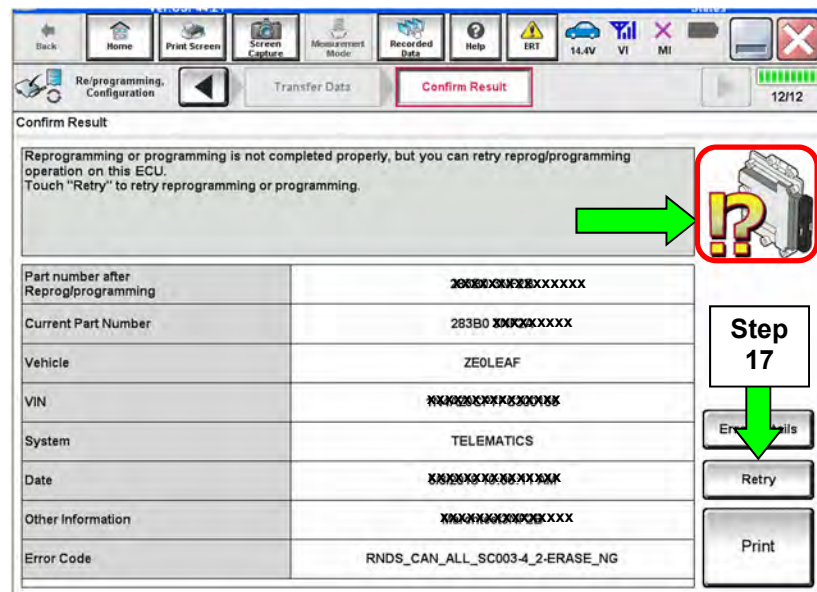
16. The progress bar (Figure 25) should go to approximately 10%, and then the error message in Figure 26 should appear. This is normal.

17. When the screen in Figure 26 displays, verify the following, and then select **Retry**.

- Check battery voltage (12.0–15.5 volts).
- Ignition is ON, engine OFF.
- External Bluetooth® devices are OFF.
- All electrical loads are OFF.
- **Select Retry and follow the on screen instructions.**
- “Retry” may not go through on the first attempt and can be selected more than once.

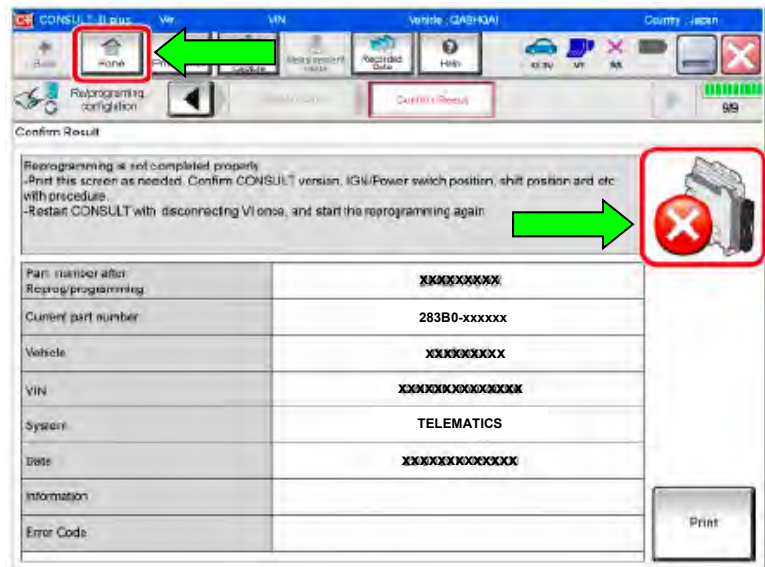
Figure 27

If reprogramming does not complete and the “X” icon displays as shown in Figure 27:

- Check battery voltage (12.0 – 15.5 volts).
- CONSULT A/C adapter is plugged in.
- Ignition is ON, engine OFF.
- Transmission is in Park.
- All C-III plus / VI cables are securely connected.
- All C-III plus updates are installed.
- **Select Home, and restart the reprogram procedure from the beginning.**

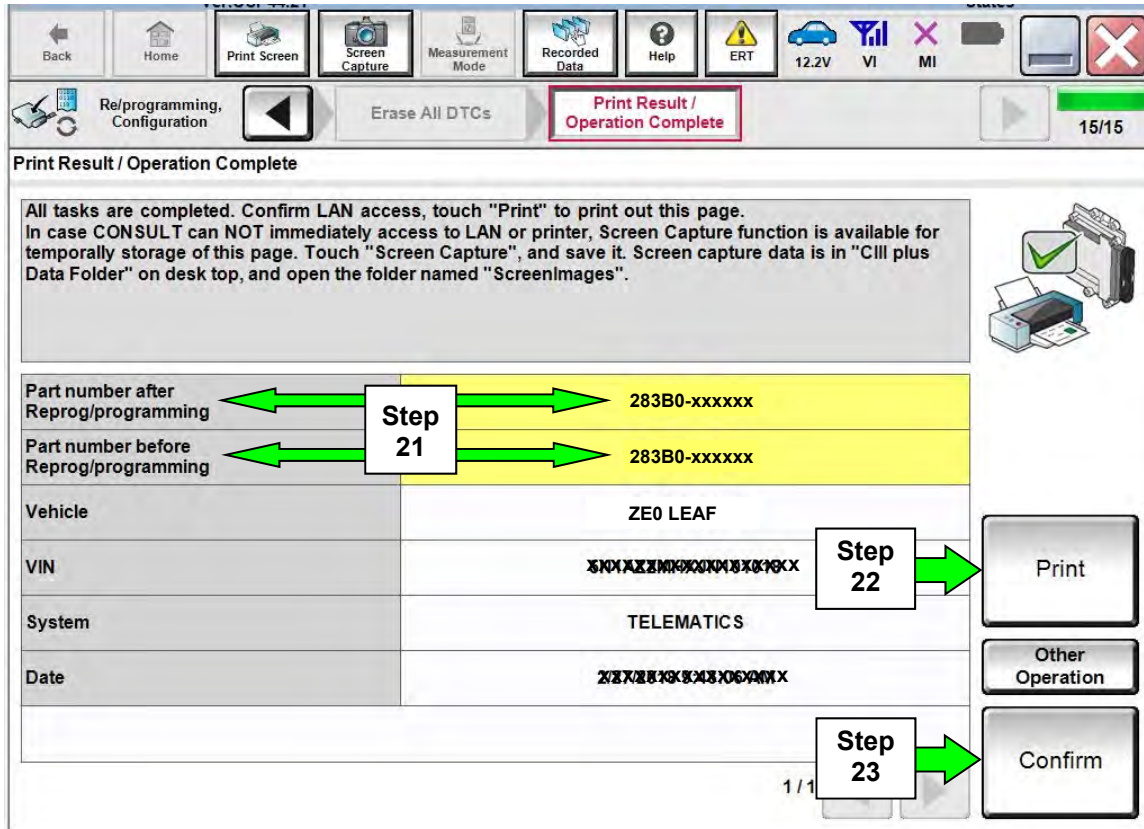
20. When the entire reprogramming process is complete, the screen in Figure 31 will display.
21. Verify the before and after part numbers are different.
22. Print a copy of this screen (Figure 31) and attach it to the repair order for warranty documentation.
23. Select **Confirm**.
