SERVICE BULLETIN

EC18-028

2018 ARMADA; MIL ON WITH DTC P0138 AND/OR P0158

APPLIED VEHICLES: 2018 Armada (Y62)

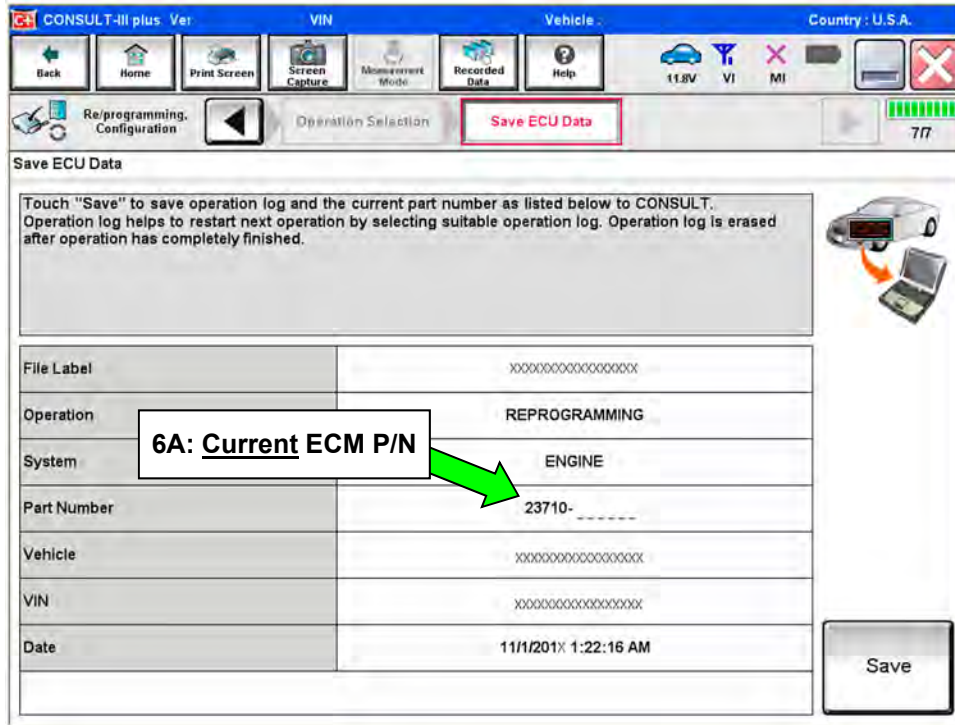
6. When the screen in Figure 2 displays, confirm this bulletin applies as follows.

A. Find the ECM **Part Number** and write it on the repair order.

B. Compare the P/N you wrote down to the numbers in the **CURRENT ECM PART NUMBER** column in **Table A** below.

- If there is a match, this bulletin applies. Continue with the reprogramming procedure.
- If there is not a match, reprogramming does not apply. Refer to ASIST for further diagnosis.

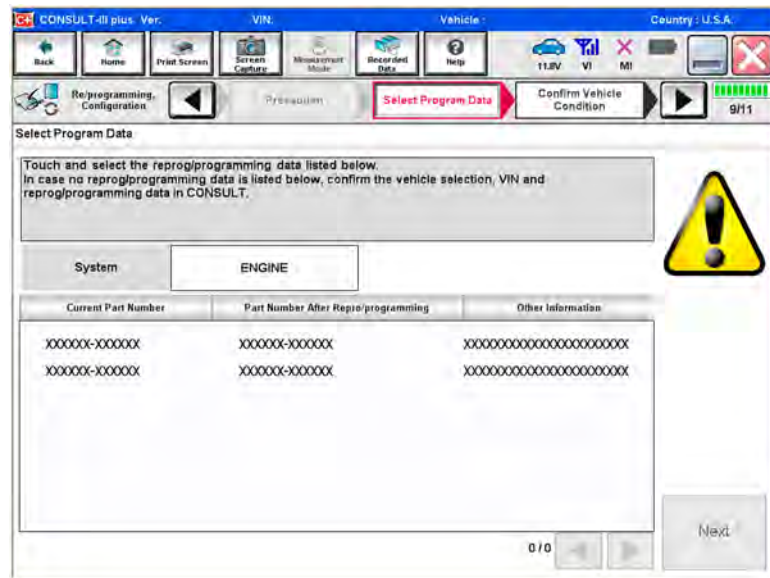
- In some cases, more than one new P/N for reprogramming is available.
 - In this case, the screen in Figure 3 displays.
 - Select and use the reprogramming option that **does not** have the message “Caution! Use ONLY with NTBXX-XXX”.
- If you get this screen and it is blank (no reprogramming listed), it means there is no reprogramming available for this vehicle. Close C-III plus and refer back to ASIST for further diagnosis.

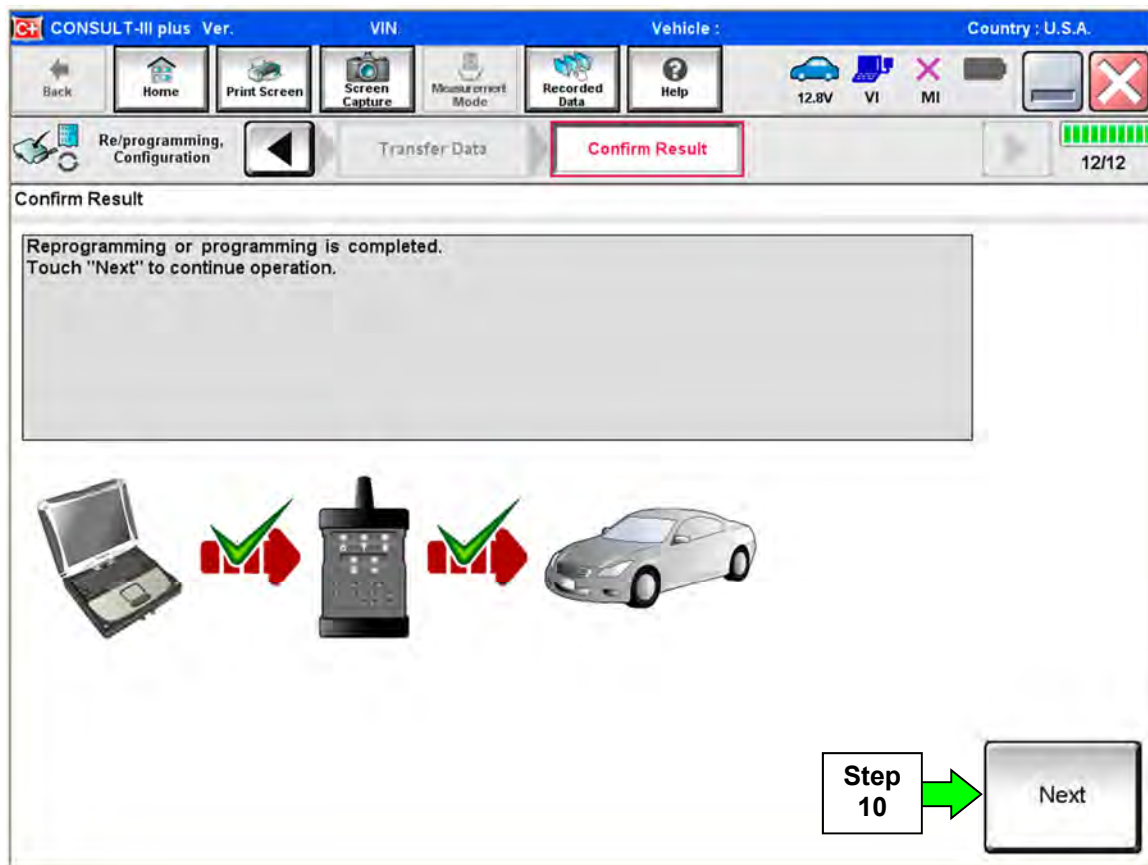
8. When the screen in Figure 5 displays, reprogramming is complete.

NOTE: If the screen in Figure 5 does not display (reprogramming does not complete), refer to the information on page 7.

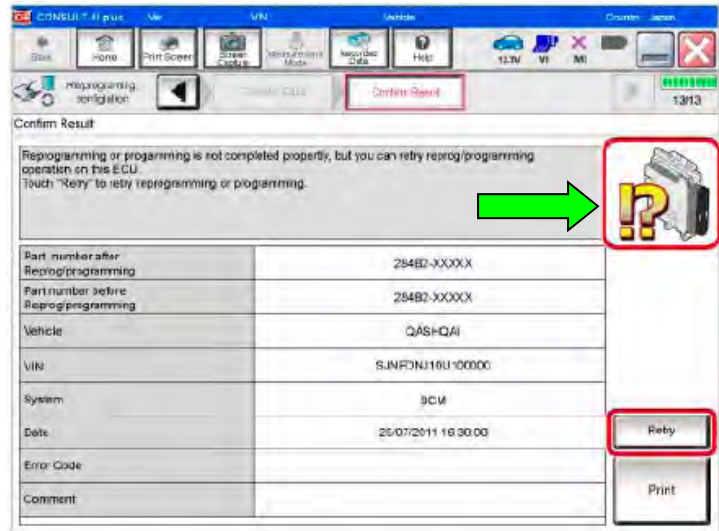
Figure 6

If reprogramming does not complete and the “!?” icon displays as shown in Figure 6:

- Check battery voltage (12.0 - 15.5 V).
- Ignition is ON, engine OFF.
- External Bluetooth® devices are OFF.
- All electrical loads are OFF.
- **Select retry and follow the on screen instructions.**
- “Retry” may not go through on first attempt and can be selected more than once.

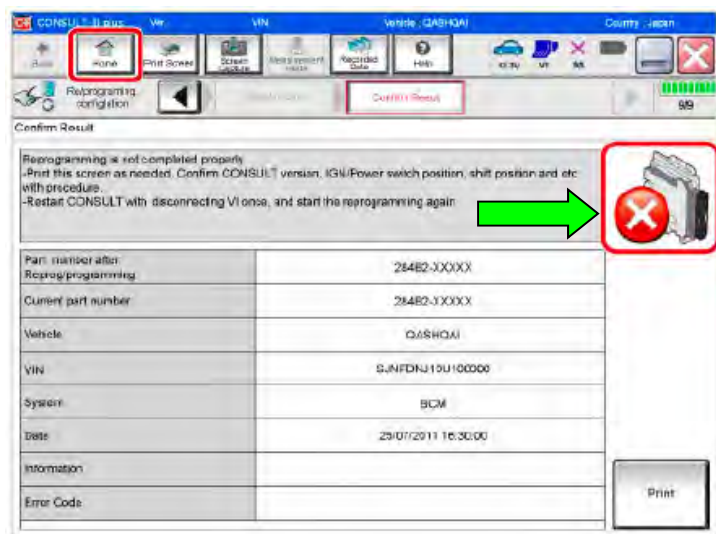
Figure 7

If reprogramming does not complete and the “X” icon displays as shown in Figure 7:

- Check battery voltage (12.0 - 15.5 V).
- CONSULT A/C adapter is plugged in.
- Ignition is ON, engine OFF.
- Transmission is in Park.
- All C-III plus / VI cables are securely connected.
- All C-III plus updates are installed.
- **Select Home, and restart the reprogram procedure from the beginning.**

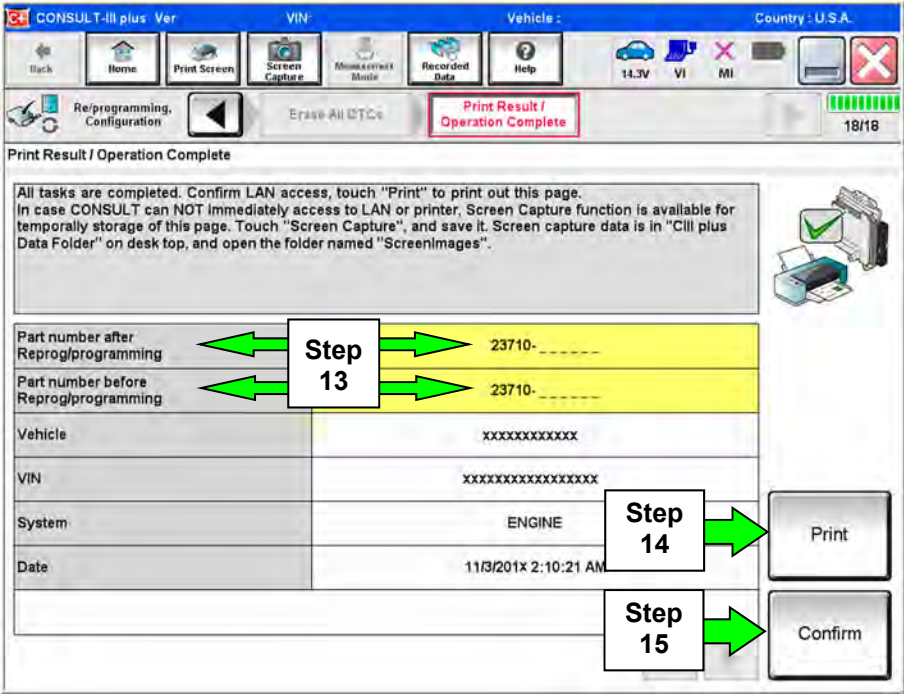
- 12. When the entire reprogramming process is complete, the screen in Figure 8 will display.
- 13. Verify the before and after part numbers are different.
- 14. Print a copy of this screen (Figure 8) and attach it to the repair order for warranty documentation.
- 15. Select **Confirm**.
