Rear Brake Hose Bracket

Reference: PC651 Date: September 21, 2018

CAMPAIGN

BULLETIN

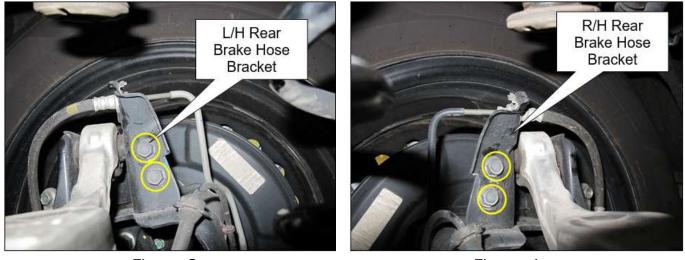
3. Locate L/H and R/H Rear Brake Hose Brackets (Figure 3, 4).

- If the Brake Hose Bracket is Loose (Moveable by hand) or a Bracket Bolt is missing go to step 5.
- 4. Place suitable Torque wrench on L/H and R/H bolts and torque to **15.75 N.m (1.61 kg-m, 12 ft-lbs)** (Figure 5, 6).

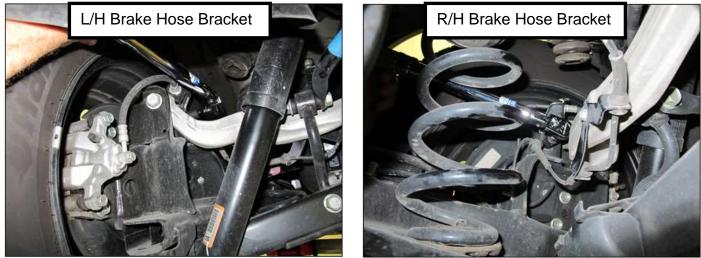
Did any of the bolts move over one quarter (1/4) turn before appropriate torque was achieved?

- If **NO** (Bolt did not move) lower the vehicle and remove from lift, submit a warranty claim using OP Code PC6510 (See claims info), and release the vehicle. No further repair is needed.
- If **YES** (Bolt moved more than one quarter (1/4) turn) lower the vehicle and remove from lift, submit a warranty claim using OP Code PC6511 (See claims info), and release the vehicle. No further repair is needed.
