# Technical Service Bulletin

## 24DB UPDATE – TCM Software (FED\_EMS)

August 10, 2018

Model(s)	Year	VIN Range	Vehicle-Specific Equipment
A3	2017	See ELSA	See ELSA

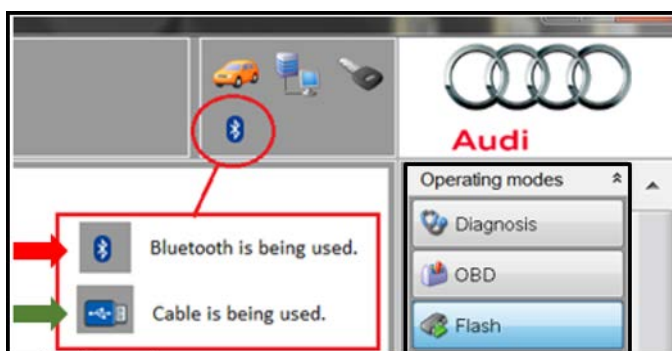
4. Attach the scan tool to the vehicle using an USB cable.
5. Confirm that the scan tool is communicating with the diagnostic head by USB <Green Arrow>. If the Bluetooth symbol is shown <Red Arrow> then disconnect the diagnostic head from the vehicle and then reattach the USB cable to the diagnostic head and then reattach to the vehicle.
