# Technical Service Bulletin

## 24DD UPDATE – ECM Software Update (FED\_EMS)

August 11, 2018

Model(s)	Year	VIN Range	Vehicle-Specific Equipment
Q3	2016-2018	See Elsa	See Elsa

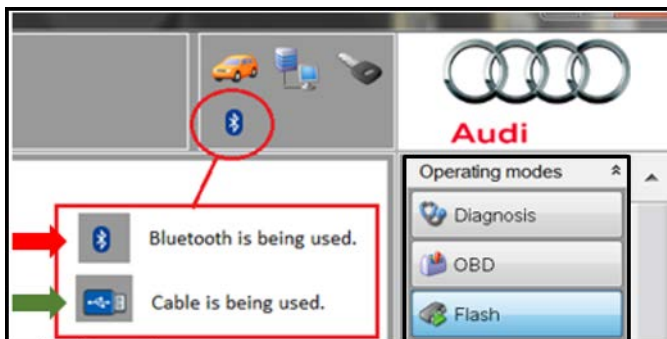
4. Attach the scan tool to the vehicle using an USB cable.
5. Confirm that the scan tool is communicating with the diagnostic head by USB <Green Arrow>. If the Bluetooth symbol is shown <Red Arrow> then disconnect the diagnostic head from the vehicle and then reattach the USB cable to the diagnostic head and then reattach to the vehicle.

6. Using ***"Flash"***, perform the update using the SVM action code, **24DDA128**.
7. After the Flashing test plan has completed upload log online.
