# Technical Service Bulletin

## 96E7 UPDATE – Gateway Software Update (NVLW)

August 10, 2018

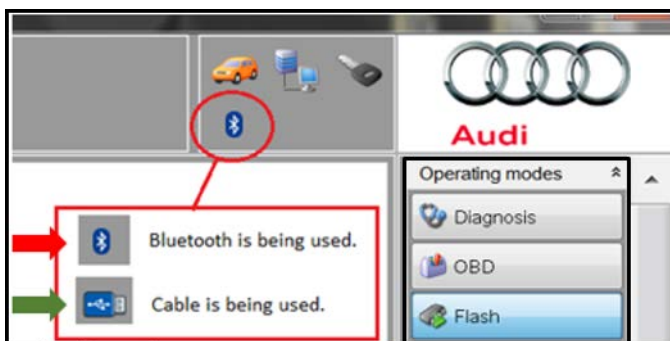
4. Attach the scan tool to the vehicle using an USB cable.
5. Confirm that the scan tool is communicating with the diagnostic head by USB <Green Arrow>. If the Bluetooth symbol is shown <Red Arrow> then disconnect the diagnostic head from the vehicle and then reattach the USB cable to the diagnostic head and then reattach to the vehicle.
