Technical Bulletin

Model(s)	Year	Eng. Code	Trans. Code	VIN Range From	VIN Range To
Tiguan LWB	2018	All	All	AX_JM000001	AX_JM135999

66 18 02 September 13, 2018 **2052184**

Water Leak - Passenger Floor

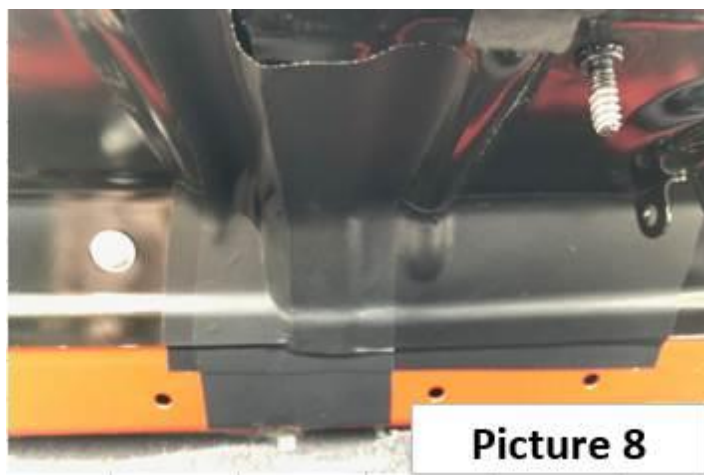
Proper placement of the tape is critical for diverting water away from the expansion valve. The tape is NOT meant to seal, it is mean to divert water.

8. Confirm the proper placement of the tapes after completing step 6 and 7 (Figure 8).
