# Technical Bulletin

**96 18 07** September 26, 2018 **2052500**

### Blind Spot Detection and Side Assist Inoperative with DTC U104500

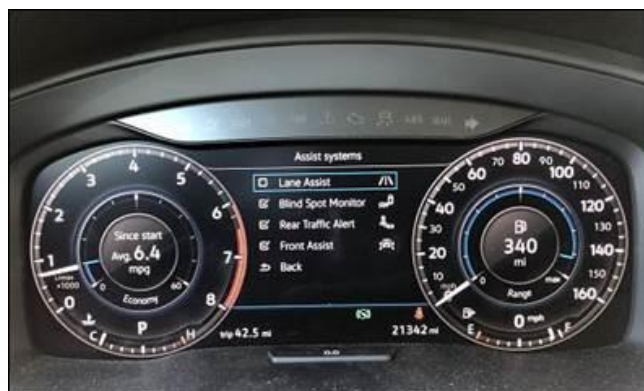
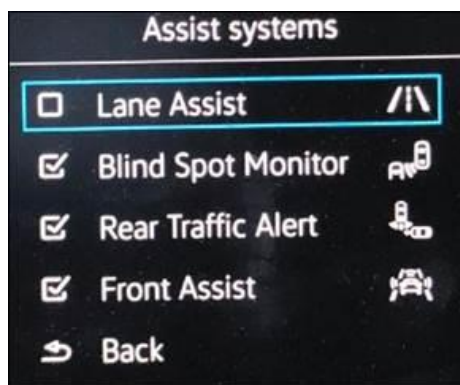
- Record customer driver assistance presets from multi-function indicator. They will be used later, after SVM flash 419B is completed (Figures 1 and 2).
