SERVICE BULLETIN

APPLICABILITY: 2017-19MY Impreza

NUMBER: 07-140-18

SUBJECT: DTC U0284, Additional Diagnostics Added

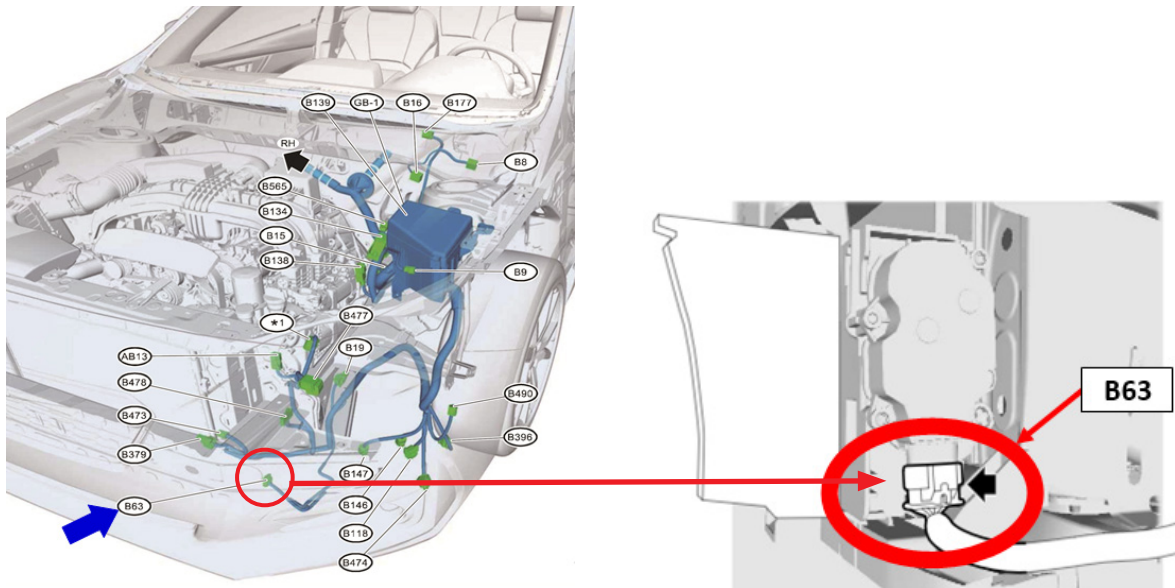
The AGS harness connector **B63** is located at the end of the AGS assembly in the l/front as shown below.

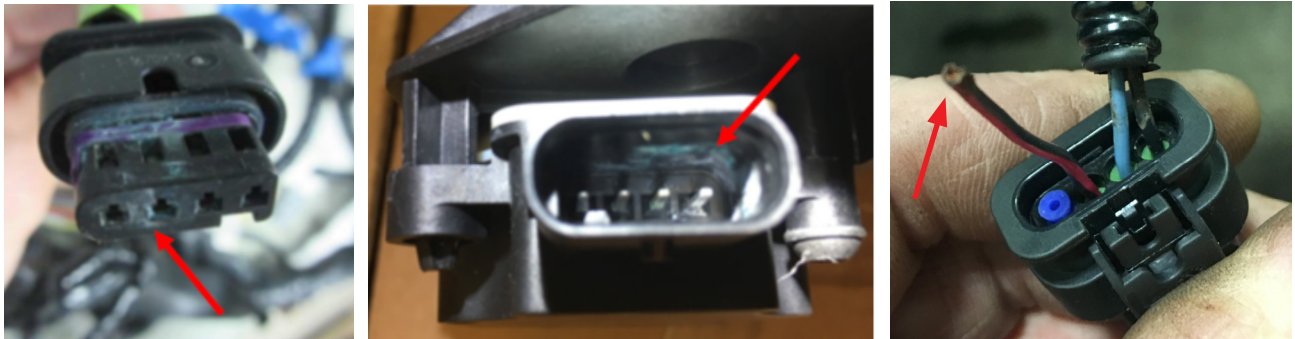
IMPORTANT: Before proceeding with any other electrical testing as directed by the current Service Manual diagnostics, access and disconnect the AGS harness connector. The photos below show both sides of the harness connection with corrosion present. If corrosion or an open circuit in the wiring is identified, replace both the bulkhead wiring harness and AGS assembly following the procedure outlined in the applicable Service Manual.

NOTE: Do not attempt to repair the wiring or clean the connector terminals. If there is no corrosion in either connector, check the wiring to the harness connector and confirm there is not an open circuit, broken wire as shown below or unexpected high resistance to indicate corrosion in the wiring. If no wiring or connector damage is identified, proceed with electrical testing Steps 3 to 6 as outlined in the applicable Service Manual for DTC U0284.
