SERVICE INFORMATION BULLETIN

APPLICABILITY: 2017-2018MY Impreza

SUBJECT: Engine Harness Retaining Clip Change

NUMBER: 07-141-18

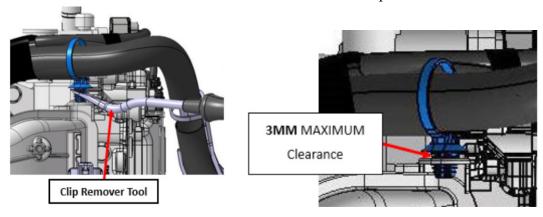
This Service Information Bulletin announces a change to the retaining clip used to secure the engine harness on the models listed above. The change to a "Tree Type" clip from an "Anchor Type" was made to secure the harness tighter and improve assembly line productivity. Comparison images are provided below.

- Whenever removing the clip from the mounting bracket, ALWAYS use a clip removal too as shown in the illustrations below to avoid damaging it.
- When installing the clip, it must be inserted into the bracket firmly with no more than 3MM clearance between the bracket and the underside of the clip.

NOTE: If the clip is replaced, put a reference mark on the harness before removing the original so the new clip can be positioned properly. After tightening the band of the new clip around the harness, trim off any excess (5mm max.) band remaining.
