## SERVICE BULLETIN

**APPLICABILITY:** 2017-18MY Impreza  
 2018MY Crosstrek  
 2018MY Legacy and Outback  
 2018MY BRZ

**NUMBER:** 15-211-17R

**SUBJECT:** Reprogramming File Availability for Additional Optimization of Harman Gen 3 Audio and Navigation Head Units

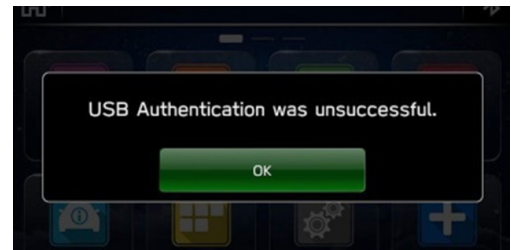
**CAUTION:** NEVER attempt to install this software on any 2019 MY vehicles as they are equipped with Gen 3.1 Audio/Navigation systems. This update is **ONLY** for models equipped with Gen 3.0 Audio/Navigation systems. Should an attempt be made to install any of these files into a Gen 3.1 head unit, the authentication error screen to the right will be displayed.

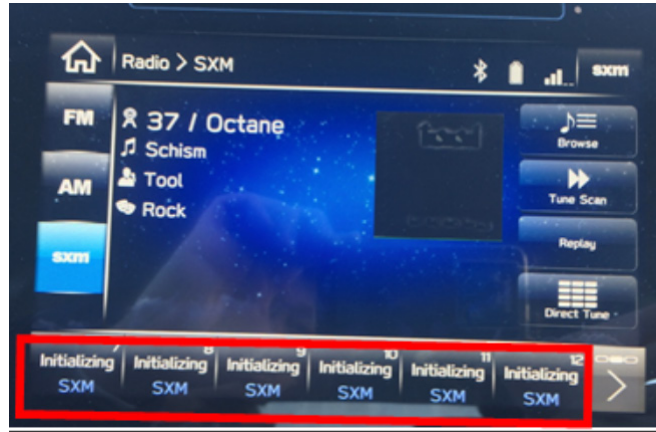
- On 2018MY Legacy / Outback models with Navigation (High) head units, the update corrects a condition where the head unit remains powered even after the ignition is OFF and the driver door is opened.
- Corrects for a condition where the SXM presets become lost and only “Initializing” appears as shown below.

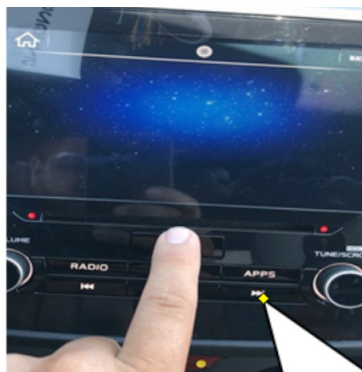
- Corrects for condition where only the star field background is displayed (without icons) after the HOME button is pressed.

**Background shown, but no icons**

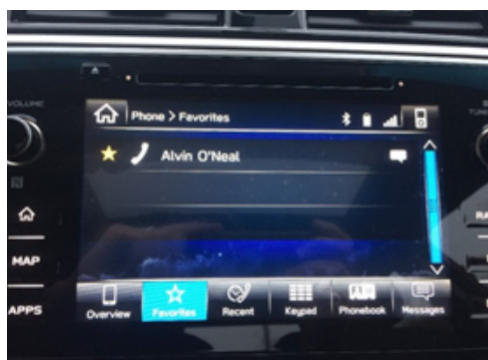
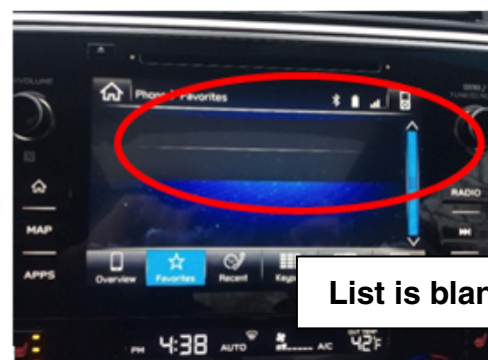
- Corrects for a “Pop” or “Crackling“ sound concern when listening to AM radio.
- Corrects for a concern of the head unit continually resetting itself.
- Corrects for a concern of after selecting a contact to be a “Favorite” and the “Favorite” list display is blank.

**List is blank**

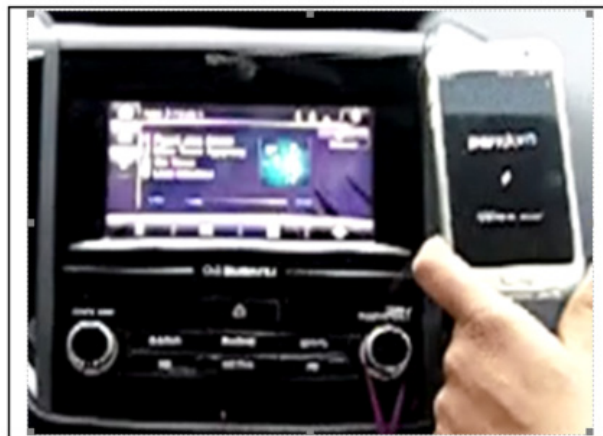
- 1- No streaming audio. When using the Pandora® app, there is no audio output.

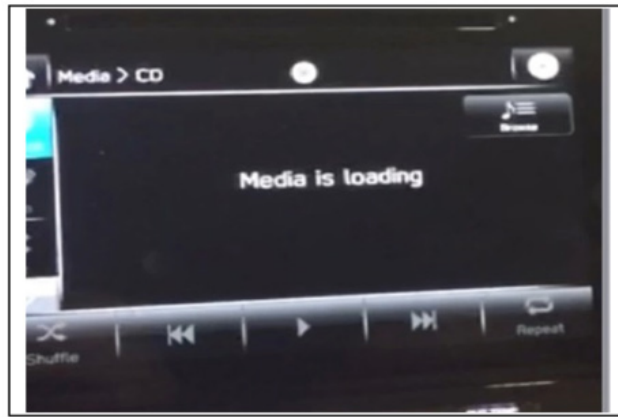
- 2- “Media is loading” is displayed on the screen but, the media never completes loading.

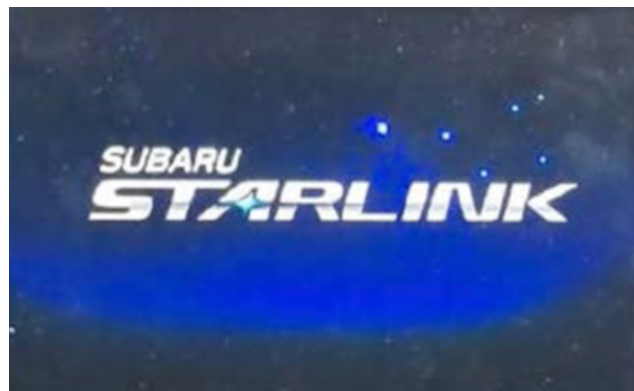
- 3- The screen freezes when the STARLINK screen is displayed.

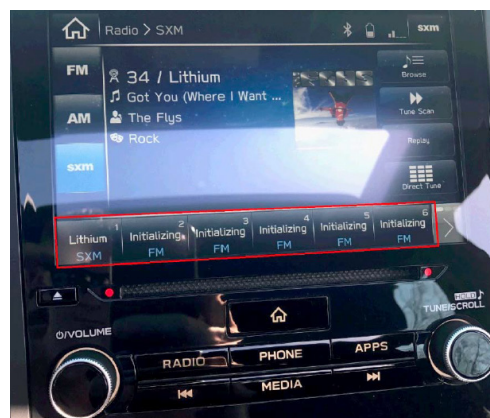
- 1- Radio station presets disappear (touch screen buttons return to “Initializing”).

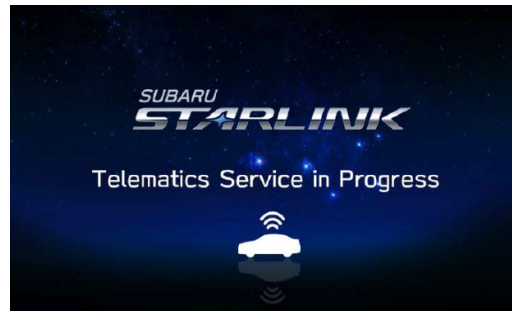
2- STARLINK “Telematics Service in Progress” screen freezes.

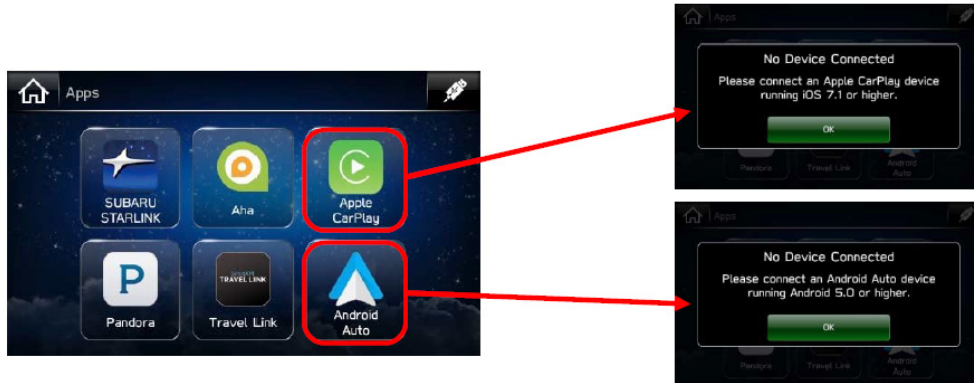
3- Apple Car Play / Android Auto function does not operate (“No Device Connected”).

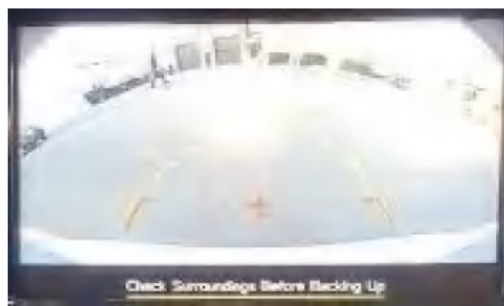
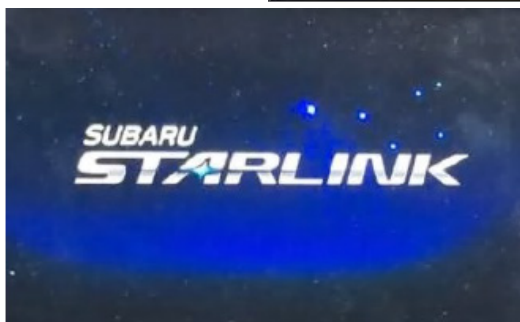
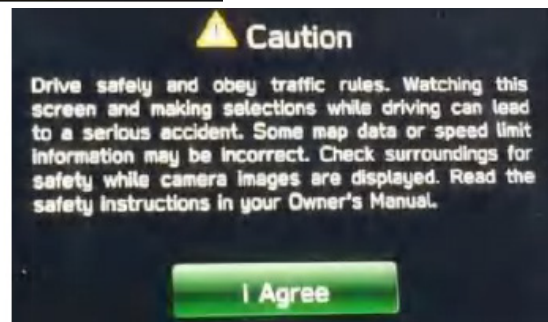
For reference, the previously released WTN-74R symptoms are also provided below. The main purpose of WTN-74R was to address display screen freeze-up during Back-Up Camera display (when the shifter is in “R”). In addition, the screen may also freeze when either the Subaru STARLINK or Disclaimer Caution / I Agree screen is displayed.

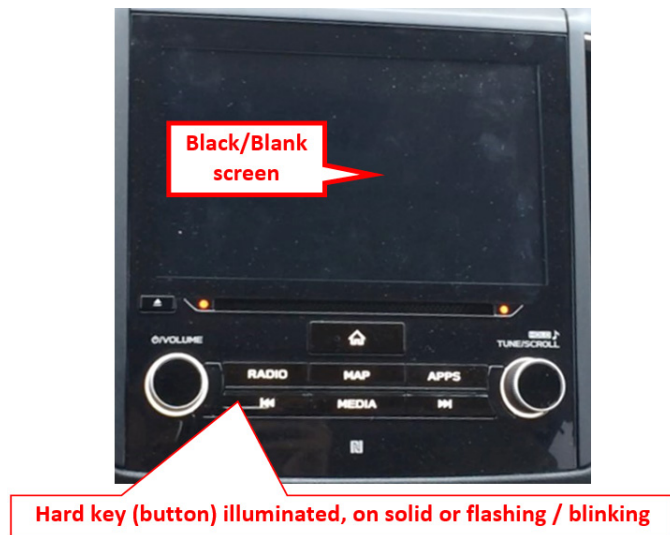
- 1) After switching the vehicle (ACC or IGN) on, the display screen goes black with no audio output and the hard key buttons are illuminated (on solid, or flashing / blinking).

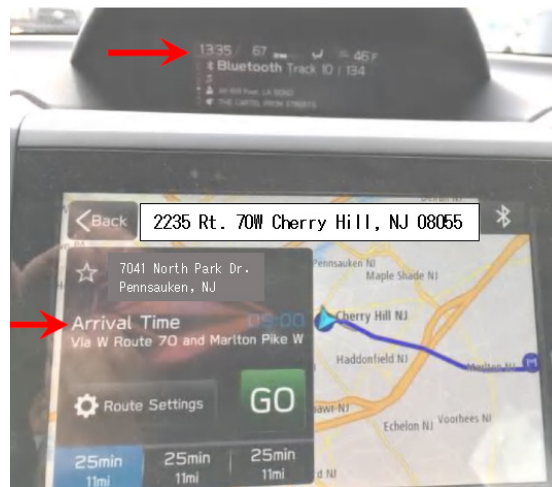
- 2) Time of day displayed in the MFD (Multi-Function Display) is incorrect and the arrival time displayed in Navigation units is also incorrect.

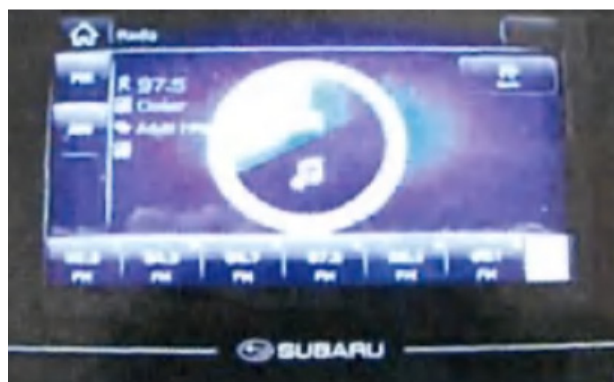
- 3) The time in the MFD automatically reverts to a “default” setting, even after setting the time using “Manual” mode.
- 4) Audio volume goes to maximum automatically after one click of the volume up button on the steering wheel. In some cases, this condition may also occur without input from the operator. Maximum volume is also displayed on the screen.

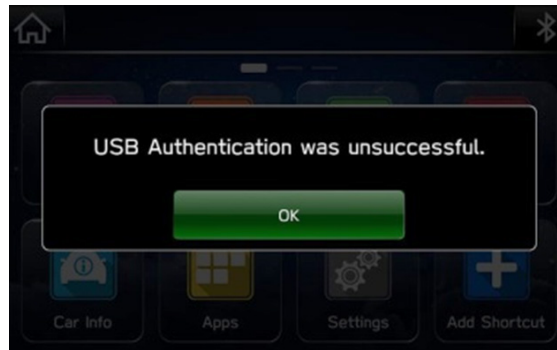
**NOTE:** If an attempt is made to install the wrong “grade” file into the wrong grade head unit (EXAMPLE: “Base” update file into a “Mid” or “High” head unit), the USB Authentication error screen below will be displayed:
