SERVICE INFORMATION BULLETIN

APPLICABILITY: 2019MY Forester

NUMBER: 07-142-18

SUBJECT: Battery Sensor Removal and Installation Precautions

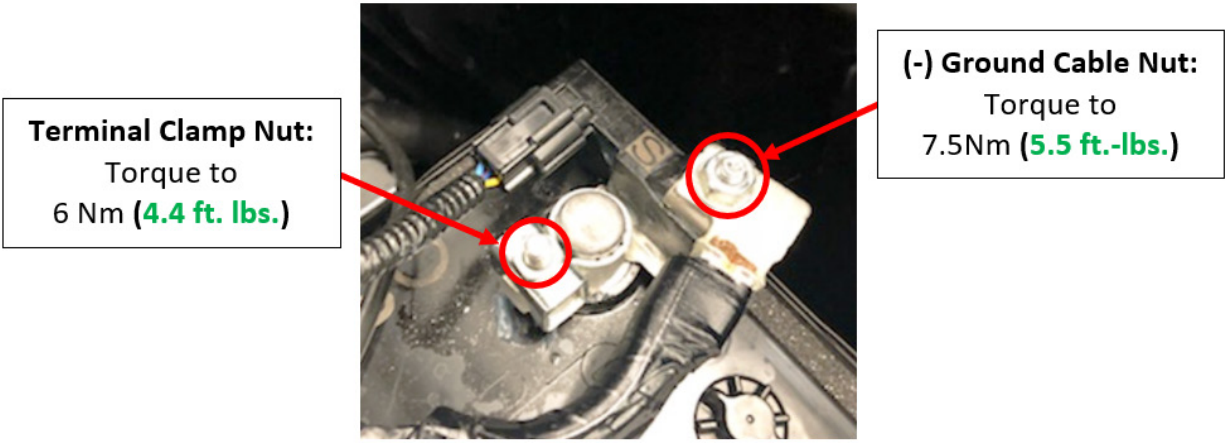
- Whenever a negative (-) battery cable disconnect is required, hold the sensor in place with one hand while loosening the 10mm hex nut securing it to the sensor. This will help support the sensor and keep the assembly from rotating on the battery post. Remove the nut from then take the cable off the stud on the sensor. It is **STRONGLY** recommended to **leave the battery sensor on the battery post** unless the battery (or the battery sensor assembly) is being replaced. This will also help reduce the chances of damaging the sensor and / or creating a poor battery ground connection.

NOTE: **Hand tools only** for this procedure as the sensor can be damaged very easily if either of the 10mm hex nuts are over-torqued.

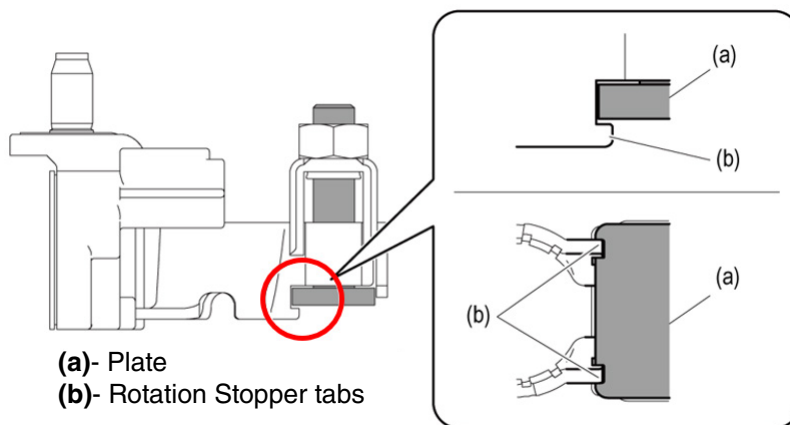
The illustration above provides an additional detail view of how the plate (a) is required to fit into the rotation stopper tabs (b).

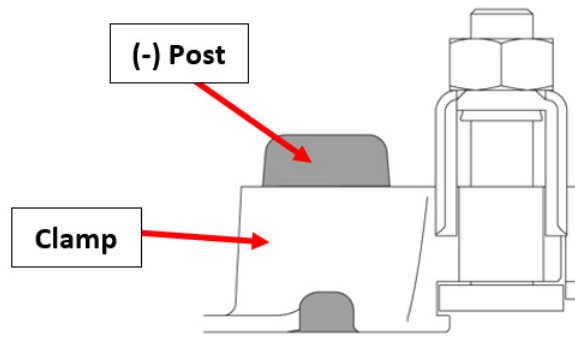
- When installing the sensor assembly onto the battery post, confirm it is fully seated and the (-) post protrudes above the clamp portion as shown below before torquing the 10mm retaining hex nut.

- Negative Battery Cable (Ground) Nut: 7.5 Nm (**5.5 ft. lbs.**)
- Terminal Clamp Nut: 6 Nm (**4.4 ft. lbs.**)
- Always hold the sensor in place with one hand while loosening or torquing either 10mm hex nut.
