SERVICE BULLETIN

APPLICABILITY: 2015-2017MY Legacy and Outback
 2015-2017MY Impreza and XV Crosstrek
 2015-2018MY Forester
 2016-2018MY WRX
 2015-2017MY BRZ

NUMBER: 15-199-16R
DATE: 05/05/16
REVISED: 10/12/18

SUBJECT: Reprogramming File Availability to Address Operational Concerns with 6.2” Clarion Display Audio Unit

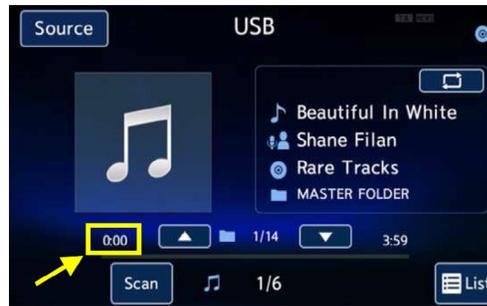
- When listening to music from a USB drive, the elapsed play time counter stays at 0:00.

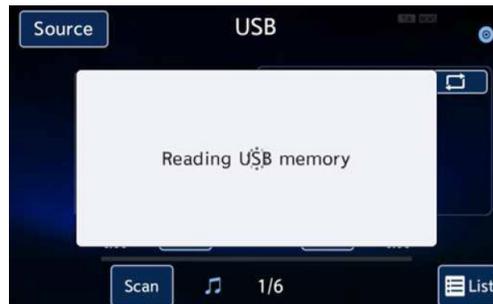
- When listening to music from a USB drive, the music plays normally but the screen display shows “Reading USB Memory”.

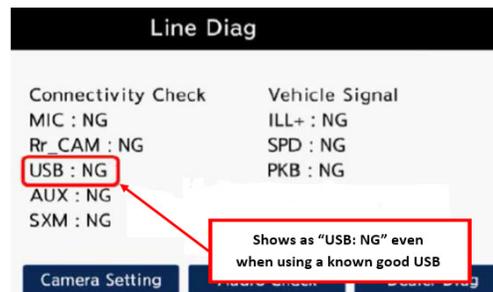
- In diagnostic mode, “USB: NG” is displayed even though a known good USB drive is plugged in.

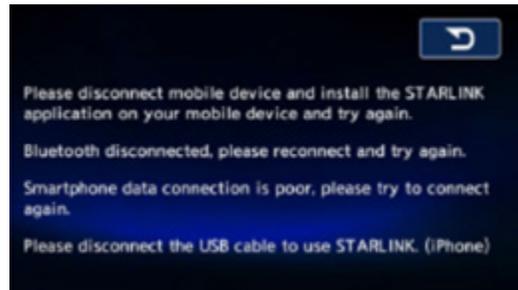
- When using the Magellan Navigation smartphone application (Release date 11/1/2016) for approximately 6 hours, the Bluetooth disconnects and the route guidance screen freezes. An error message screen displays asking the user to disconnect their mobile device, install the STARLINK application on their mobile device and try again along with three other connection-related messages.

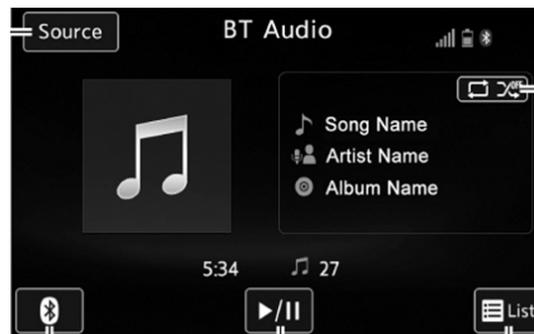
- All the function keys such as the steering switch, hard keys on the head unit and touch panel (display) become inoperative after playing music for 3-4 hours using a Bluetooth-connected device and no input from any of the keys on that connected device. When this occurs, music continues to play normally but the display screen freezes.

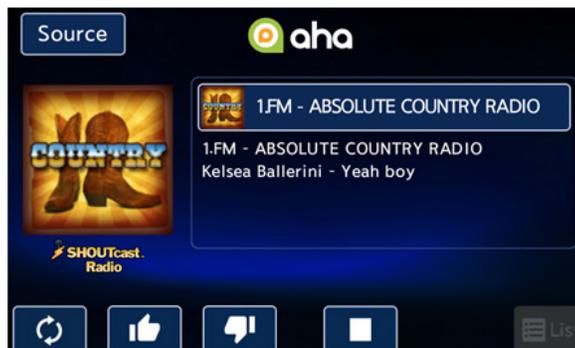
- ✓ When making a hands-free call using the voice command function, the ring-back tone is not heard from the speakers.
- ✓ When making a hands-free call using the voice command function, the user enters the number using the phone's buttons but, a dial tone is not heard from the speakers.
- ✓ When receiving a call using the hands-free and voice command functions, the ringtone is not heard from the speakers.
- When using the ahaRadio feature, song title and artist information does not update after the previous song ends.
