Business Class M2  
> Cascadia  
108SD/114SD  
New Cascadia

**Freightliner  
Service Bulletin**

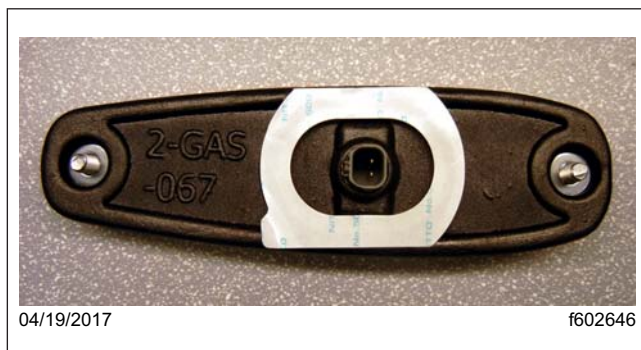
**Fig. 1, Marker Light with Peel-and-Stick Adhesive Gasket**

On November 14, 2016, the Cascadia marker light was changed in production to include an adhesive gasket. On some Cascadia vehicles built before November 14, 2016, water may intrude into the cab through the marker light seals. If a leak is detected in a vehicle built before that date, install new peel-and-stick adhesive gaskets on all five marker lights; see [Fig. 1](#).

1. Park the vehicle on a level surface, shut down the engine, and set the parking brake. Chock the tires.
2. Remove the two screws that attach the marker light to the cab roof.
3. Remove and discard the old gasket.

4. Peel the paper from the film adhesive on the lamp-facing side of the new gasket.
5. Install the new gasket on the marker light.

6. Scrape any remaining sealant or gasket material from the cab surface, then using soapy water, clean the cab roof where the marker light will be installed.
7. Make sure the cleaned surfaces are dry, then peel the backing off the roof side of the marker light gasket.

8. Install the marker light, using two screws to fasten it securely. Tighten the screws 31 lbf·in ± 4.4 lbf·in (350 N·cm ± 50 N·cm).

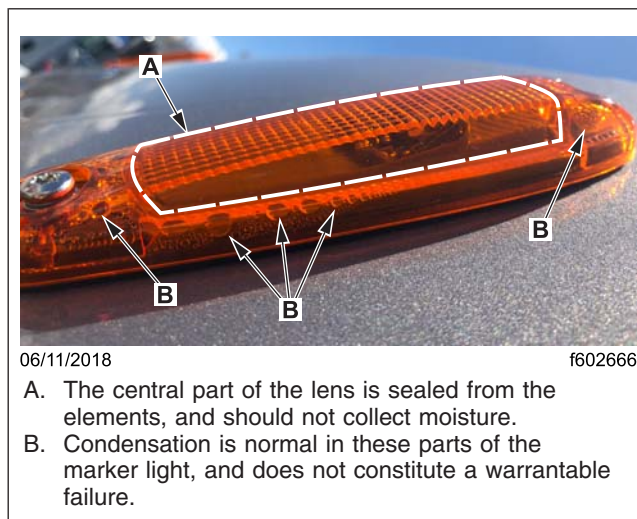
NOTE: The roof marker lights may collect moisture between certain portions of the lens and the gasket. This is completely normal and does not constitute a warrantable failure. Only the part of the lens which contains the electronics, in the center of the marker light, is sealed from the elements. See [Fig. 2](#).

**Fig. 2, Condensation in Marker Light**  
A. The central part of the lens is sealed from the elements, and should not collect moisture.  
B. Condensation is normal in these parts of the marker light, and does not constitute a warrantable failure.
