# FIELD SERVICE CAMPAIGN BULLETIN

Subject: **Field Service Campaign 18M1**  
**GHG14 Heavy Duty Engine Platform Vocational Application**  
**Programming**

## Field Service Campaign Bulletin 18M1

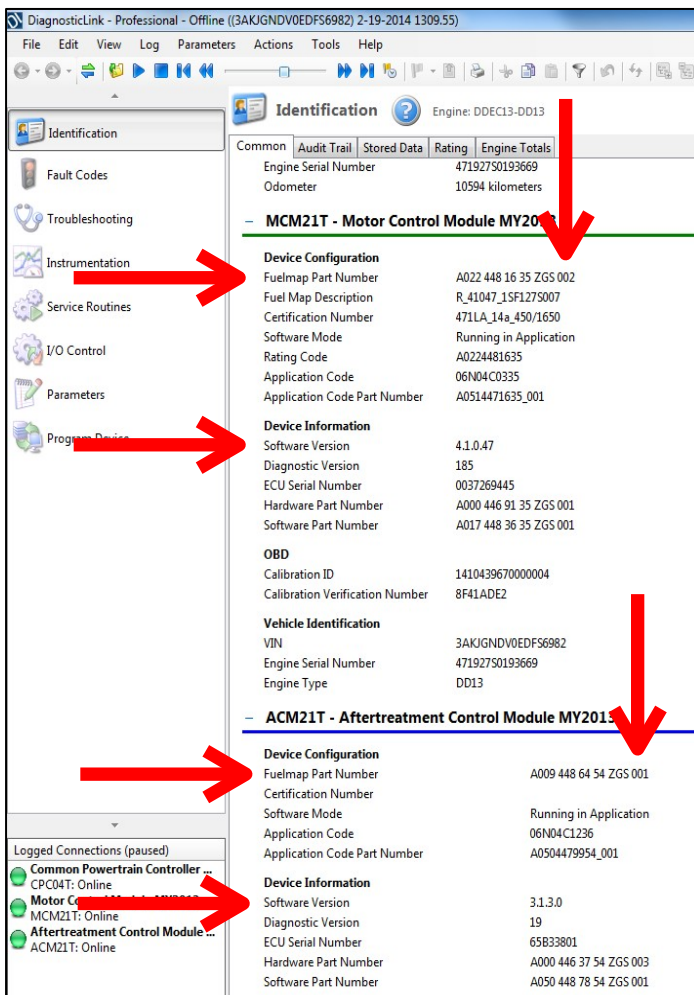
**Figure 1 – DiagnosticLink® Identification Screen**

6. Is the software level for the MCM, ACM, CPC, and if applicable the TCM, less than, equal to, or higher than the minimum software levels listed in step 5? All modules must meet the **MINIMUM** requirements. For example, in Figure 1, MCM software 4.1.0.47 and ACM software 3.1.3.0 are both less than the minimum levels of 4.7.0.0 and 5.57.0.0, and thus would require programming, regardless of fuel map ZGS version.
  - a. If less than the minimum software levels, proceed to step 8.
  - b. If equal to the minimum software levels, proceed to step 7.
  - c. If greater than the minimum software levels, no programming is necessary. Proceed to step 13.

5. On the Identification screen, check the current MCM, ACM, CPC, and if applicable the TCM, software and fuel map level. Listed below are the **MINIMUM** levels required. See Figure 1 for an example of the Identification screen for the MCM and ACM.
  - a. MCM **4.7.0.0 software** and fuel map version **ZGS 003**, except for three ratings that are ZGS 004:
    - i. DD13 450/1450/1650 1-box, fuel map P/N: A0294487935 ZGS 004
    - ii. DD15AT 455/1550/1750 1-box, fuel map P/N: A0304480035 ZGS 004
    - iii. DD15AT 400/1750 1-box, fuel map P/N: A0304480335 ZGS 004
  - b. ACM **5.57.0.0 software** and fuel map version **ZGS 004**
  - c. CPC **R34 00 000A software**
  - d. If applicable, TCM **NAMT070700 software**

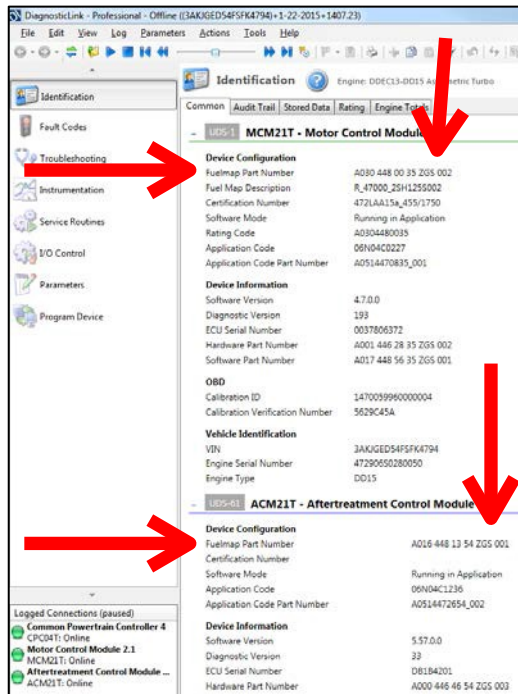
Figure 2 – DiagnosticLink® Identification Screen

7. Is the fuel map ZGS version level for the MCM and ACM less than, equal to, or higher than the fuel map ZGS revision levels listed in step 5? The MCM and ACM fuel map ZGS version levels must meet the **MINIMUM** requirements. For example, in Figure 2, both the MCM and ACM software levels meet the minimum required of MCM 4.7.0.0 and ACM 5.57.0.0, but the fuel map ZGS version levels of MCM 002 and ACM 001 are less than the minimum levels of MCM 003 (except for three ratings that are 004) and ACM 004, and thus would require programming.
  - a. If less than the minimum fuel map ZGS version levels, proceed to step 8.
  - b. If equal to, or greater than, the minimum fuel map ZGS version levels, no programming is necessary. Proceed to step 13.
