FIELD SERVICE CAMPAIGN BULLETIN

Subject: **Field Service Campaign 18M4**
Remanufactured Detroit™ DT12™ Transmission

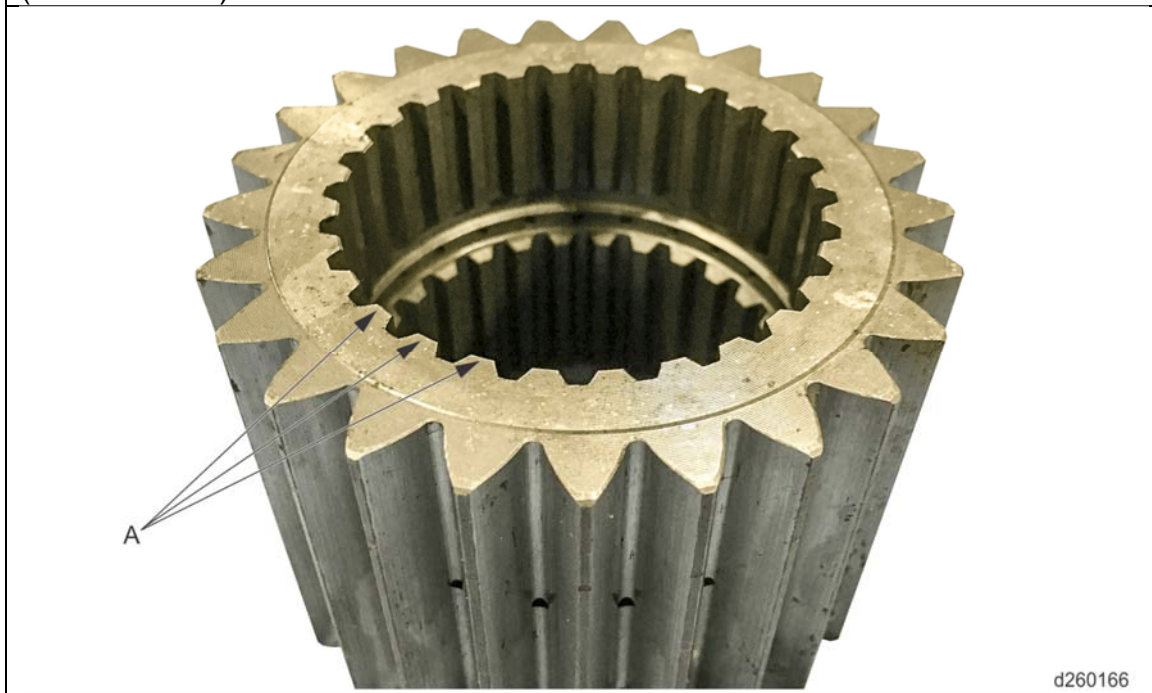
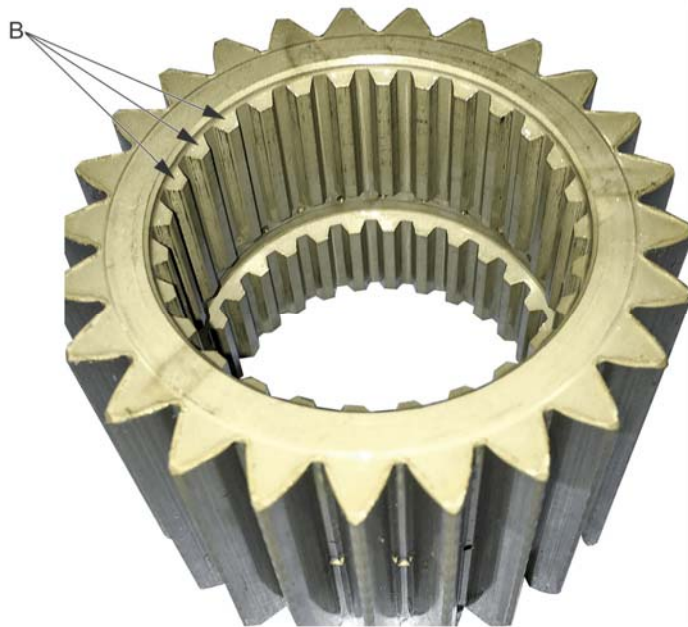
The location of the oil groove, holes in the sun gear, and the oil holes in the main shaft need to be aligned to supply oil between the sun and planet gears of the range group. Install the sun gear with the flat side facing out towards the snap ring groove is shown below (See callout A). The sun gear with the beveled spline side facing inwards towards the center case is shown below (See callout B).

- 19.** Install the new sun gear and snap ring. Read note below before installing to ensure proper gear orientation. See Figures 9 and 10.
