May 2018  
INT FL766-01  
NHTSA #18V-191  
Transport Canada #18-190  
**INTERIM RECALL BULLETIN**

## **Subject: Western Star Power Cable Studs**

**Models Affected: Specific Western Star 4700, 4900, 5700, and 6900 model vehicles manufactured September 12, 2016, through February 6, 2018.**

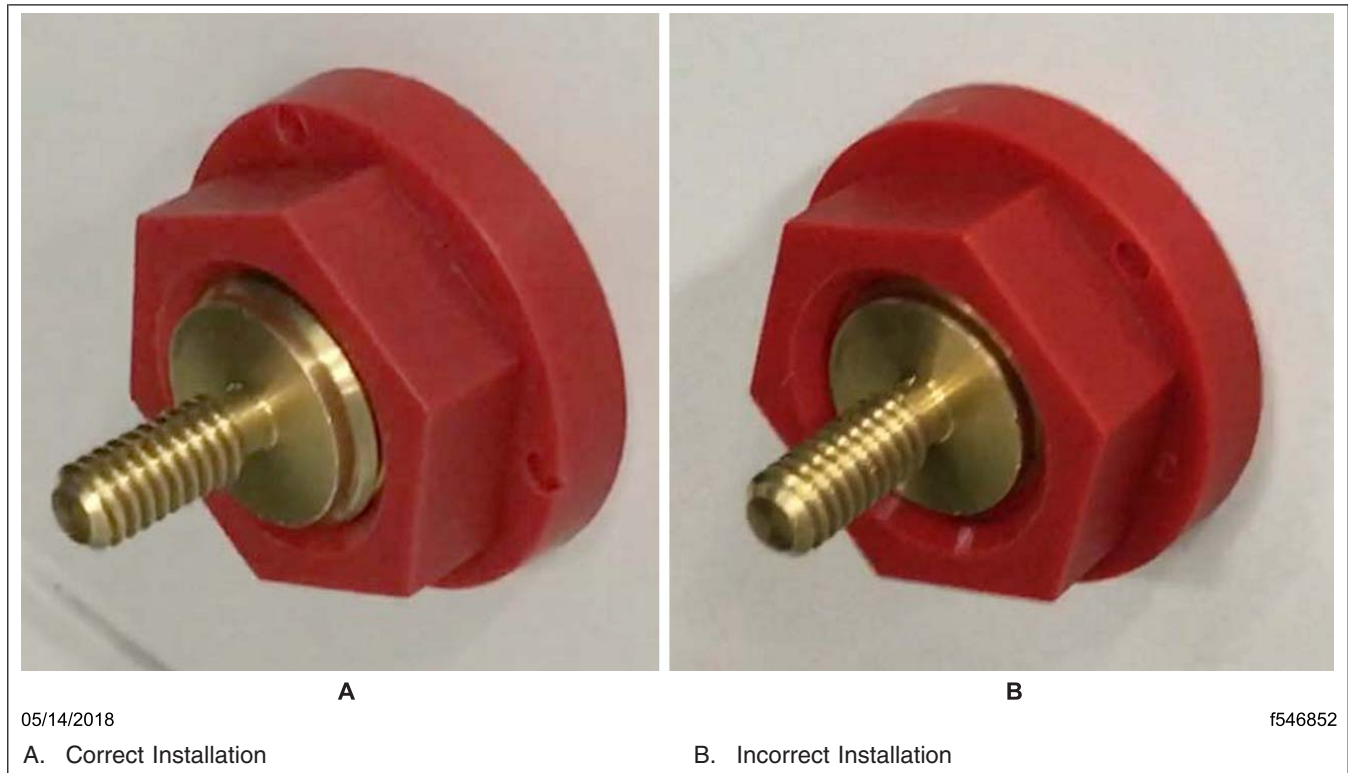
**Fig. 3, Installation Inspection**

1. Check OWL prior to performing the interim recall to ensure the vehicle is involved and the campaign has not been previously completed. **DO NOT** use a completion sticker for the interim inspection or repair. Attaching a recall completion sticker may prevent the customer from getting the final recall repair.
2. Park the vehicle on a level surface, shut down the engine, and set the parking brake. Chock the tires.
3. Open the hood and locate the three battery bulkhead connectors on the front wall. See [Fig. 1](#).
4. Pull back the covers on the battery bulkhead connectors. See [Fig. 2](#). Inspect the bulkhead studs to make sure at least one thread protrudes past the plastic nut. See [Fig. 3](#) and [Fig. 4](#).

*If at least one thread does NOT protrude past the plastic nut, the installation is INCORRECT. Proceed to the next step.*

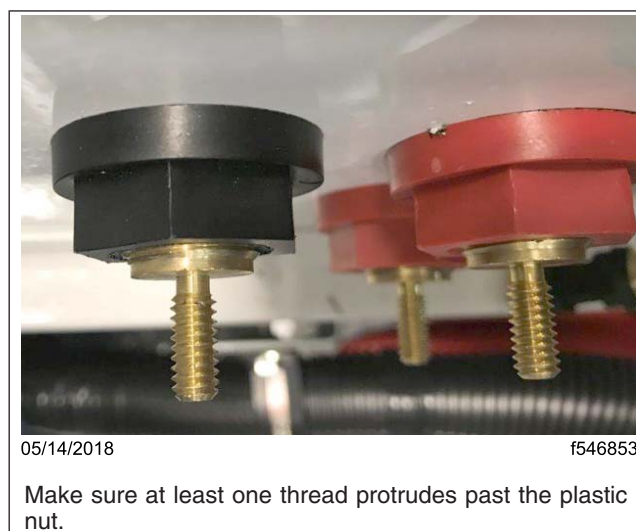
**Fig. 4, Correctly Installed Pass-Through**

*If at least one thread protrudes past the plastic nut, the installation is CORRECT and the recall is complete. Install the connector covers. **DO NOT** use a completion sticker for the interim inspection or repair. Attaching a recall completion sticker may prevent the customer from getting the final recall repair.*
