# EMISSION RECALL BULLETIN

Subject: **Emission Recall D18R3**  
**GHG14 DD Platform Model Years 2013-2015 Software**  
**Reprogramming For California Inspection and Maintenance**

## Emission Recall Bulletin D18R3

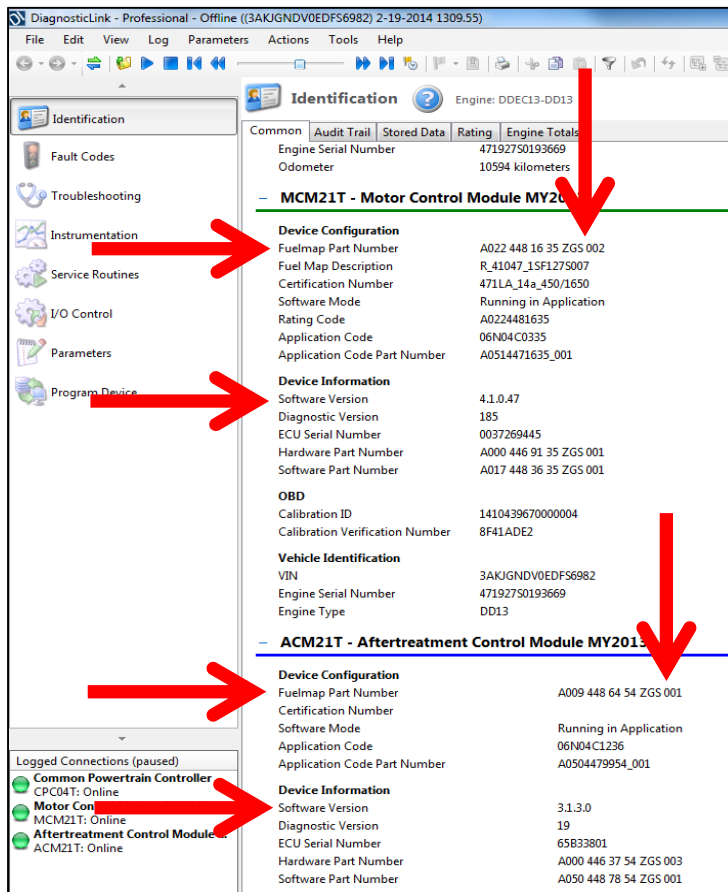
**Figure 1 – DiagnosticLink® Identification Screen**

5. On the Identification screen, check the current MCM and ACM software and fuel map level. Listed below are the **MINIMUM** levels required. See Figure 1 for an example of the Identification screen for the MCM and ACM.
  - a. MCM **4.7.0.0 software** and fuel map version **ZGS 002**, except for these ratings:
    - i. DD13 380/410/1450 1-BOX for Oshkosh, fuel map p/n A0364483035 ZGS 001
    - ii. DD13 435/1550 1-BOX for Oshkosh, fuel map p/n A0364483135 ZGS 001
    - iii. DD13 450/1550 Two-box for MCI, fuel map p/n A0364482735 ZGS 001
    - iv. DD13 450/1450/1650 1-BOX, fuel map p/n A0294487935 ZGS 003
    - v. DD15AT 455/1550/1750 1-BOX, fuel map p/n A0304480035 ZGS 003
  - b. ACM **5.57.0.0 software** and fuel map version **ZGS 003**

6. Is the software level for the MCM and ACM less than, equal to, or higher than the minimum software levels listed in step 5? All modules must meet the **MINIMUM** requirements. For example, in Figure 1, MCM software 4.1.0.47 and ACM software 3.1.3.0 are both less than the minimum levels of 4.7.0.0 and 5.57.0.0, and thus would require programming, regardless of fuel map ZGS version.
  - a. If less than the minimum software levels, proceed to step 8.
  - b. If equal to the minimum software levels, proceed to step 7.
  - c. If greater than the minimum software levels, no programming is necessary. Proceed to step 13.

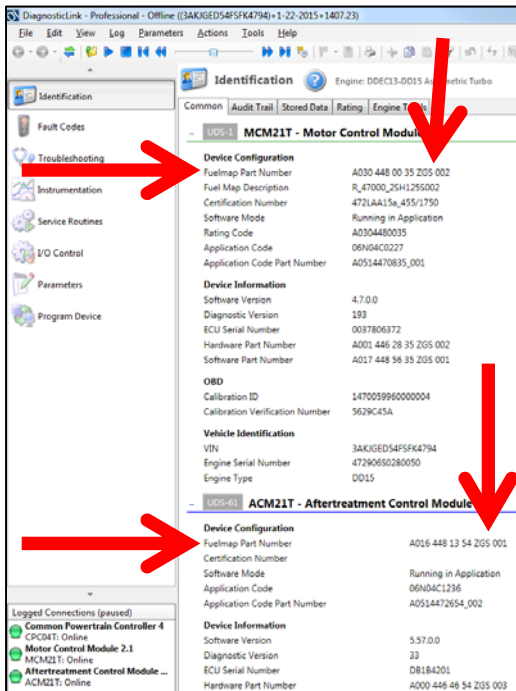
Figure 2 – DiagnosticLink® Identification Screen

7. Is the fuel map ZGS version level for the MCM and ACM less than, equal to, or higher than the fuel map ZGS revision levels listed in step 5? The MCM and ACM fuel map ZGS version levels must meet the **MINIMUM** requirements. For example, in Figure 2, both the MCM and ACM software levels meet the minimum required of MCM 4.7.0.0 and ACM 5.57.0.0, but the fuel map ZGS version levels of MCM 002 and ACM 001 are less than the minimum levels of MCM 002 (except for five ratings that are different, including the one shown) and ACM 003, and would require programming.
  - a. If less than the minimum fuel map ZGS version levels, proceed to step 8.
  - b. If equal to, or greater than, the minimum fuel map ZGS version levels, no programming is necessary. Proceed to step 13.
