SS 1033403 - WST Wiper Motor not Parking Issues

Applicable Vehicles

WST 4700, 4800 and 4900

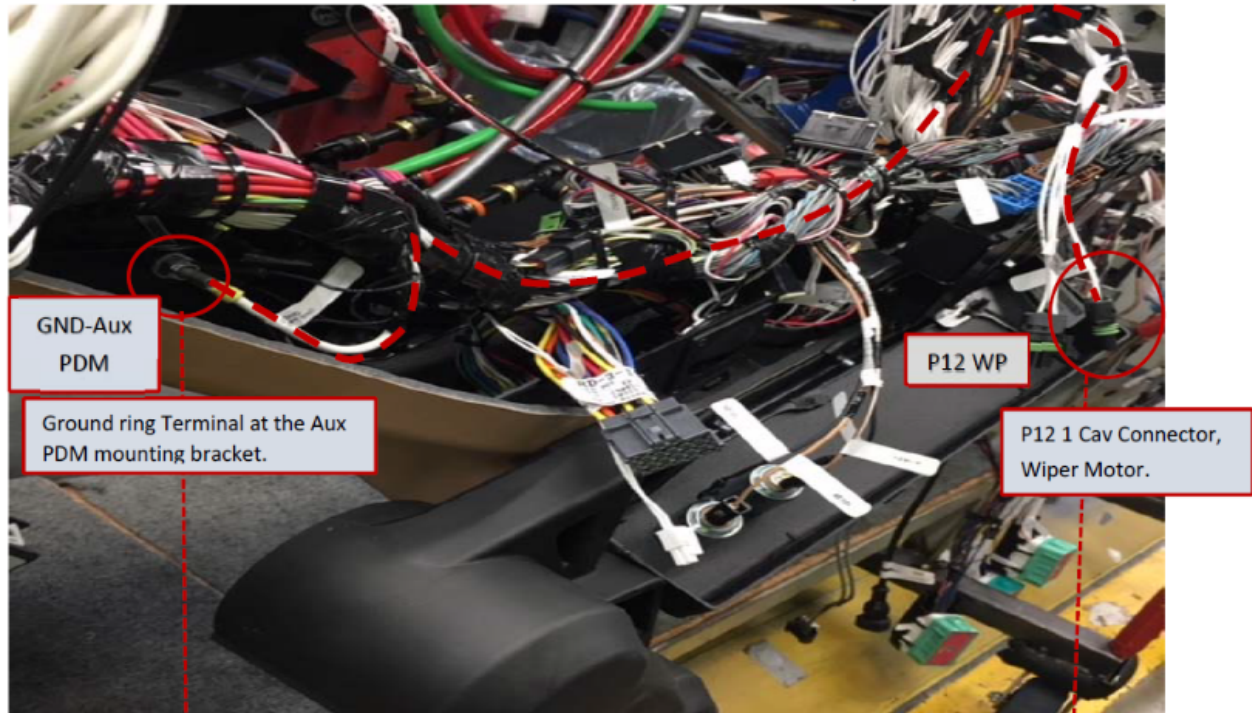
Below are shown the locations of the Gnd Terminal Aux PDM Bracket and P12 Wiper Motor Gnd 1 Cav Connector.

Route new Jumper Harness from P12 WP to GND-Aux PDM as shown with the red dashed line. Use 12 AWG TXL White Cable with Ring Terminal **PAC 12103513** and Term Female W-P **PAC12124581** and seal **PAC 15324981 B**

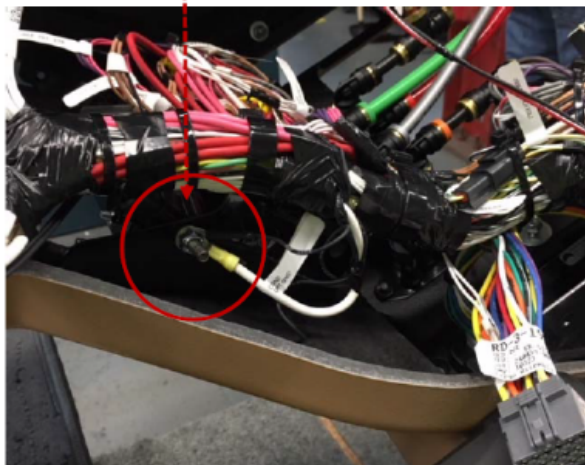
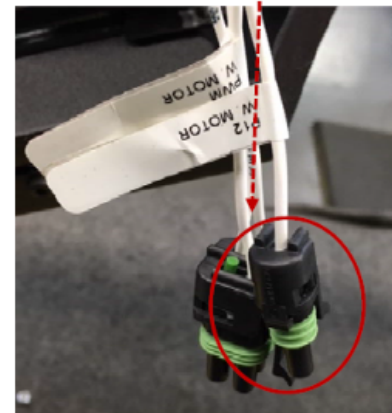
Jumper Harness: 12 AWG TXL White.

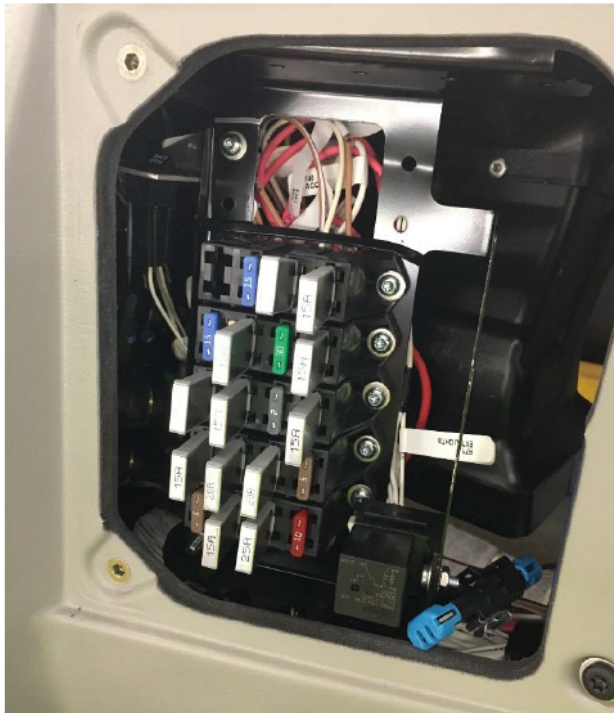
Aux PDM and location of Ground stud on Aux PDM Bracket

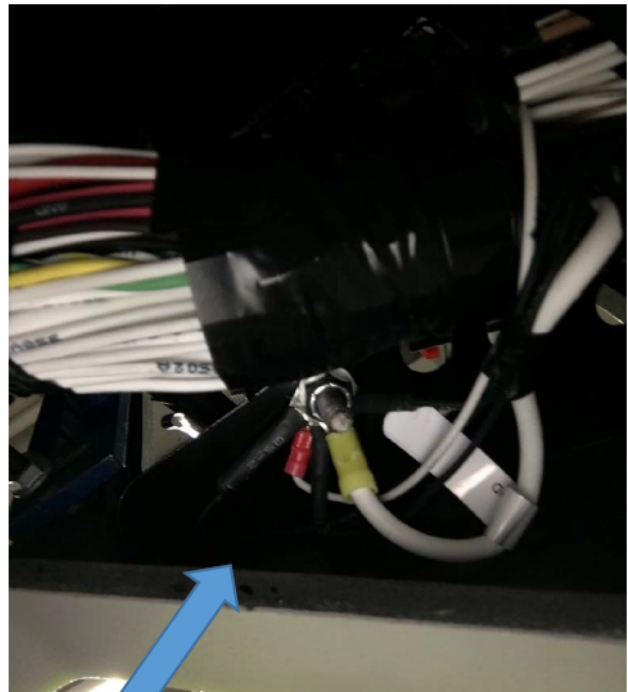
View from the bottom – Ground Stud
