# SS 1033463 - WST 4700 Transmission Oil Cooler Lines Routing Improvements

## **WST 4700 Transmission Oil Cooler Lines Routing Improvements**

WST 4700 w/Allison Transmissions

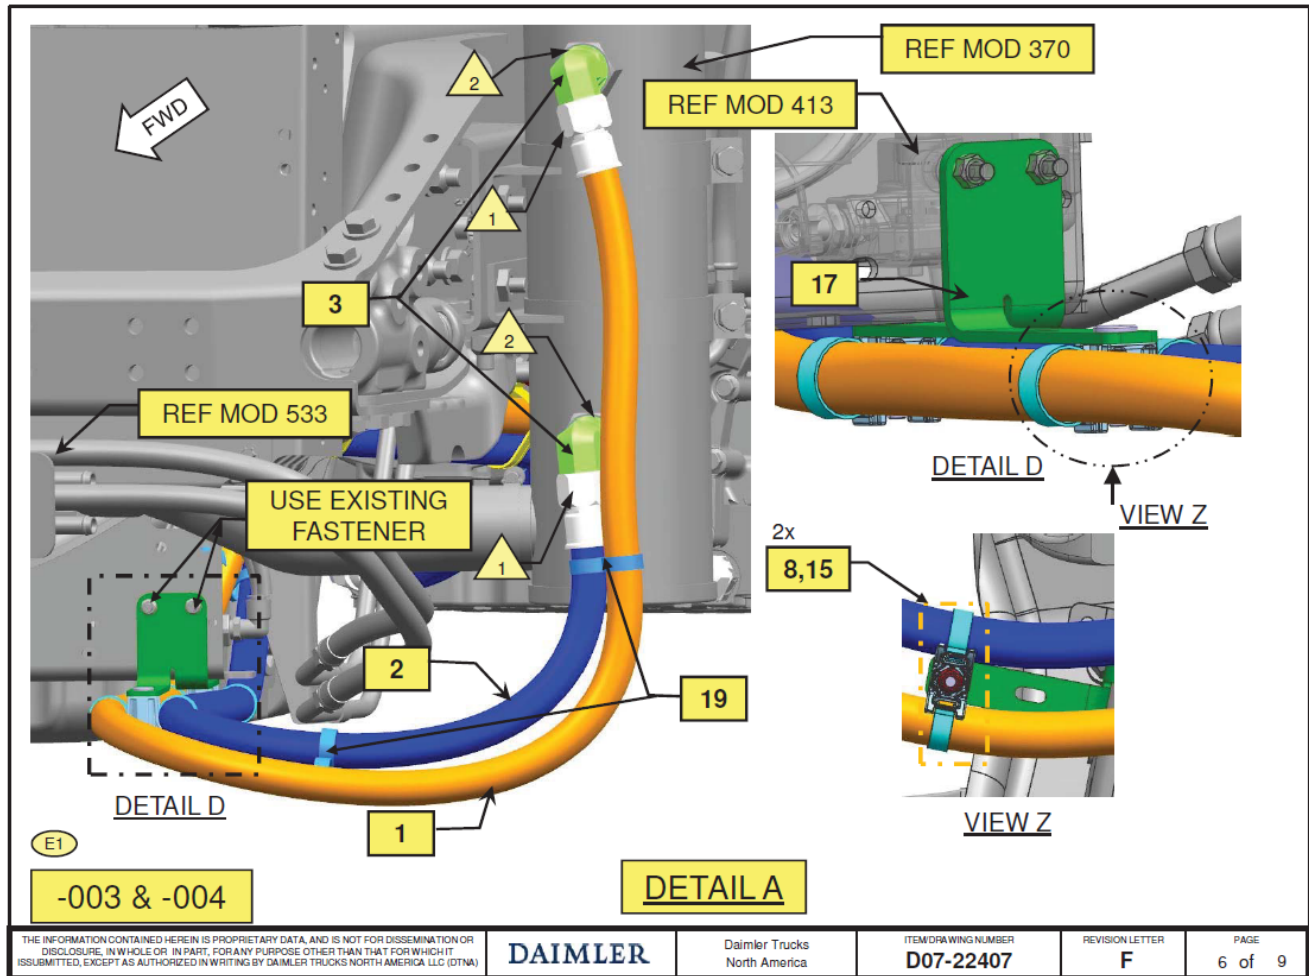
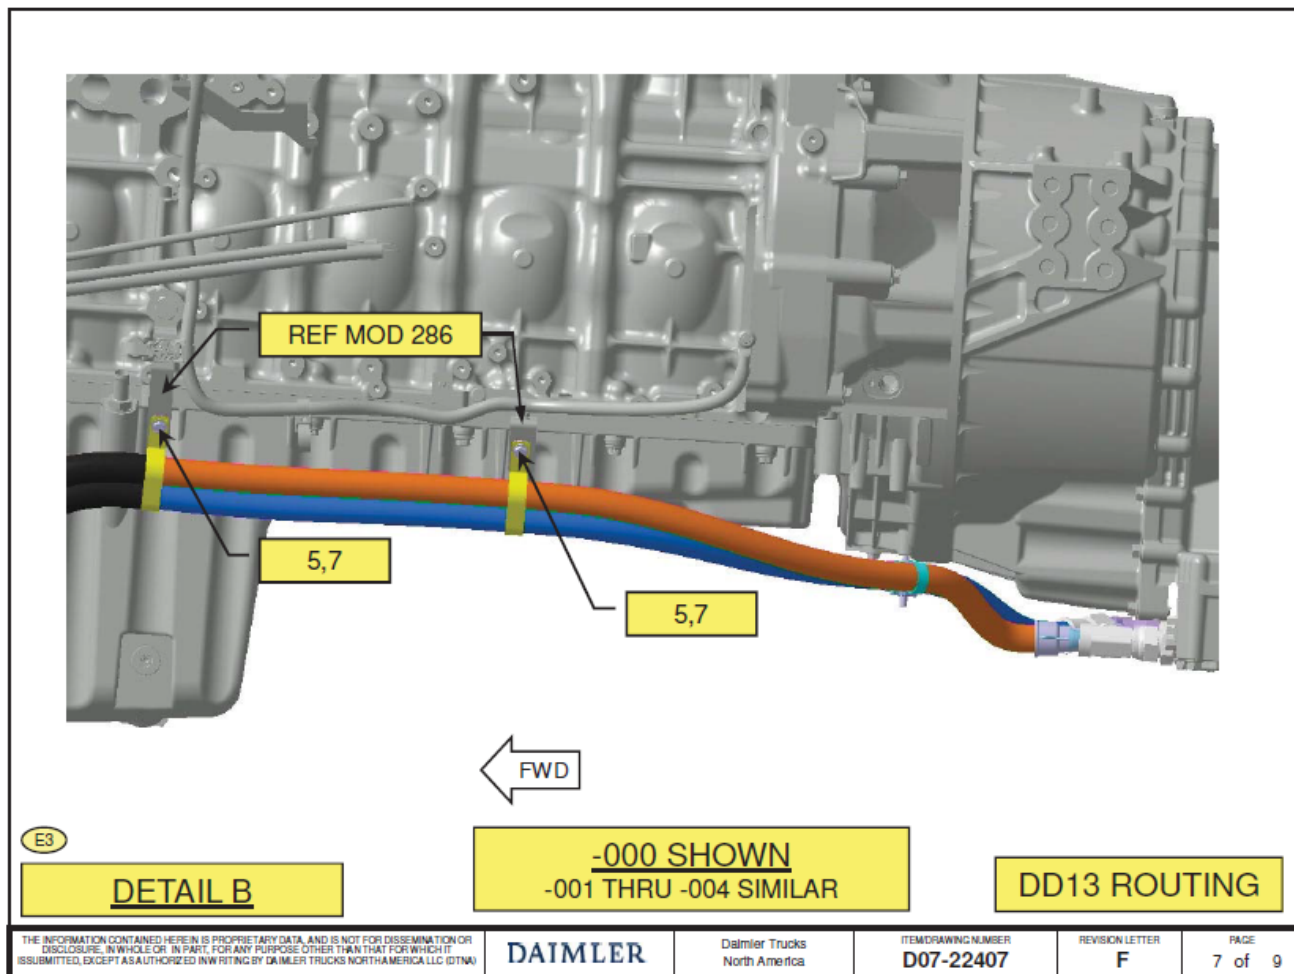
Follow new installation diagram D07-22407-003/004 to resolve issues:

Transmission cooler lines are routed below the oil pan where they may be exposed to potentially damaging road debris.

Transmission Cooler Lines routing has been revised to raise them higher in the truck eliminating the potential for damages due to road debris. New shorter Oil Cooler Lines are required besides new Clamps and a new bracket.
