Business Class M2  
Cascadia  
108SD/114SD  
> New Cascadia

**Freightliner  
Service Bulletin**

# Water Leaks Between Rain Tray and Nosebeam, New Cascadia

# 60-162

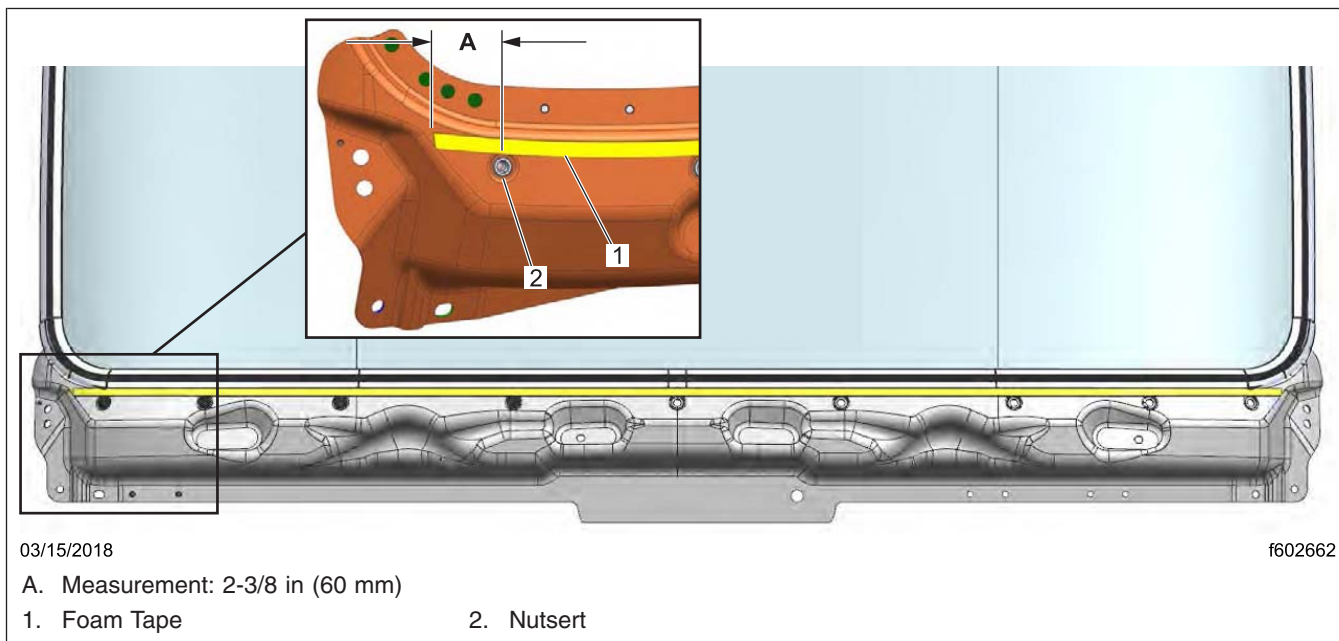
Fig. 4, Foam Tape Application

On some New Cascadia vehicles, the rain tray can warp and leave gaps, which can allow water to get past the seal and leak down the front wall. From March 21, 2018, foam tape has been installed between the rain tray and the nosebeam to prevent water leaks. On vehicles built before March 21, 2018, if water is found to get past the rain tray, use the procedure in this bulletin to install the foam tape.

6. On the passenger side, remove the screws that attach the cowl panel to the end of the rain tray and the hood support.
7. Remove the screws that attach the rain tray to the cab front wall.
8. On the passenger side of the vehicle, pull the cowl outboard and remove the rain tray.
9. Apply foam tape to the nosebeam as shown in [Fig. 4](#) and [Fig. 5](#). Align the tape along the tops of the nosebeam nutserts, extending 2-3/8 in (60 mm) outboard of the outboard nutserts on both sides of the vehicle.
