# SS 1033628 New Cascadia Ground Strategy - Steering Wheel Clockspring Failures

### **Applicable Vehicles**

All New Cascadia models (P4).

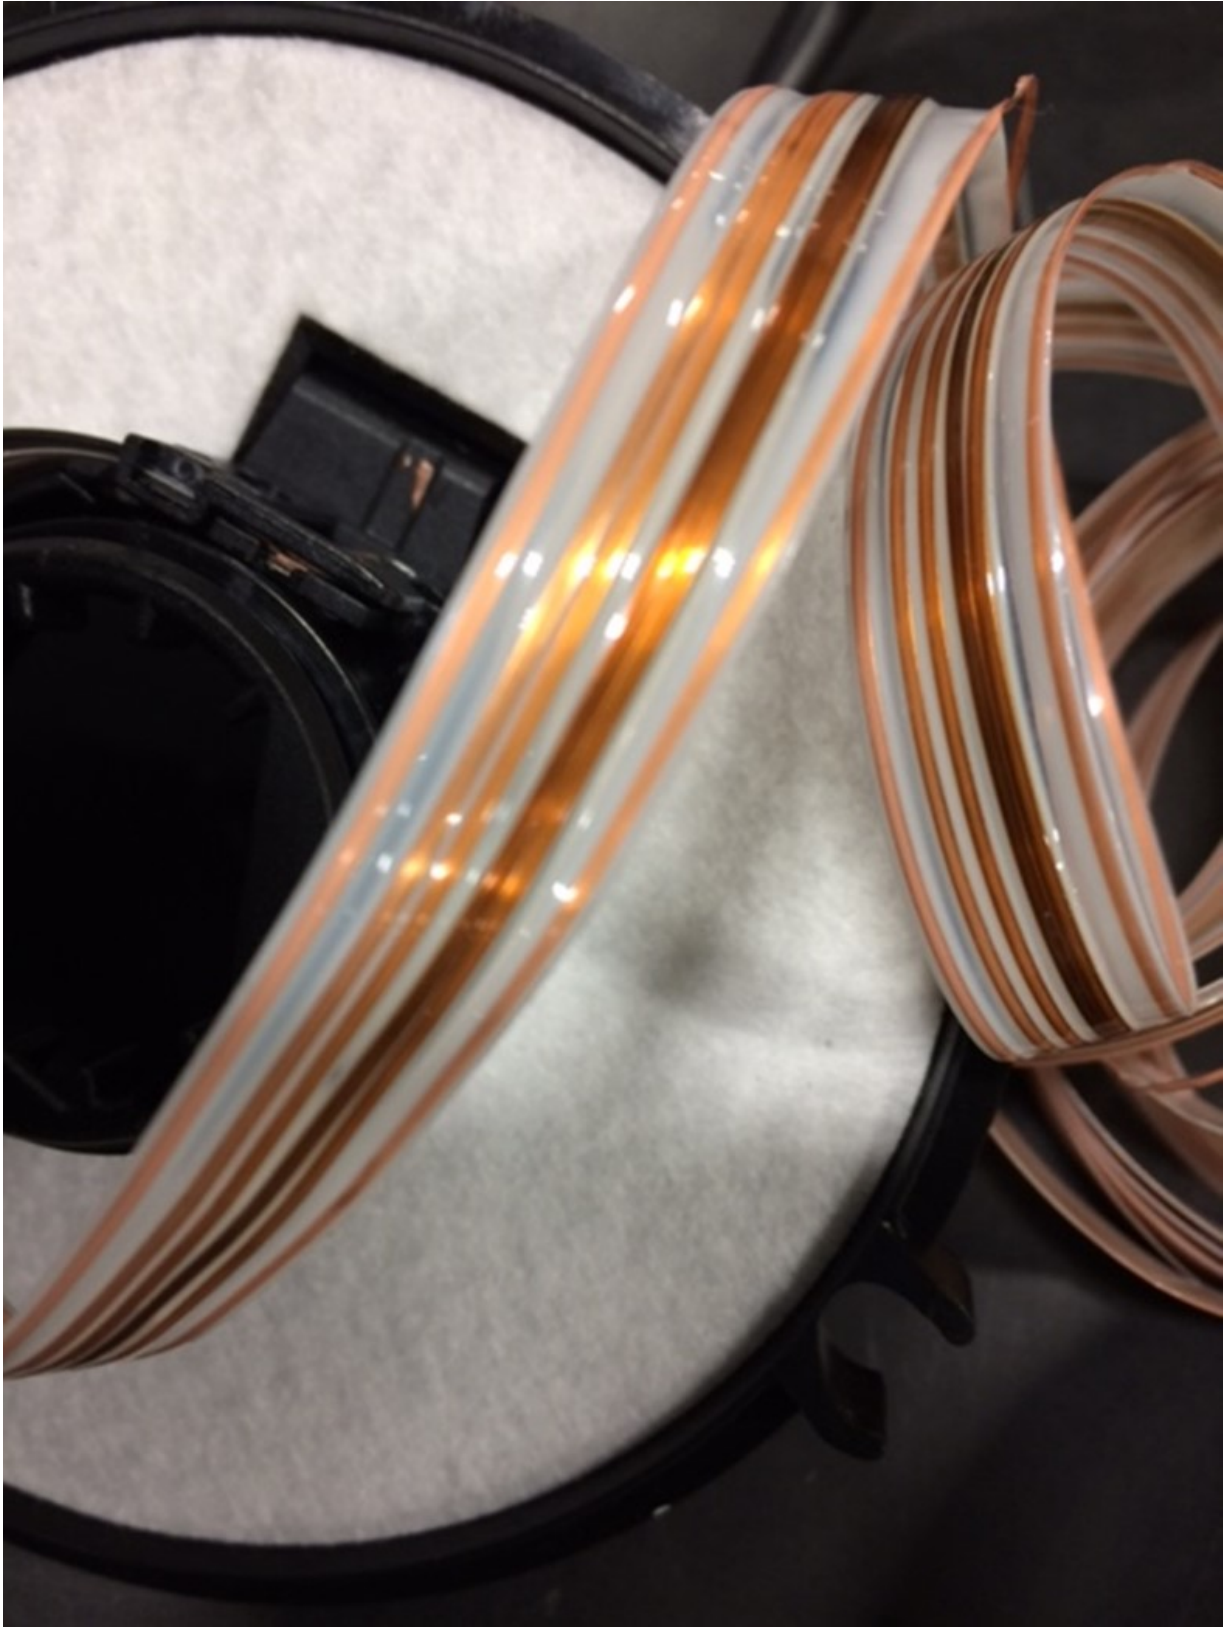
New Cascadia products have a new **separated ground strategy** that must be strictly adhered to. Incorrect mapping of the ground circuits may allow backfeed and overload an isolated portion of the grounds, possibly resulting in component damage (e.g. steering wheel clock spring, base part number 14-19090). Please see the [DTTS Insider 1: New Cascadia - Separated Ground Strategy](#) instructional material for additional information on this ground strategy.

Units reporting symptoms like those above may find failure of the clockspring, with delamination of the internal ribbon, overheating, and shorting or fused circuits, as pictured here:

If you find the clockspring failed in this way, inspect the frontwall GNDE / GNDP installation near the MGJB for correct ground separation and correct as needed.

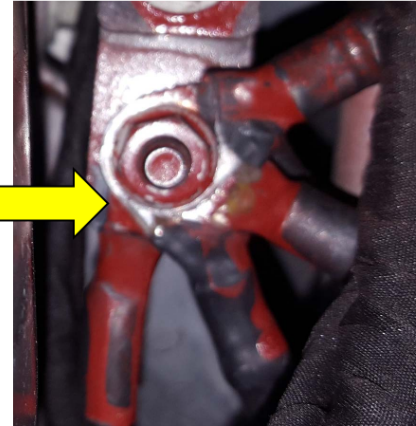
Non-isolated stud (GNDP)

Currently, every New Cascadia should have **FOUR** GNDP ring eyes here, **NOT** on the MGJB. Look for labels and white tape. The exception is the GNDP skin, which is not currently marked.

1. Cab skin stud (under cab)
2. Frame rail stud (near engine mount)
3. FWD GND module (28G)
4. AFT GND module (28G)  
(GND module A06-90236-000)

- There are a total of four (4) circuits on ring eyes that must be attached to the GNDP non-isolated stud on EVERY TRUCK. If you have more or less than four (4), it is not correct.
- Make sure all ring eyes are "fanned-out" correctly to get maximum "flat surface" contact.
- These cables are often identified by a label marked "GNDP" and white tape wrap, BUT NOT ALWAYS (the cab skin cable does not have ANY packaging currently).
- This non-isolated stud is not a return path to ground through the bracket. It relies on the cable returning it to frame to get proper return to ground.
