SS 1033833 Cascadia Parksmart 100 amp Durakool relay upgrade

Cascadia and New Cascadia built prior to 1/15/18.

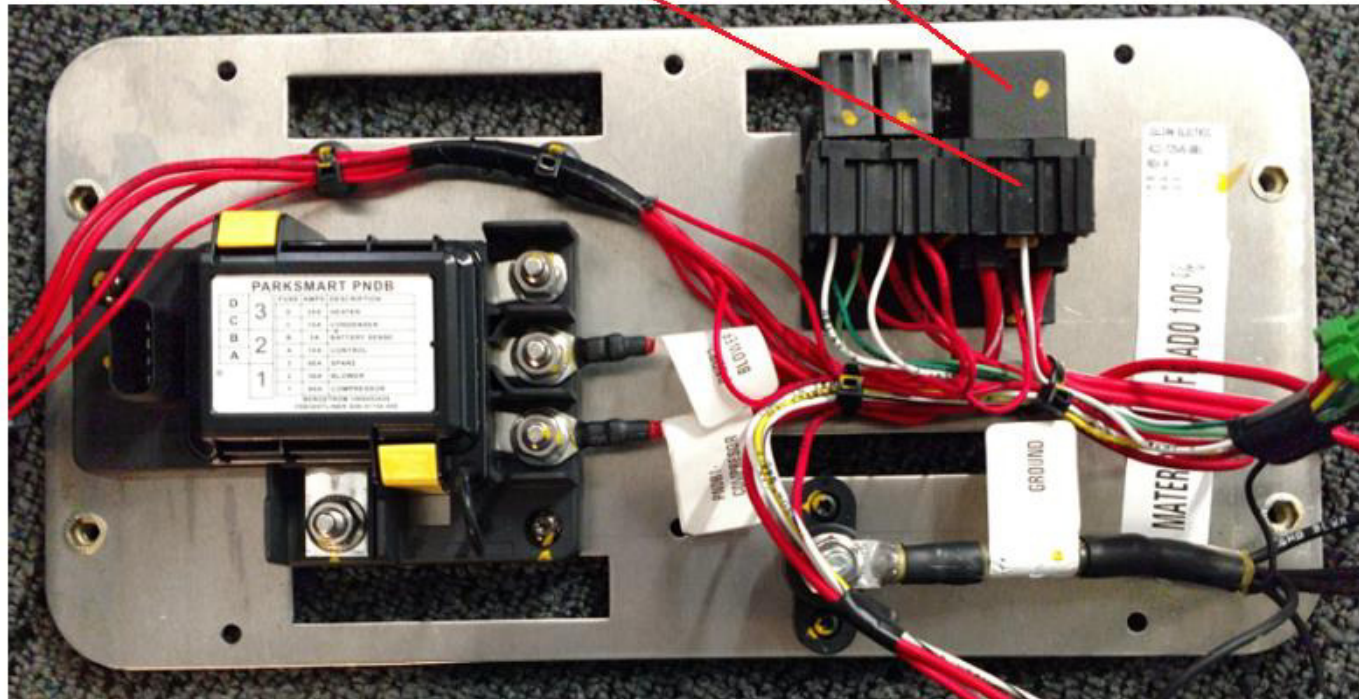
Parksmart compressor fails to operate due to distortion of the Dilblock for the LS1 100 amp Durakool relay.

-001 version. Note 100 amp Durakool relay and related dilblock assembly.

Remove the Dilblock and 100 amp Durakool relay and replace with a 150 amp HD relay. See attached.

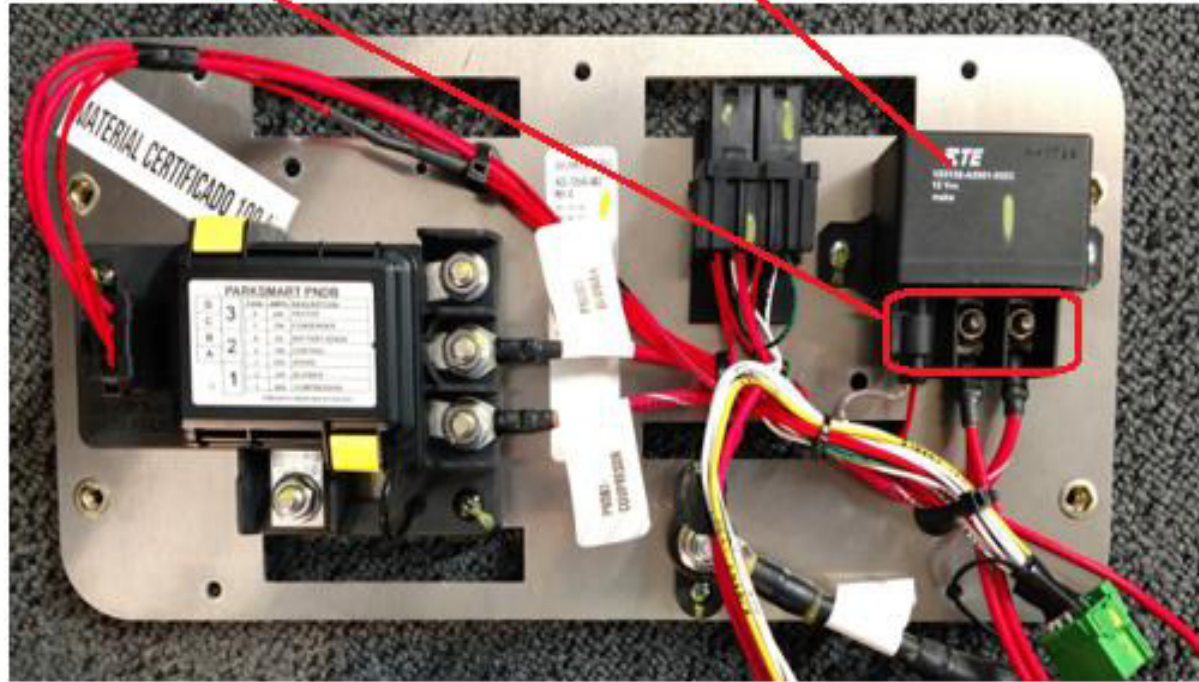
-003 version. Note 150 amp high current relay and lack of dilblock assembly
