August 2018  
SF542A-Y  
REVISED NOTICE

## Subject: New Cascadia Retrofit

**Models Affected: Specific Freightliner Pre-series Cascadia models  
manufactured June 13, 2016, through February 13, 2017.**

The early production New Cascadia vehicles may not perform optimally under all conditions.

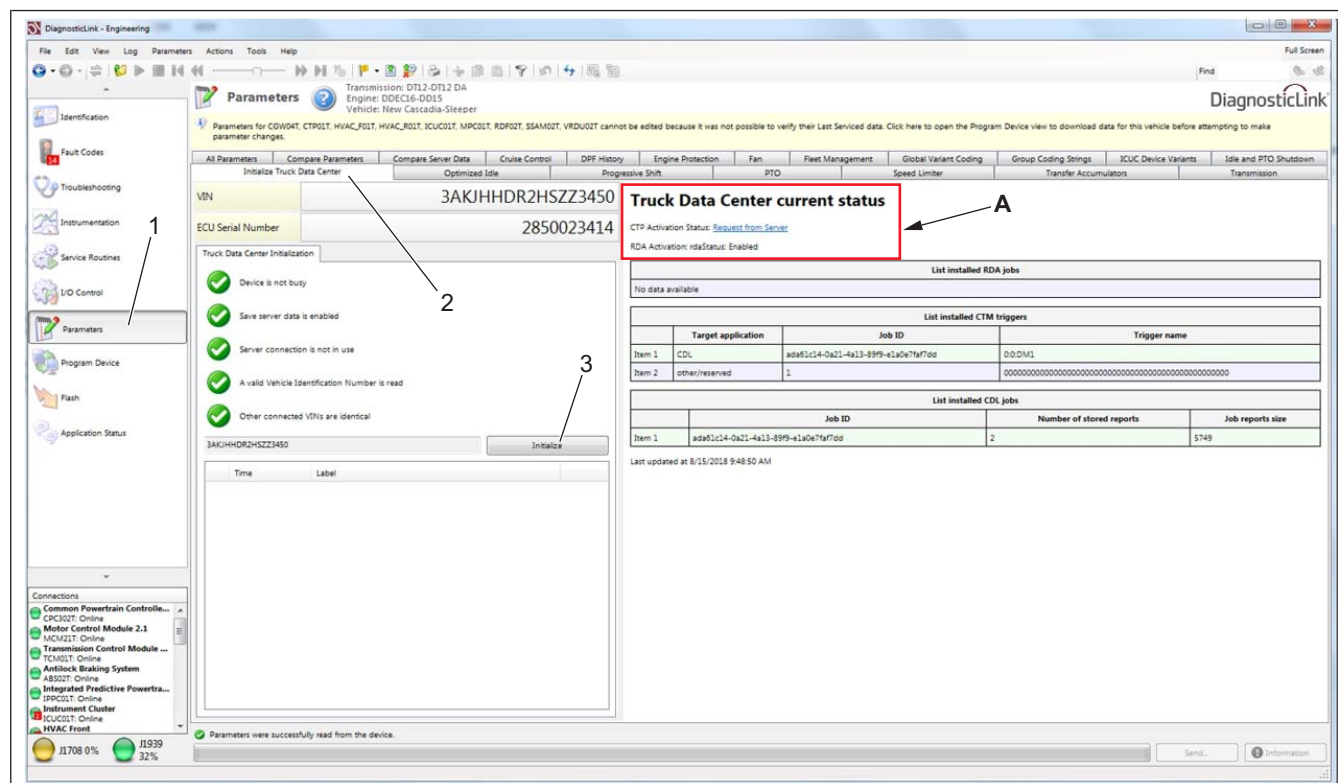
**Fig. 4, Initialize Truck Data Center Panel**

A. The cTP status can be verified by reviewing the "Truck Data Center Current Status" field.

7. Connect the antenna to the cTP, and all other connections that were removed earlier. See [Fig. 2](#).
8. Initialize the cTP.
  - 8.1 Connect the vehicle to DiagnosticLink. Click on "Parameters" then select the "Initialize Truck Data Center" tab. Run the initialization procedure by clicking on the "Initialize" button. See [Fig. 4](#).

- 8.2 Wait 15 minutes to allow the new cTP information to be processed on the servers.
- 8.3 Confirm the active status of the cTP by requesting the status in the upper right-hand section of the panel. Take a screenshot of the status to confirm initialization, and to submit with warranty claims.
9. Install the VPDM, but leave the cover open for the next procedure. Refer to Section 54.08, Subject 100 in the *New Cascadia Workshop Manual* for instructions.
