**Customer / Dealer Advisory**

**Subject: M2 All-Wheel Drive Passenger Side Step Modification.**

Models Affected: Specific Freightliner M2 106 manufactured January 27, 2017, through August 8, 2018 and equipped with an all-wheel drive chassis.

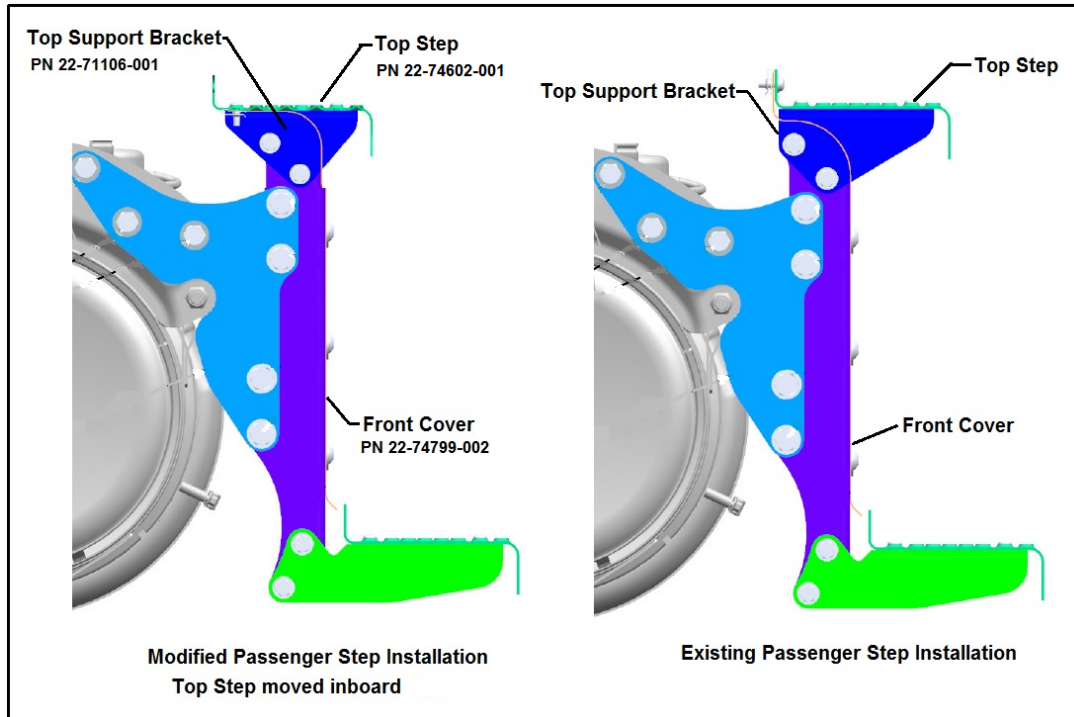
Fig. 1

**The passenger side top step will be relocated inboard to increase the horizontal spacing related to the bottom step, the top step will be moved inboard approximately 3.34”.**

1. Park the vehicle on a level surface, shut down the engine, and set the parking brake. Chock the rear tires.
2. Remove the existing passenger side top step. Save the fasteners for reuse. Fig. 1.
3. Remove front cover. Save the fasteners for reuse.
4. Remove the existing passenger side top support brackets. Save the fasteners for reuse.
5. Install the replacement top support brackets P/N 22-71106-001. Fig.1.
  - 5.1 Tighten the 3/8” fasteners to 26 ft lbs.
6. Install the replacement front cover P/N 22-74799-002.
  - 6.1 Tighten the 5/16” fasteners to 11 ft lbs.
- 7 Install the replacement top step P/N 22-74602-001
  - 76.1 Tighten the 1/4” fasteners to 5 ft lbs.
